Evaluating the Effects of Storm Water Infrastructure Projects on Flooding in Ghana

Robert Awuah Baffour, PhD, Abena Offe, MSc, Joseph Peter Nii Okai Otoo, BSc

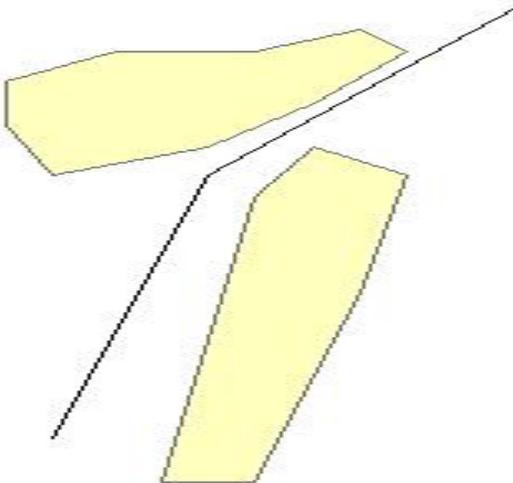
Figure 1: Extent of Flooding at Achimota before construction of Storm Water Infrastructure

The line in Figure 1 represents the storm water infrastructure. The two polygons show the extent of flooding in the area. Both areas have roads, residential, commercial and church buildings. There is also a railway line located in the area on the right of the infrastructure. The extent of flooding in the left and right areas is 3.51 acres and 2.96 acres respectively.

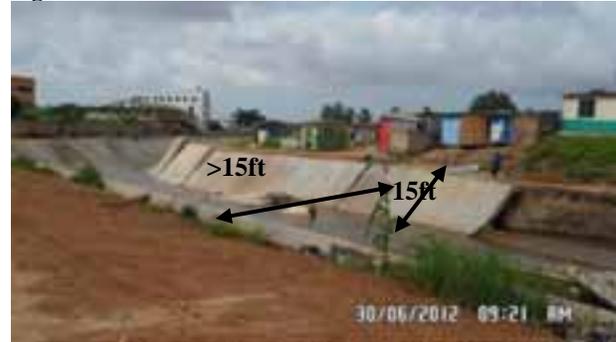
The storm water structure which was built to help manage flooding in Achimota is shown in Figure 2. It starts from an over head bridge and runs through to Apenka and Alajo.

Figure 2: Storm Water Infrastructure

Shape	Measurements		Structural make	General condition
	Height	Width		
Squared entrance (under bridge)	12ft	24ft	Pre-stressed reinforced concrete slabs	Bad; Poorly maintained
Trapezoidal open-end	15ft	40ft

Following the construction of the huge drain, flooding in the area is now a thing of the past. Areas that were previously submerged in water are now unaffected when it rains heavily. However, if the current state of the drain is not checked, it might not be able to serve the purpose for which it was constructed.

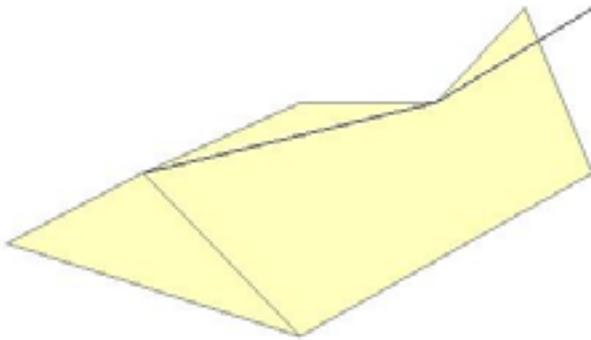
Figure 3: Extent of Flooding at Apenkwa before construction of Storm Water Infrastructure

The area covered by the floods during heavy down pour is approximately 4.16 acres. The floods cover residential and commercial buildings and some of the main access roads in the area.

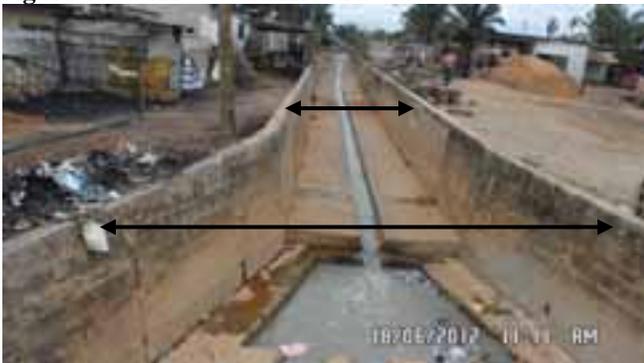
Figure 4: Storm Water Infrastructure

Shape	Measurements		Structural Make	General Condition
	Height	Width		
Squared	6ft	6ft	Concrete reinforced, cast in-situ	Not lined or plastered; Poorly maintained
Ends of drain at the mouth of bridge	6ft	7ft

The construction of the bridge and the storm water drainage has not helped the situation. There is a spill over from the drain when it rains continuously for days. According to local residents, an expansion of the current

infrastructure will help in solving the flooding problem in the area. Currently, the extent of flooding is still the same even though a drain was constructed. An assessment of the area indicates that an expansion can only be done if neighboring structures are demolished.

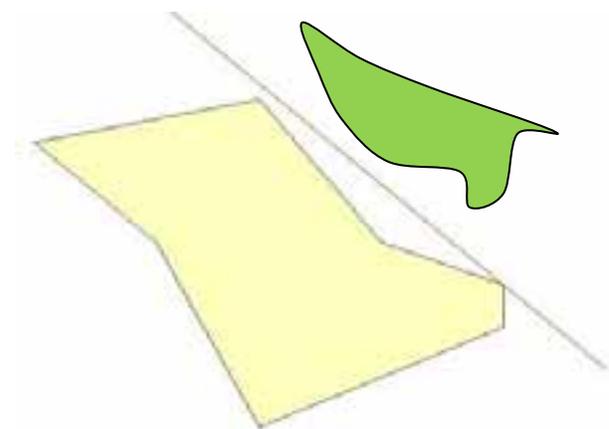
Figure 5: Extent of Flooding before and after Storm Water Infrastructure at Darkuman

The line represents the storm water structure. The area on the left side of the structure represents the flooding area before the construction of the drainage structure. This flooding area is estimated at 3.0 acres. This area is mainly occupied by residential buildings with some access roads. The area to the right depicts the flood situation after the construction. The flooding area has significantly reduced to 0.70acres.

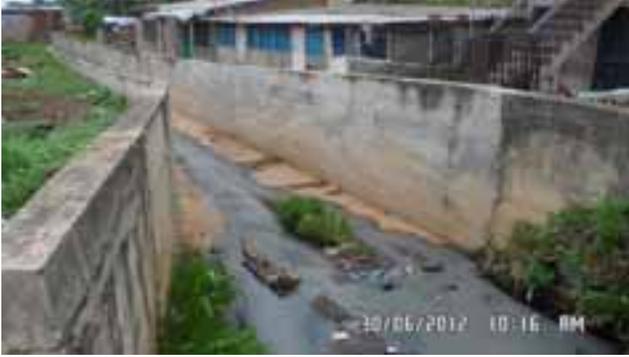
Figure 6 provides a pictorial view of this structure. The polygon shows the extent of flooding in the area. The infrastructure was constructed about three years ago.

Figure 6: Storm Water Infrastructure at Darkuman

Shape	Measurements		Structural make	General condition
	Height	Width		
Squared	7ft	12ft	Concrete reinforced, cast in-situ	Fairly good; Completion at left end is needed to guarantee optimum results
