# CityPlace Fire

## March 20, 2017

On Monday afternoon, at 3:00, what began as a simple welding task, within minutes sparked into a fire up the side of a post on the second floor of the southernmost residential building under construction. Eventually it erupted into the biggest fire in Overland Park's history.

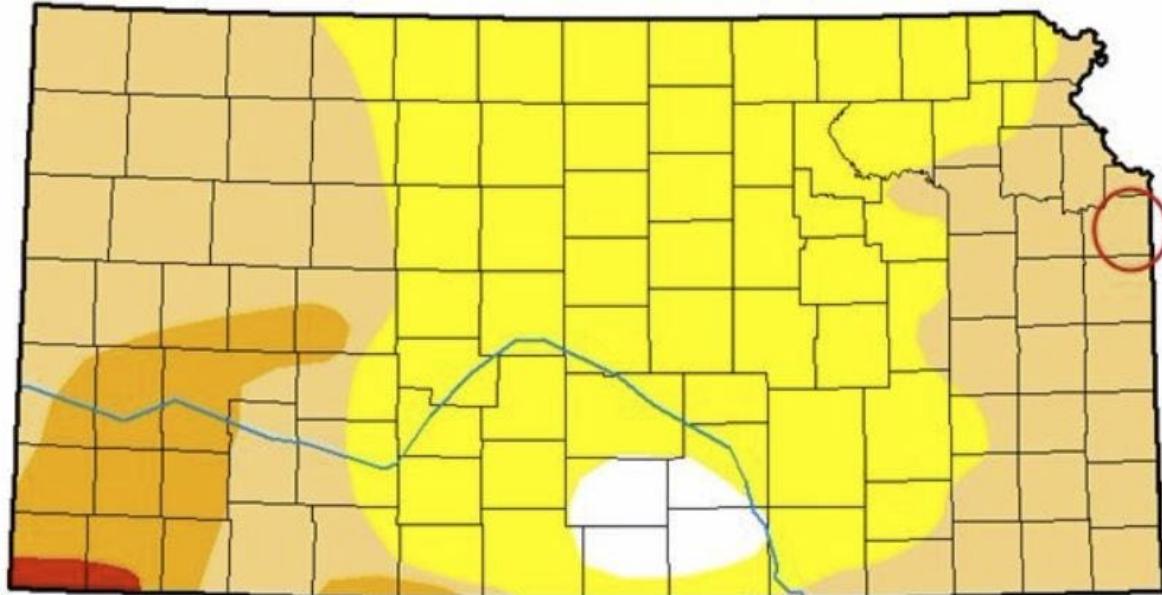
Weather conditions exacerbated the spread and affected the paths of more fires. The area experienced drought conditions for most of March.

*The Drought Monitor focuses on broad-scale conditions. Local conditions may vary. See accompanying [text summary](#) for forecast statements.*

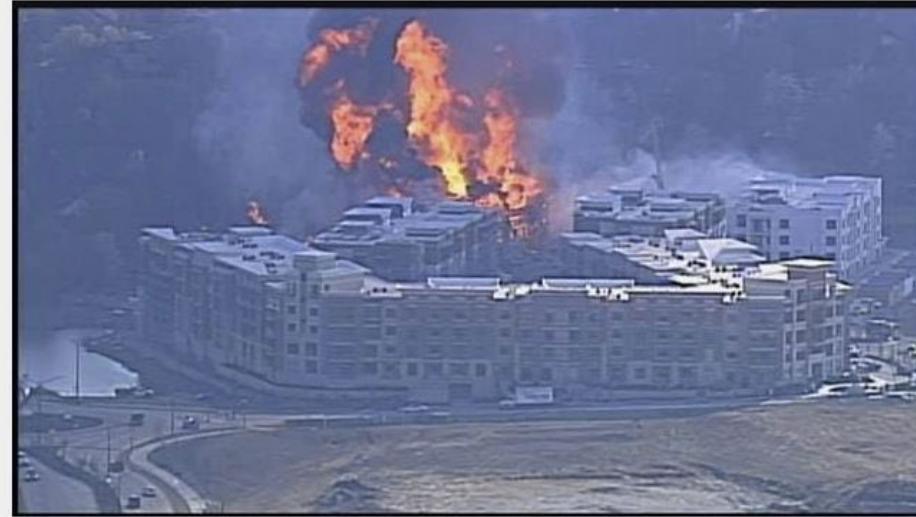
A local news broadcast showed radar imagery (left side of image) captured by the National Weather Service out of Pleasant Hill, Mo. The image displayed reflectivity from the plume as it moved southwest. The particle density ranges from **red**, representing the highest, to **green** showing the lowest. The radar image does not represent the location or extent of the fire, but the density of the plume at approximately 1500 foot view sometime after 4 p.m. It should be noted that embers which fell on houses, came from the plume area.

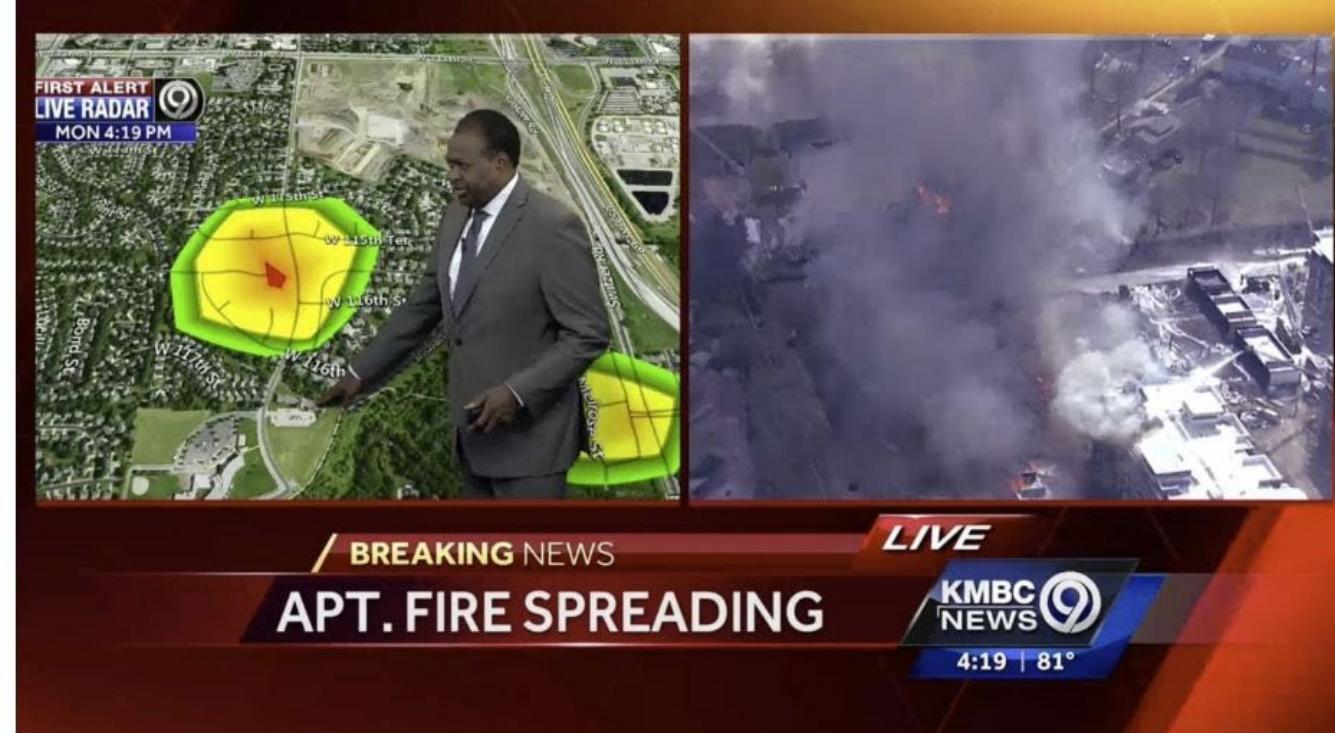
### Animated radar imagery

Animated imagery of radar provided by the National Weather Service shows the plume developing over the fire, then blowing to the south-southwest by the prevailing wind. The video begins at 3:20 p.m. and ends at 4:45 p.m. Color scheme shows high particle density in yellow and low density in green and blue.

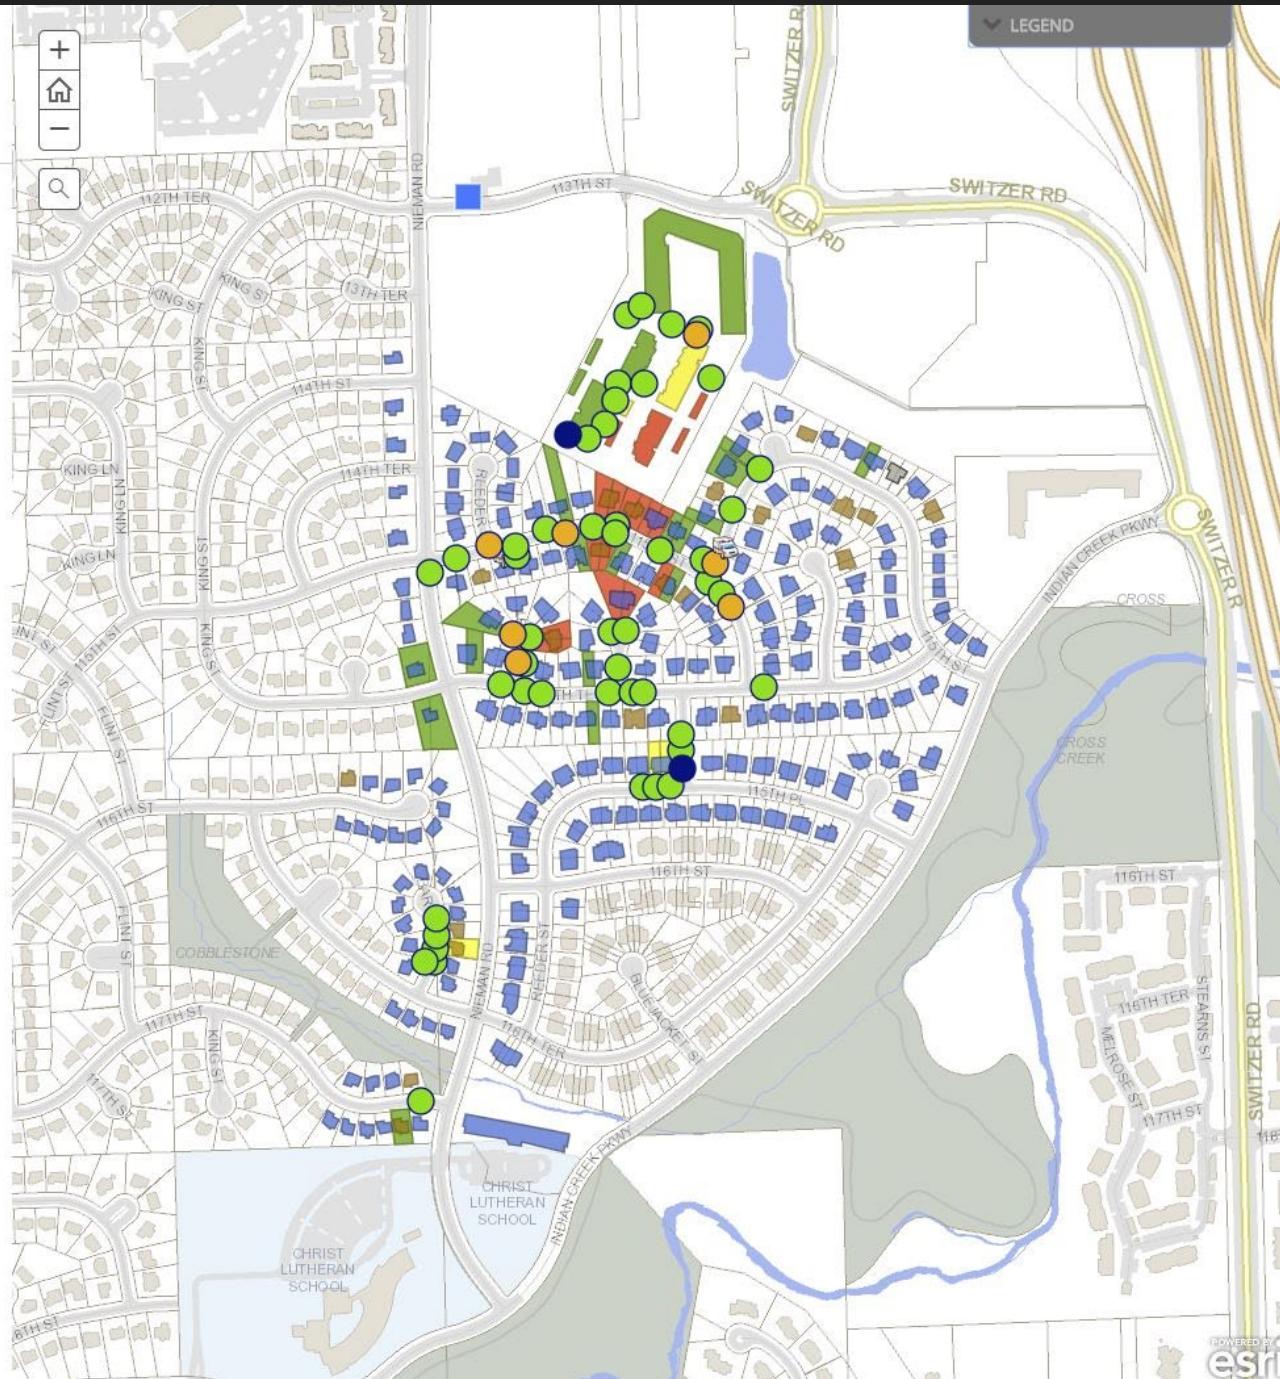
The adjoining map shows times of calls coming into dispatch along with locations of types of trucks. Shaded polygons show the extent of final damage.

*Legend for assignments:*

### *Green - primary*

### **Orange** - secondary

### *Blue - third*

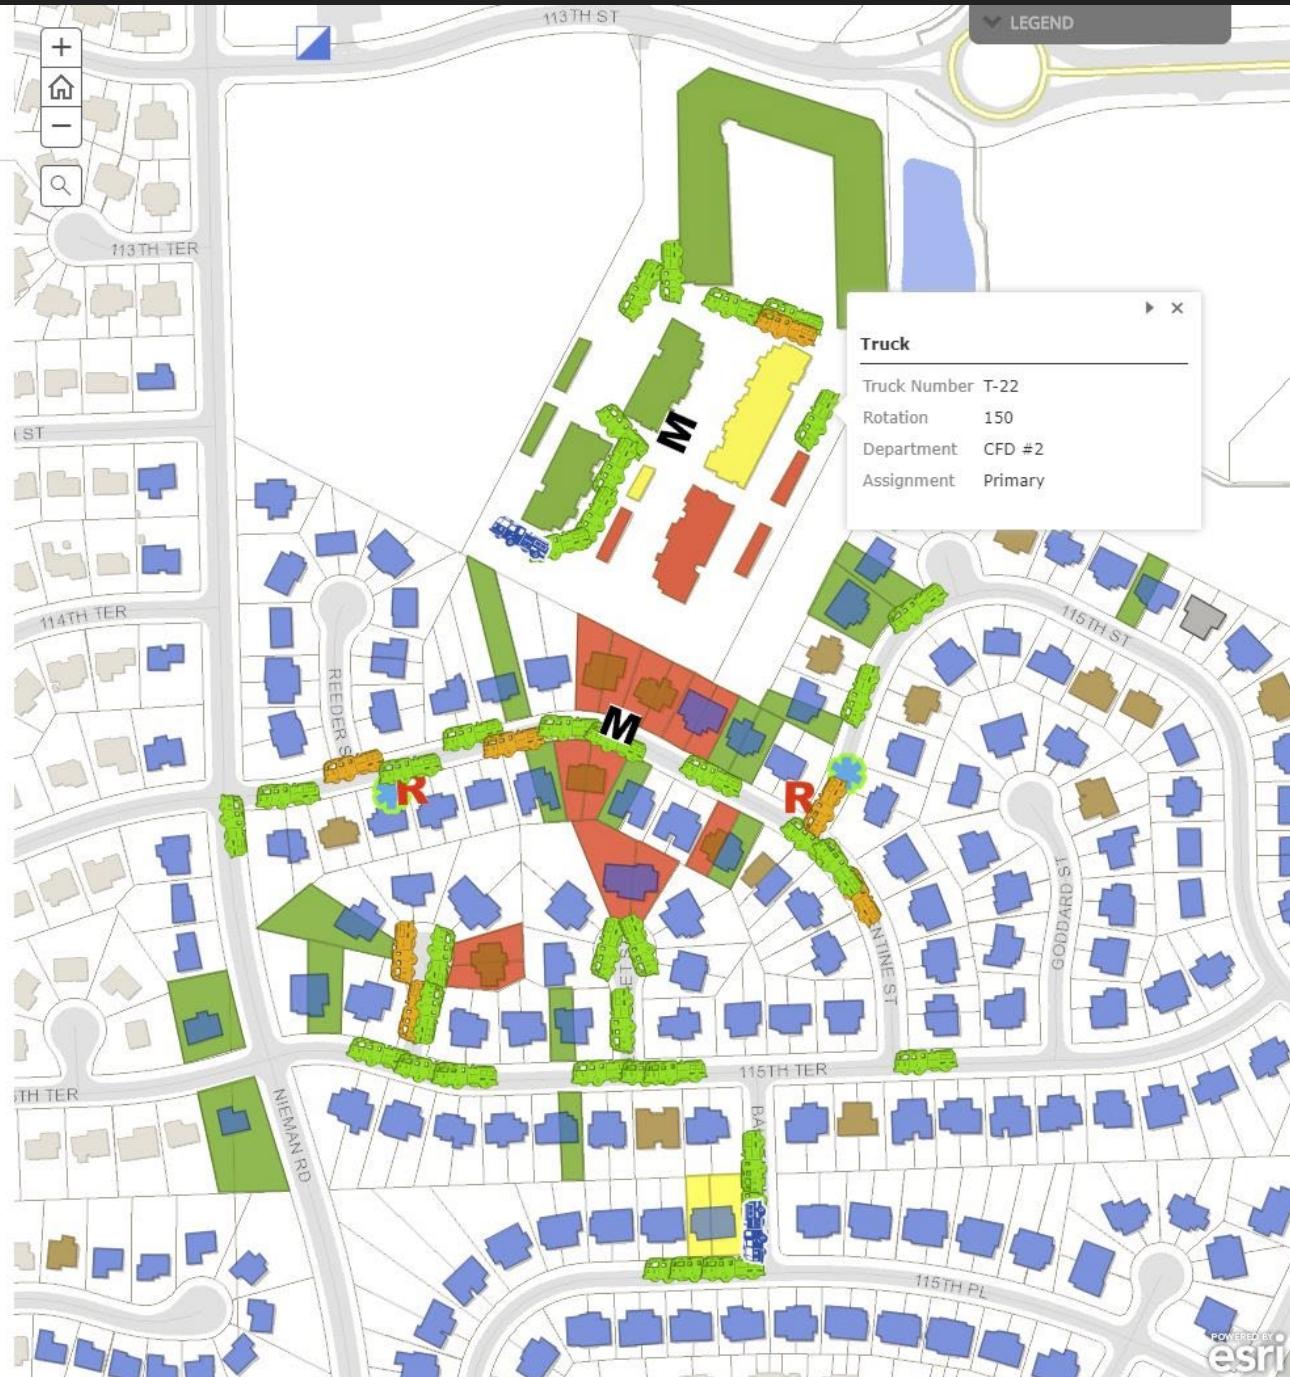
**Orange** - secondary

**Blue** - third

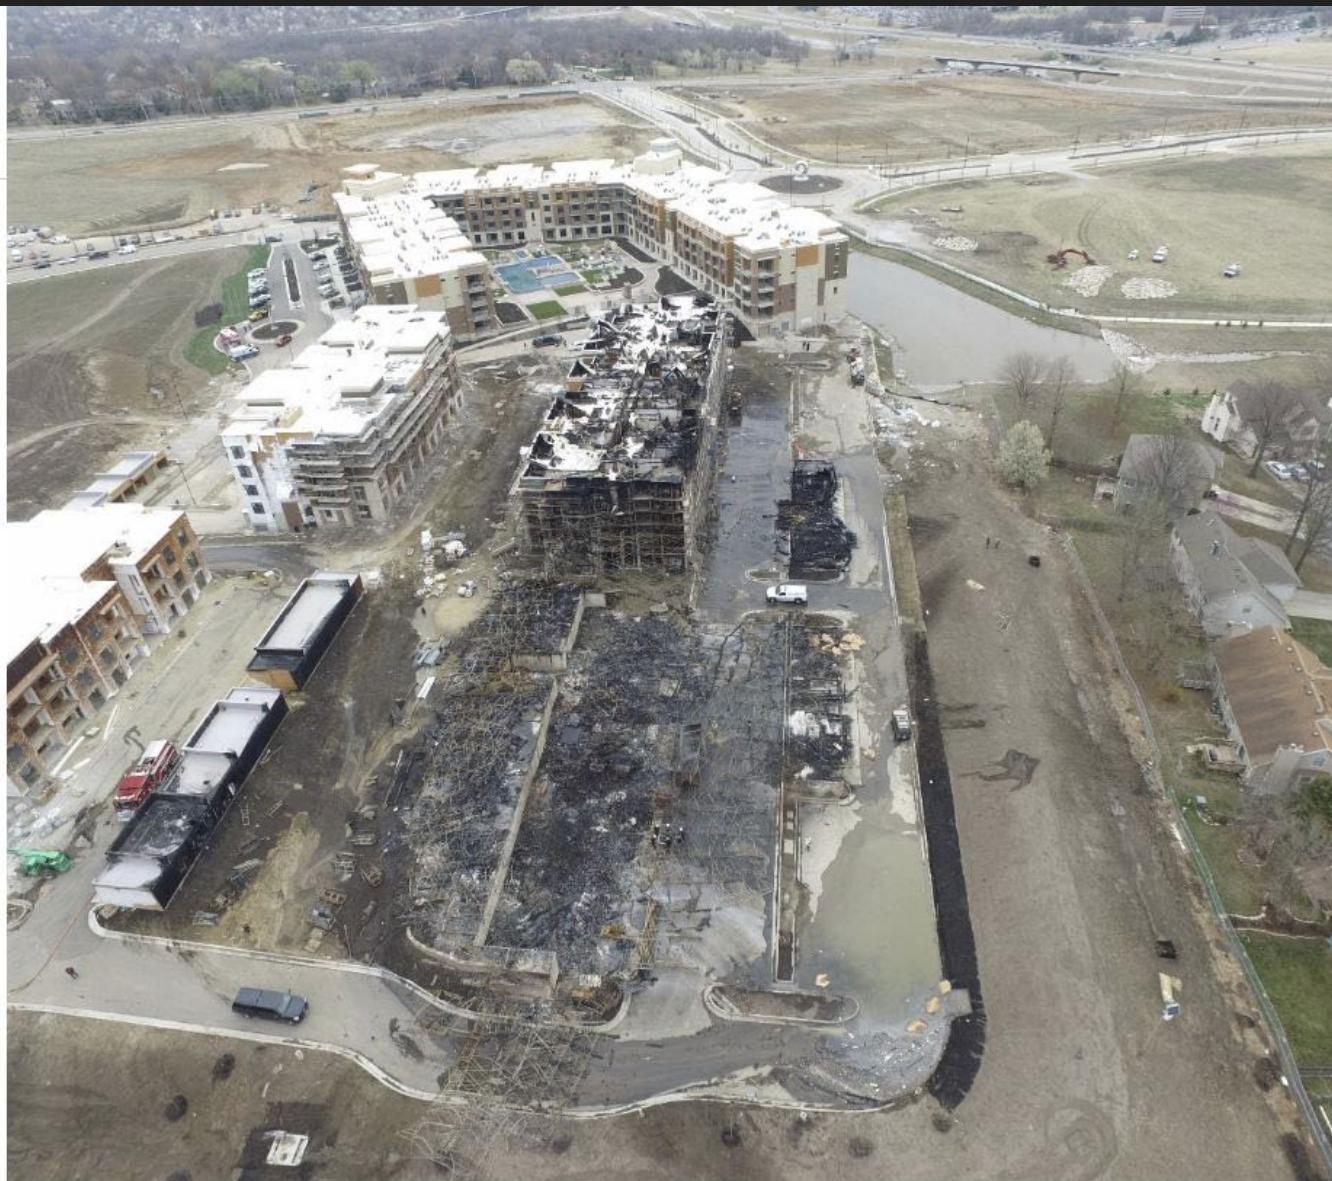
The new day revealed the extent of the damage. It covered an area of almost one-half mile by one-eighth of a mile. Three firefighters went to local hospitals to be treated for minor injuries and were soon released. No civilians were hurt.

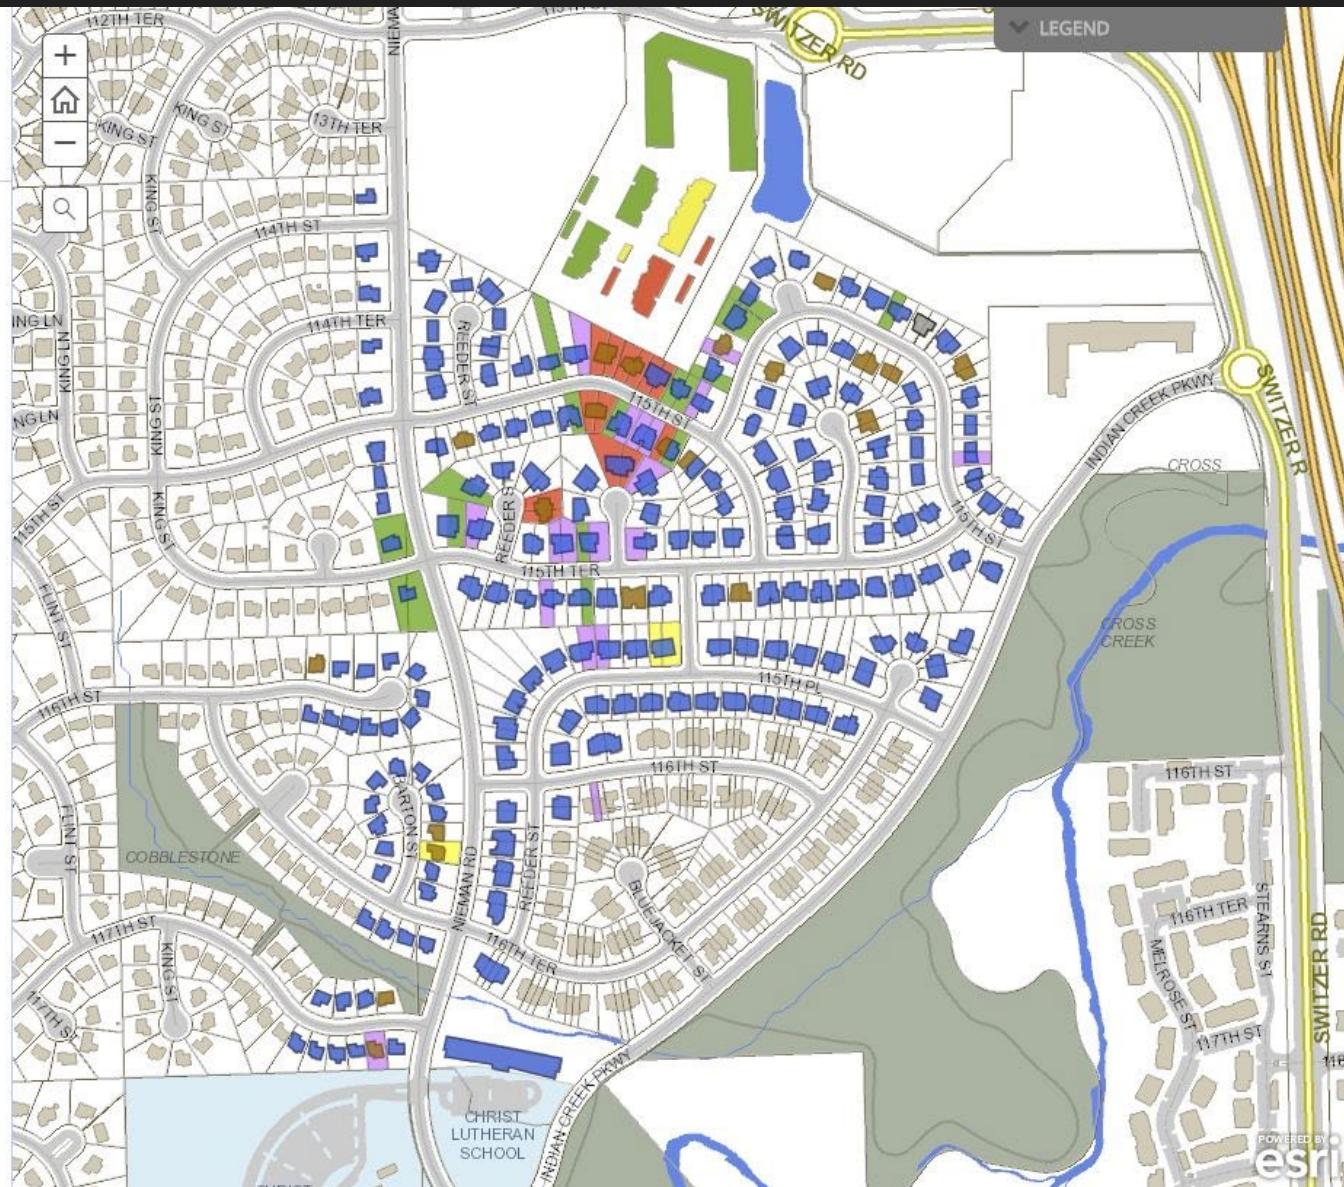
On the day of the fire, dispatch received calls from property owners related to damage to their property. The identified properties were part of the initial damage assessment by the OP Planning Department. These properties were divided into three major categories of assessment. (See the adjoining map.)

**Green** - Minimal damage, Safe to occupy  
**Yellow** - Structural damage, Limited entry  
**Red** - Serious damage or destroyed, Do not enter

Subsequent to the initial assessment were meetings with the surrounding property owners who called the OP Planning Department to report possible damage to their property related to the fire. These were recorded and are here shown in a **purple** shading.

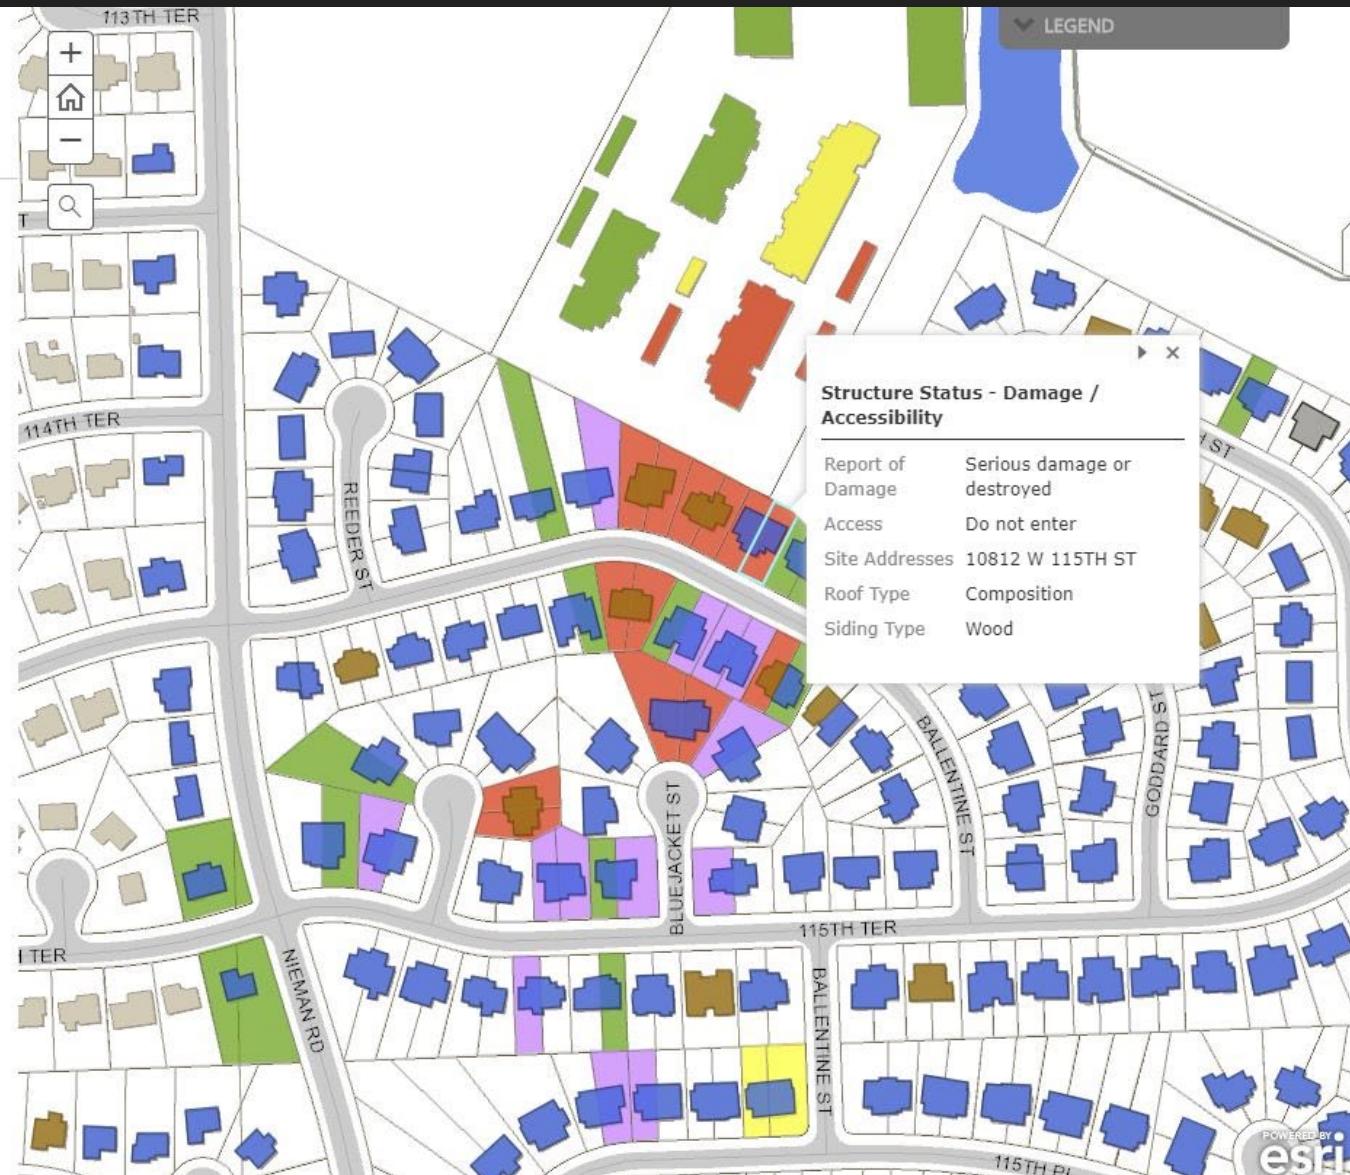
On the day of the fire, dispatch received calls from property owners related to damage to their property. The identified properties were part of the initial damage assessment by the OP Planning Department. These properties were divided into three major categories of assessment. (See the adjoining map.)

**Green** - Minimal damage, Safe to occupy  
**Yellow** - Structural damage, Limited entry  
**Red** - Serious damage or destroyed, Do not enter

Subsequent to the initial assessment were meetings with the surrounding property owners who called the OP Planning Department to report possible damage to their property related to the fire. These were recorded and are here shown in a **purple** shading.

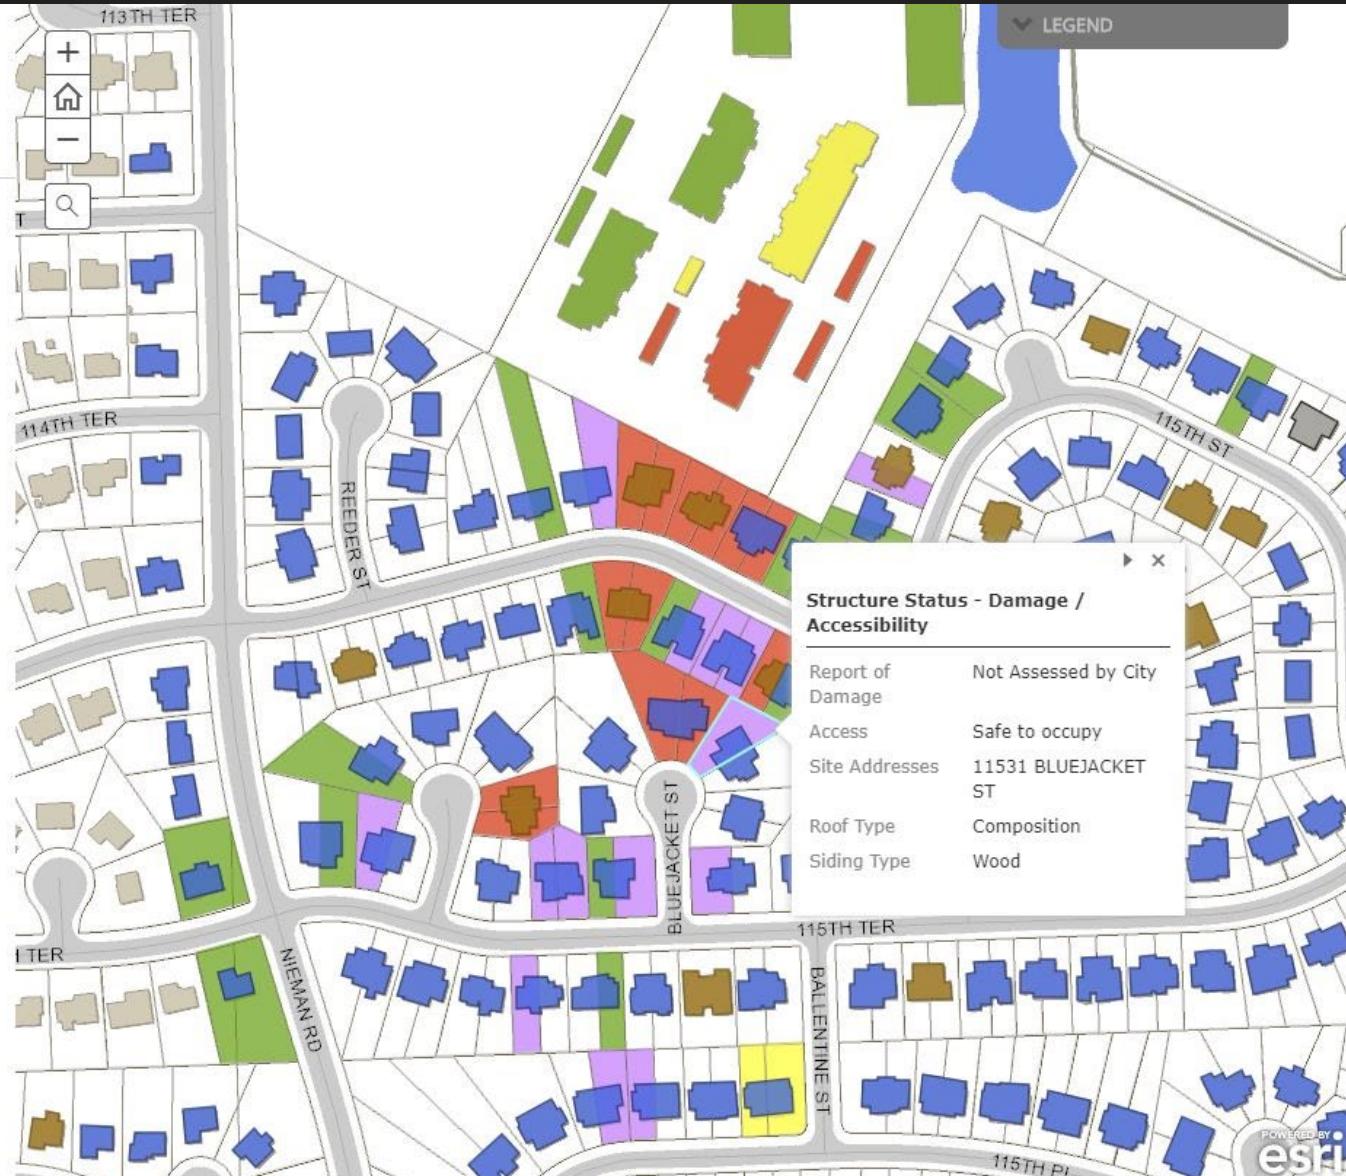
On the day of the fire, dispatch received calls from property owners related to damage to their property. The identified properties were part of the initial damage assessment by the OP Planning Department. These properties were divided into three major categories of assessment. (See the adjoining map.)

**Green** - Minimal damage, Safe to occupy  
**Yellow** - Structural damage, Limited entry  
**Red** - Serious damage or destroyed, Do not enter

Subsequent to the initial assessment were meetings with the surrounding property owners who called the OP Planning Department to report possible damage to their property related to the fire. These were recorded and are here shown in a **purple** shading.

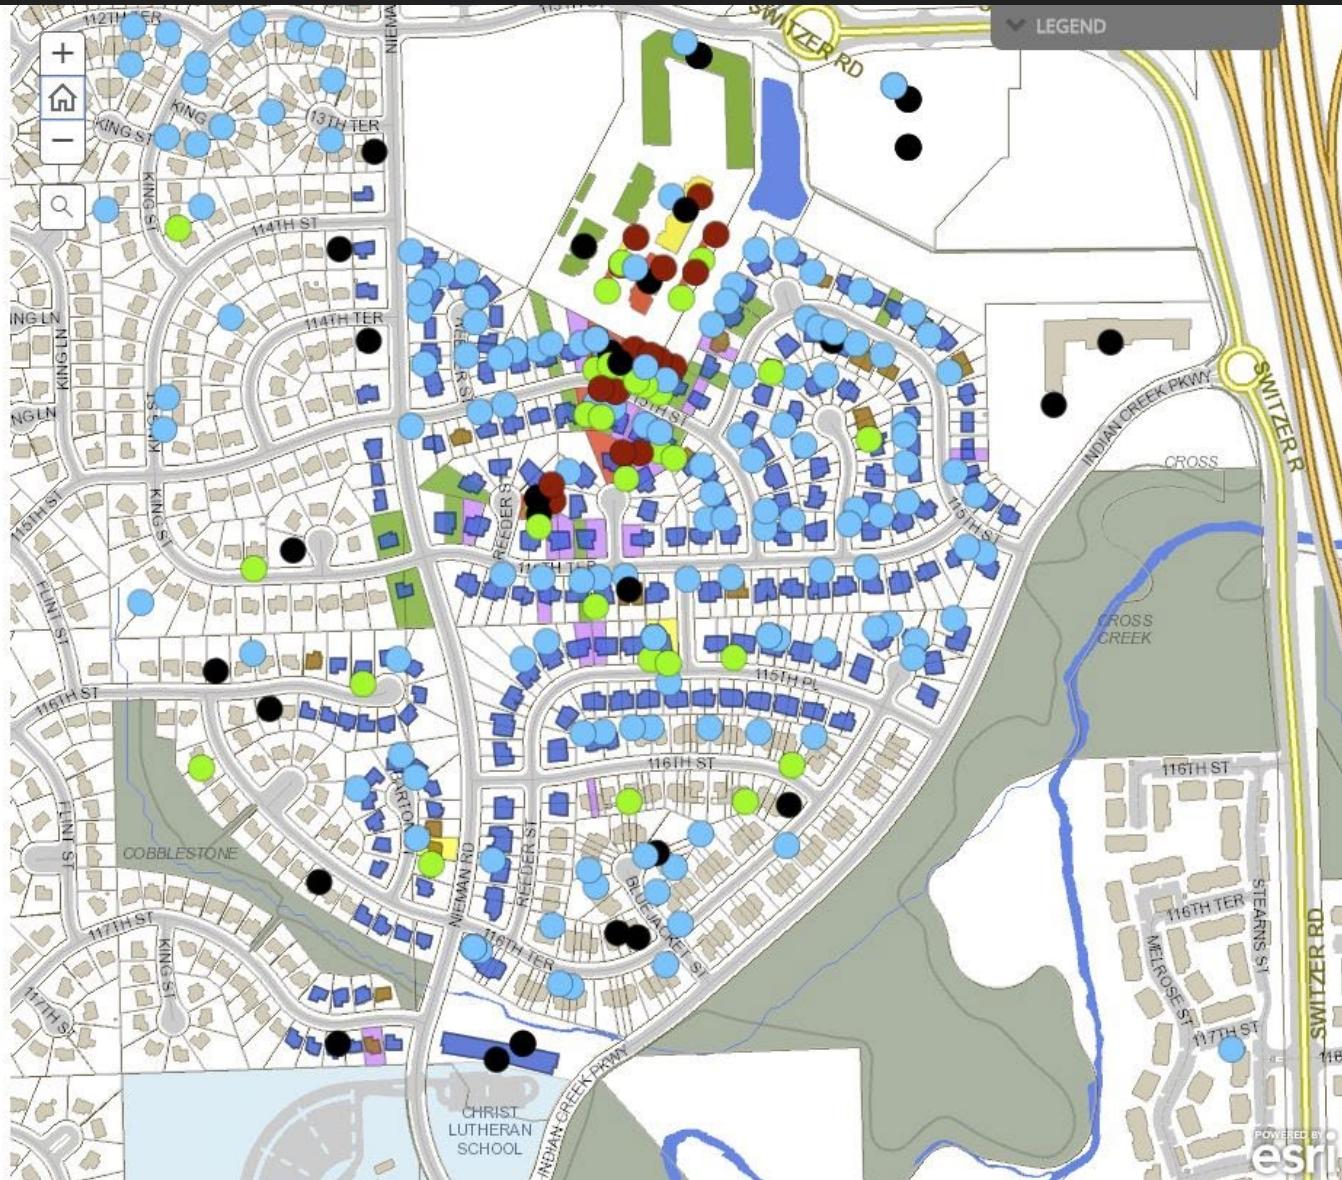
The adjoining map shows current status of properties which have requested permits for demolition, new work to rebuild or repair work since the fire.

*Light green* - Repair or miscellaneous permits

*Dark Red* - Demolition permits

*Black* - All other permits

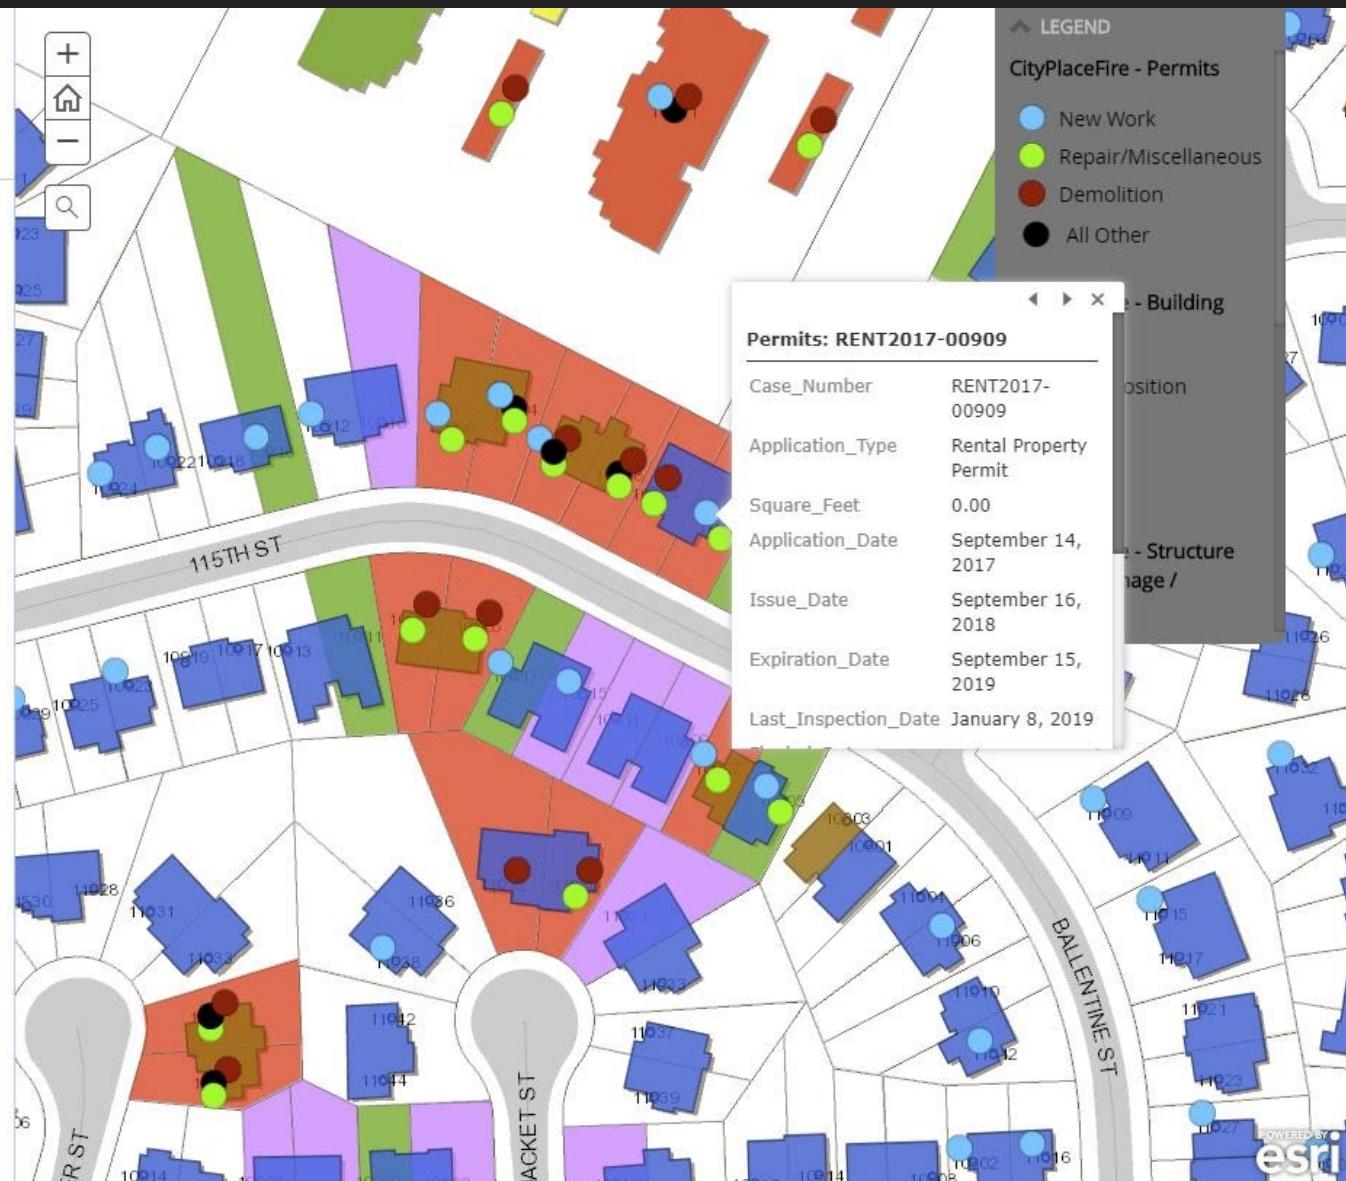
The adjoining map shows current status of properties which have requested permits for demolition, new work to rebuild or repair work since the fire.

**Light green** - Repair or miscellaneous permits

**Dark Red** - Demolition permits

**Black** - All other permits

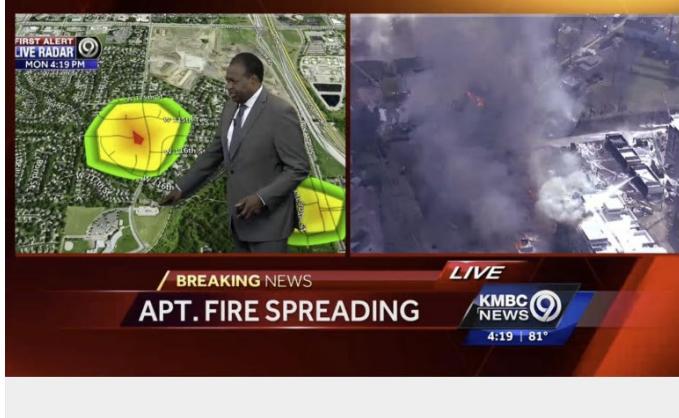
*News items showing radar reflection of plume over CityPlace*

A local news broadcast showed radar imagery (left side of image) captured by the National Weather Service out of Pleasant Hill, Mo. The image displayed reflectivity from the plume as it moved southwest. The particle density ranges from red, representing the highest, to green showing the lowest. The radar image does not represent the location or extent of the fire, but the density of the plume at approximately 1500 foot view sometime after 4 p.m. It should be noted that embers which fell on houses, came from the plume area.

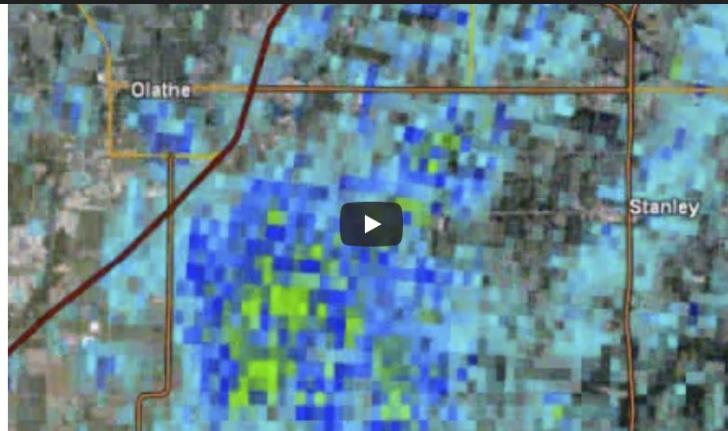
*Animation of radar imagery of plume by National Weather Service*

Animated imagery of radar provided by the National Weather Service shows the plume developing over the fire, then blowing to the south-southwest by the prevailing wind. The video begins at 3:20 p.m. and ends at 4:45 p.m. Color scheme shows high particle density in yellow and low density in green and blue.

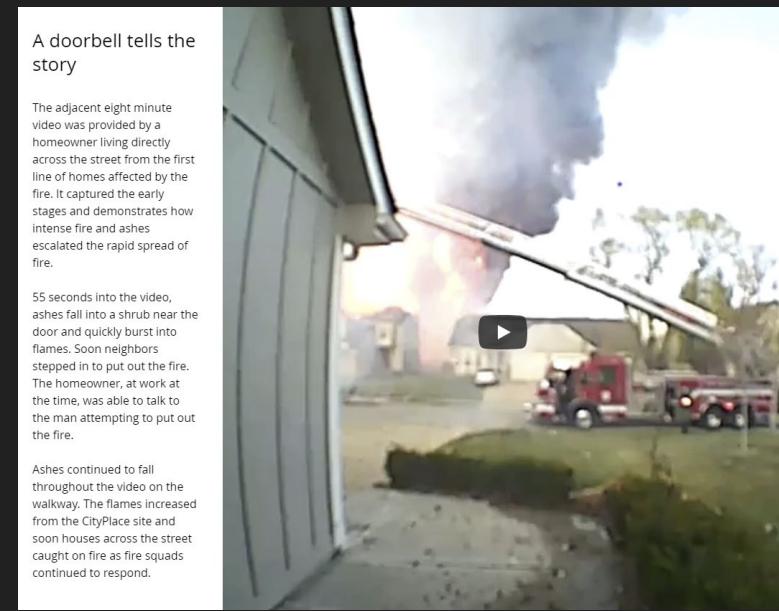
55 seconds into the video, ashes fall into a shrub near the door and quickly burst into flames. Soon neighbors stepped in to put out the fire. The homeowner, at work at the time, was able to talk to the man attempting to put out the fire.

*Doorbell video provided by homeowner which allowed them to see active intensity of fire and how embers were a factor in the spread of the fire.*
