Impacts of Acid Mine Drainage: Building Streams Database and Analyzing Toby Creek Sub-Basin

Yasser Ayad, Paul Ryberg, Vicky Bernecky and Jim Hnat

Clarion University of PA
Department of Anthropology, Geography and Earth Science
335 Peirce,
Clarion PA 16214
yayad@clarion.edu

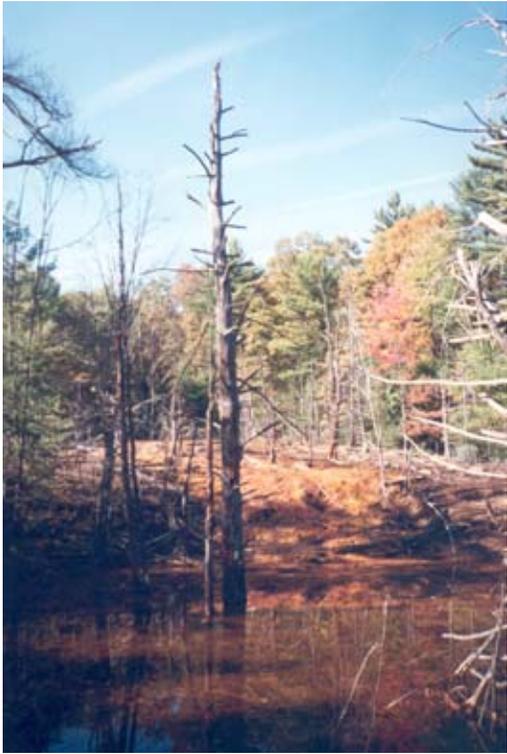
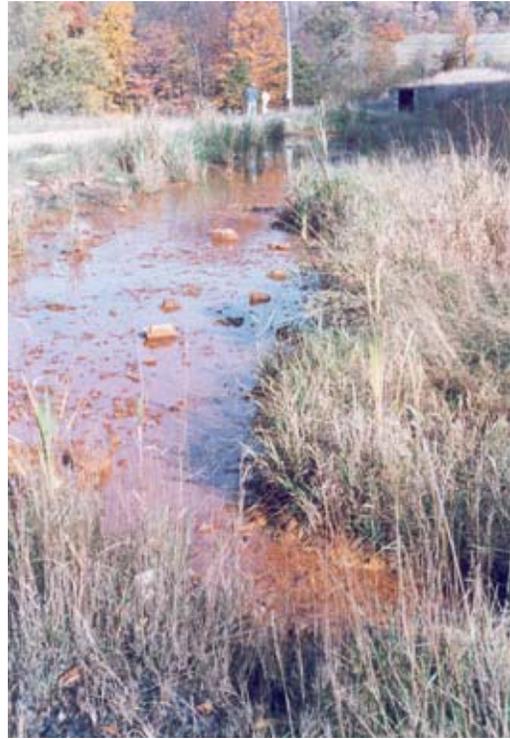
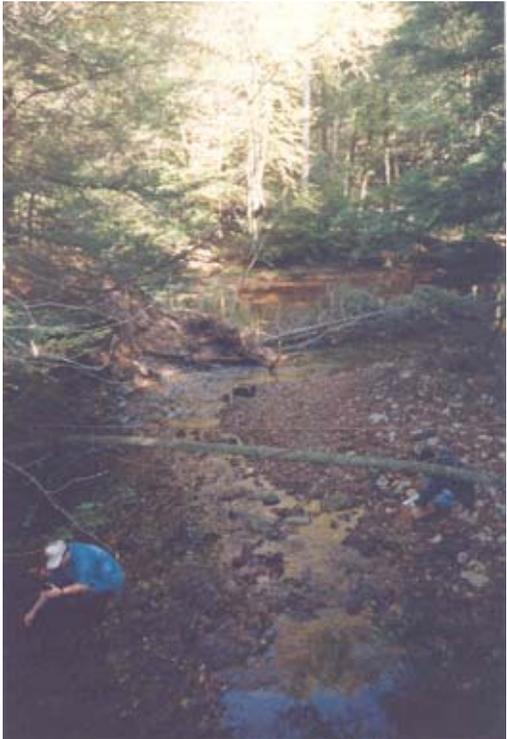
The watershed under investigation has been the subject of intensive mineral resource recovery operations from the early 1800. Primarily, these activities have included the surface and underground extraction of bituminous coal and the drilling for petroleum and natural gas (PA-DEP, 1976). Parts of the watershed are affected by severe AMD from several surface coal strip mines and a few abandoned deep shaft mines. Mining activity ceased in the late 1930's, but water quality problems persist to this day at several locations. Headwater stream reaches unaffected by mining activity have near-neutral pH and normal water quality characteristics, which sustain small populations of small native brook trout. Fish and other aquatic life are totally absent in lower reaches of the stream because of low pH values and very high iron and Total Dissolved Solids (TDS) content (See photos 1-4).
