# Quantitative Slope Stability Mapping With ArcGIS: Prioritize Highway Maintenance

**Pankaj Bhattarai, Binod Tiwari, Hideaki Marui and Kiyomichi Aoyama**

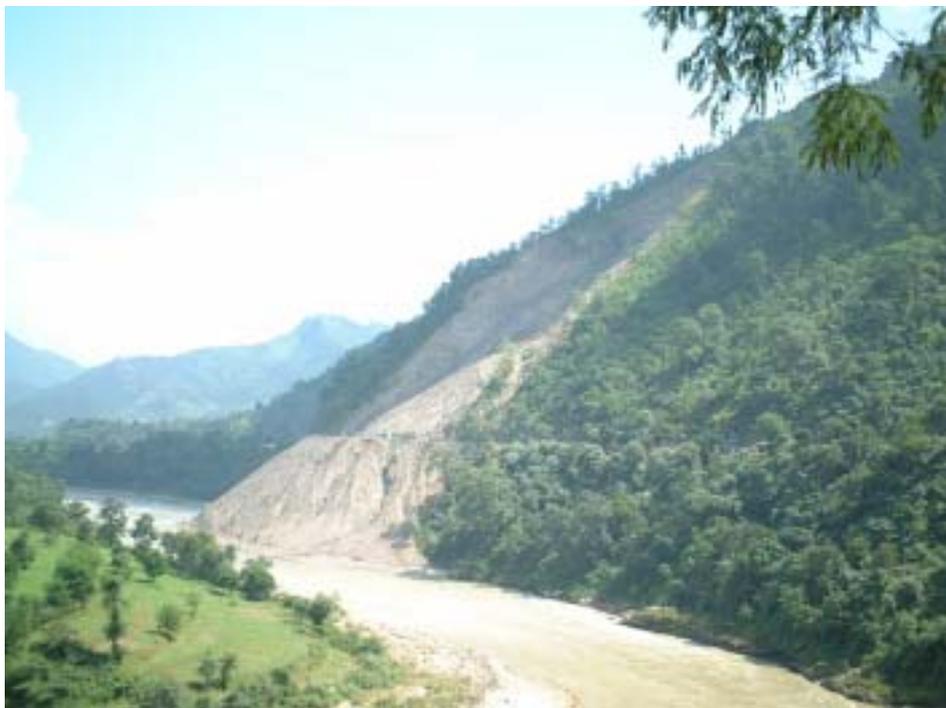
Photo 1: Krishnabhir landslide one of the troublesome landslides along study stretch

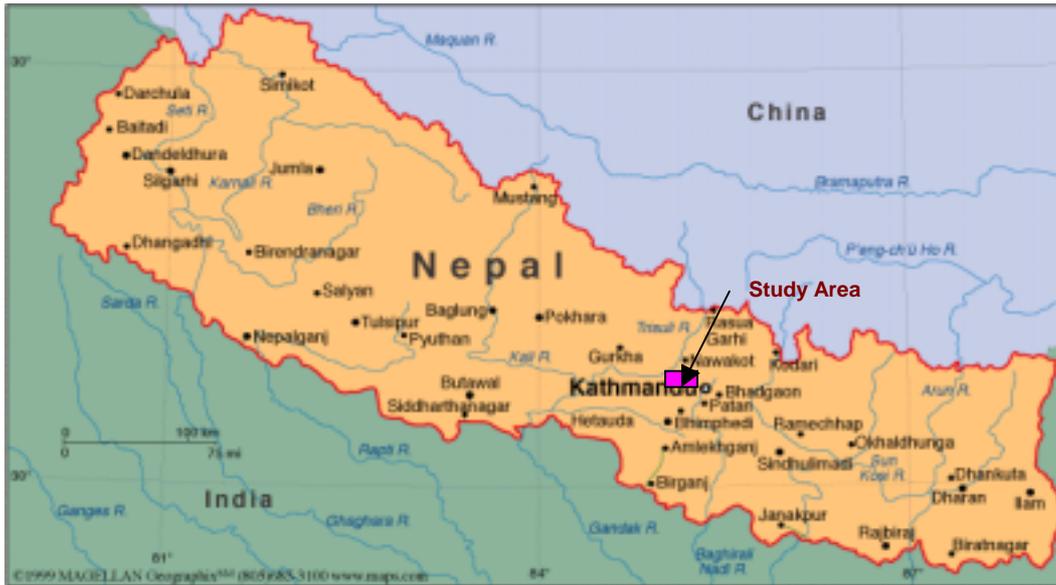
Figure 1 Prithwi highway and study area of this research

Krishanabhir-Kurintar sector of Prithvi highway of Nepal (Fig. 1), which is suffered from frequent slope failure problems every year, has been considered for this study. This sector is a part of two hundred kilometers long Prithvi highway of Nepal, which connects Kathmandu, the capital with the tourist city, Pokhara. Landslides and other mass movements in every rainy season, which block the highway, sometimes for several days (Bhattarai et. al, 2001), are the chronic problems of this highway (Photo 1). Due to the lack of information on potential failure sites, road clearance equipments are neither properly placed nor the pre-monsoon failure prevention strategies are well considered.
