## GIS--A Valuable Watershed Assessment Tool

Mark Johnston, Earth Tech; Jane Almon, Earth Tech; Kilmeny Stephens, Earth Tech.

GIS is transforming watershed planning approaches within the State of North Carolina. The North Carolina Ecosystem Enhancement Program selected Cathey's Creek Watershed, within the Broad River Basin of North Carolina, for a detailed technical watershed assessment. The purpose of the assessment was to characterize the watershed, identify general problem areas related to ecological functions, determine how to address these problems, and develop a plan that includes solutions to the problems. The bulk of initial characterization was based on existing GIS data. Summarization of existing data and detailed spatial analysis was used to describe the condition of the watershed in terms of hydrologic, water quality and habitat functions. Assessment of the watershed will support stakeholders in development of a Watershed Management Plan. A future management Plan will aid in facilitating reestablishment of water quality, hydrology, and habitat functions; produce mitigation credits; and meet the community's priorities to formulate optimum projects.

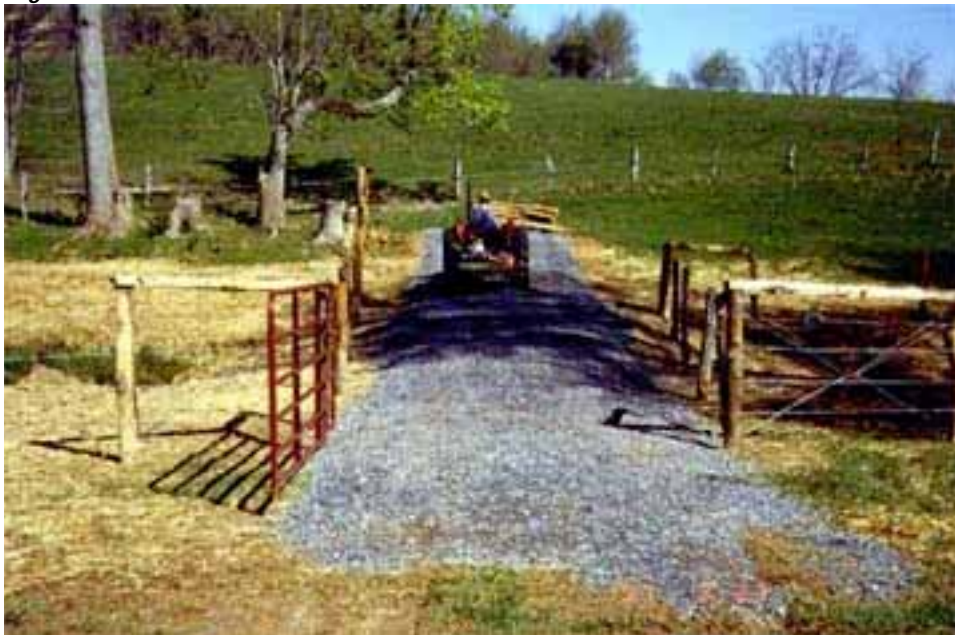
Accelerated stream bank erosion in pastures because of unlimited livestock access to streams can be significantly reduced by installing fencing to exclude the animals from streams. The amount of sediment reduction depends on many factors including the type of livestock, stocking density, the size of the stream, and the amount and type of vegetation present.

***Figure 10 – Cattle Exclusion***

Extending the excluded area further can also reduce sediment, nutrients, and fecal coliform bacteria. Planting a succession of native species of grasses, upland trees, and bottomland hardwoods from the fence to the stream would help maximize the water

quality and wildlife habitat benefits along the stream. Alternate sources of water would need to be constructed if the stream is the only source of drinking water for the cattle.
