## **USING GIS TO DEFINE GRADES OF POVERTY.**

When developing proposals for Los Claveles, a squatter development located in Venezuela, ARC GIS was the supporting tool for analyzing spatial and no spatial data. Data measured and categorized through urban and environmental indexes allowed the definition of categories of poverty and terms for improvement interventions.

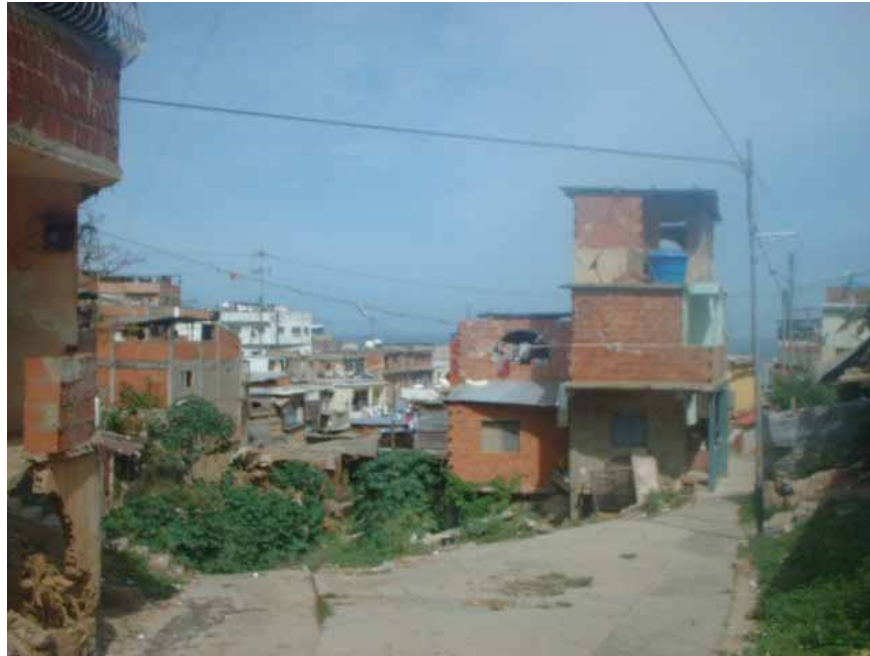
Graphic 1: Typical Public Space. UPF 5- Maiquetía". Proyecto UDU 5.4 Los Claveles.

When analyzing the quality of public space the most relevant aspect are the absence of adequate infrastructure, urban furniture and maintenance. Combined these aspects produce unhealthy and insecure conditions. In this case, quality results from a combination of components that provide a major or minor index of poverty. Graphic 1 shows a typical example of public space from a squatter development.

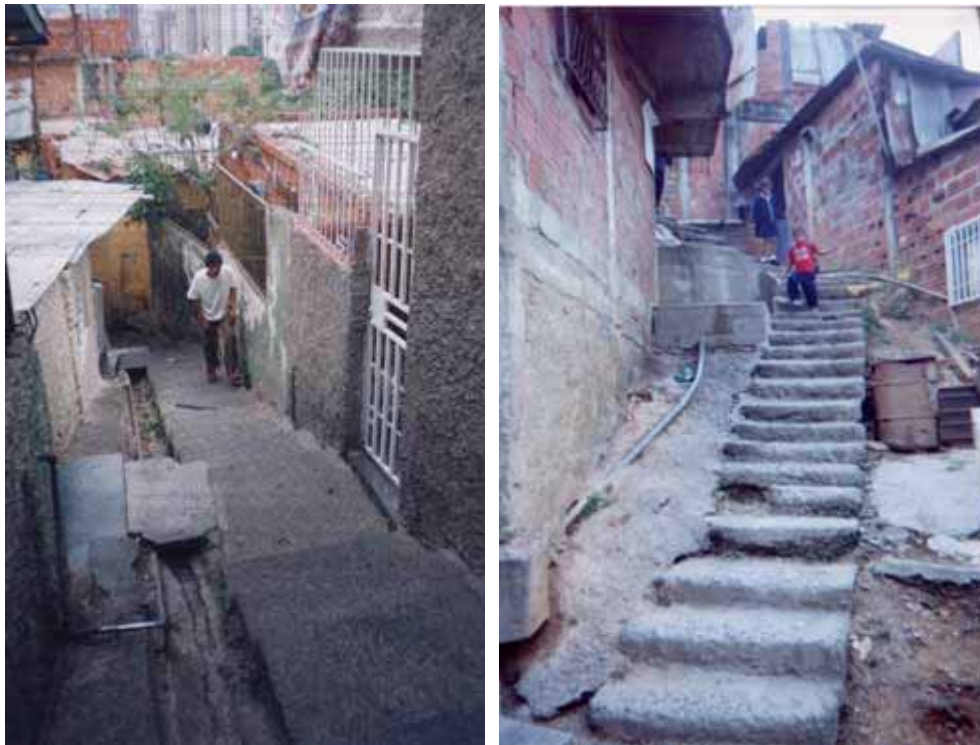
Graphic 2: Typical pedestrian routes. "Petare Norte". Proyecto UDU 4.2 Agricultura.

Downhill travel to access facilities of surrounding areas requires less physical effort, but inhabitants are aware of the difficult uphill return. A multiplier effect that increases poverty condition is added when pedestrian routes require strong physical effort. Graphic 2 shows typical pedestrian routes within a squatter development.

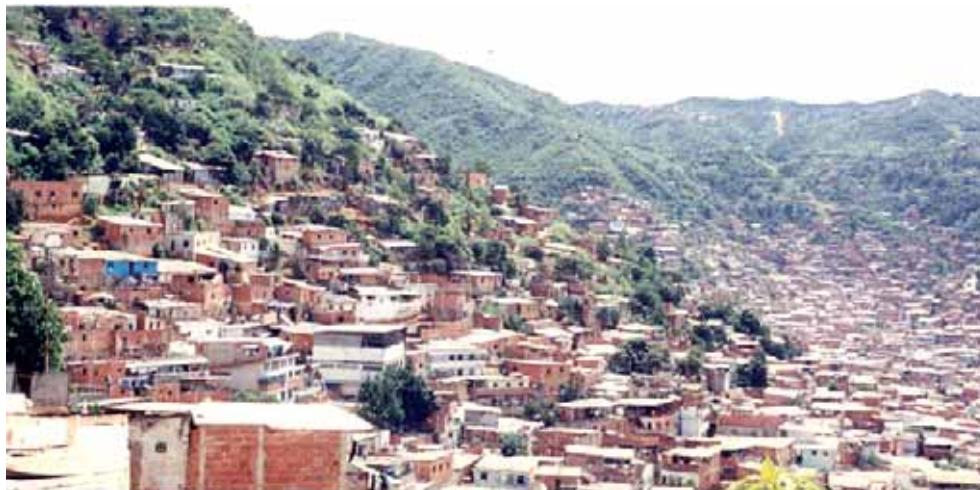
Graphic 3: Typical urban image with high restrictions for change. La Vega, Caracas.

This urban order is a key element to be identified when carrying out site analysis. Graphic 3 is a dual example of a settlement with high restrictions for change and a typical urban image of a squatter development.

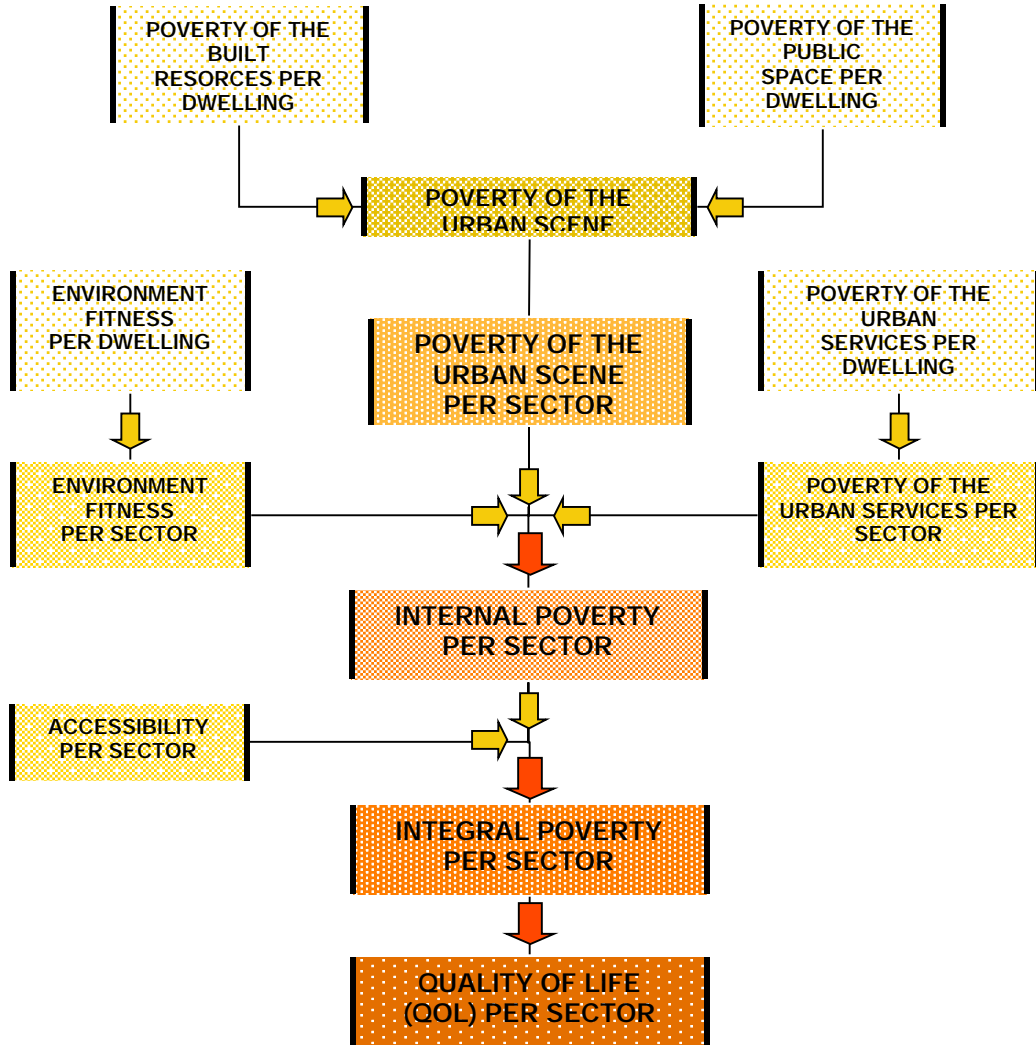
## PROCESS TO OBTAIN MAPS OF INTEGRAL POVERTY AND "QOL"

This paper emphasizes the analysis of spatial internal characteristics of the settlement to establish internal poverty as a combination of factors of the settlement per se. Finally to obtain an integral poverty we included as a multiplier factor access to the surrounding formal area where urban services are located. The process to obtain different poverty maps is included in the Appendix B.
