Dig Alert Intelligence Paves Off

Introduction

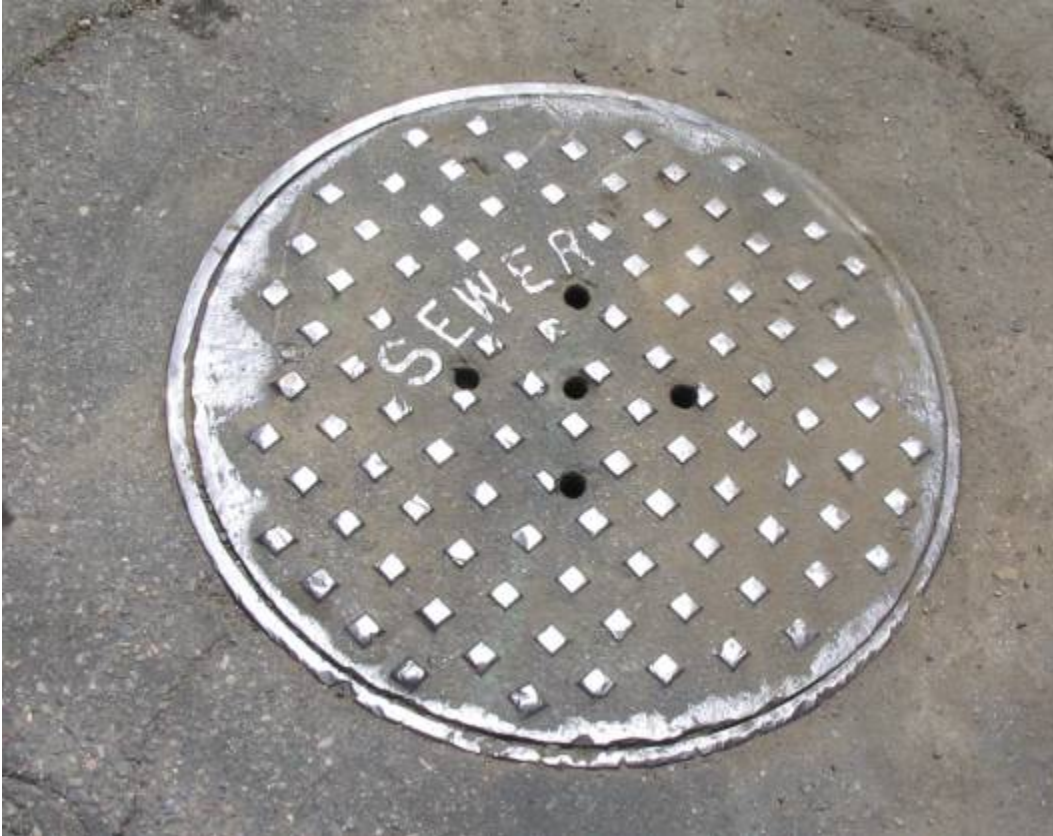
Figure 1 – Worn OCSD frame and cover

This street-overlay project impacted 4 OCSD manholes and took place in April of 2004 along Highland Avenue. After the ticket was received from Dig Alert, the entire team, which includes members from engineering construction and planning, was notified of the work. The Dig Alert crew inspected the impacted manholes and prepared an inspection report identifying which frames and covers should be replaced. After reviewing the inspection report, we decided to replace all 4 worn frames and covers. Figure 1 shows a worn OCSD frame and cover to be raised to grade as part of the City of Fullerton’s street-overlay project.

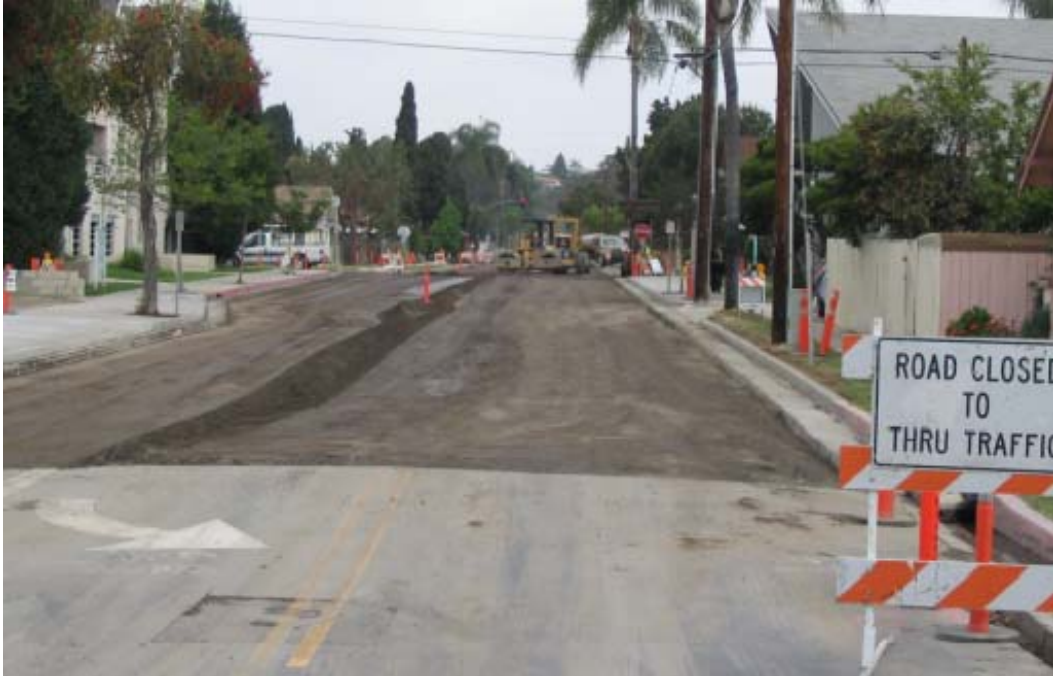
Figure 2 – Street Overlay in progress along Highland Ave.

Figure 2 shows the ensuing work of grinding Highland Avenue while Figure 3 shows a covered OCSD manhole structure. The covered manhole structure is located at the bottom of the photo marked by a green “RR.” A contractor provided steel plate covers the buried manhole structure to keep construction debris out of the sewer during paving. The contractor will pave right over the steel plate and after paving is complete, a utility raise to grade subcontractor will cut a hole in the fresh pavement to remove the steel plate. He will then install a new frame and cover (or raise the existing in the case of the City of Fullerton) and adjust the cover so that it is flush with the new street grade. Sometimes the subcontractor will add pre-cast concrete grade rings and / or mortar to build up the height of the frame and cover.

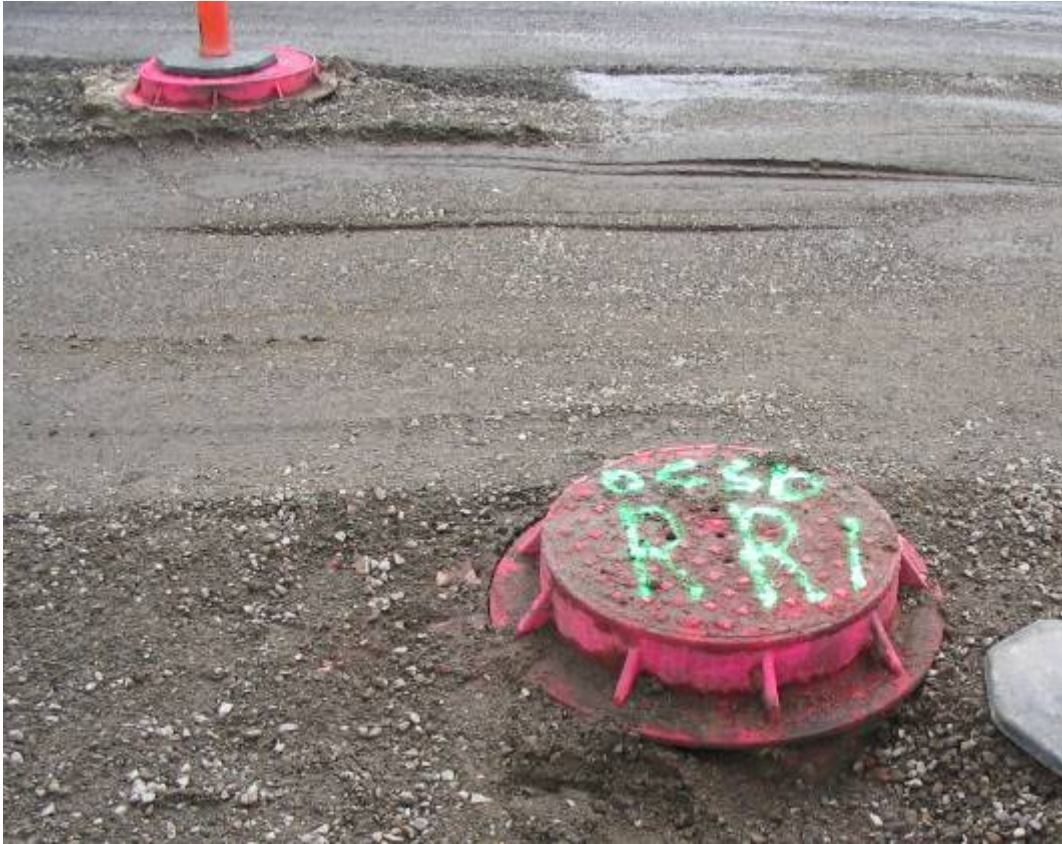
Figure 4 – Frames and covers ready to be removed (OCSD shown at bottom)

Figure 4 was taken before the existing manhole frame and cover was removed by the contractor. The contractor painted the existing frame and cover pink to make it stand out prior to removal. Per our agreed upon convention with street-overlay contractors, the Dig

Alert crew paints “RR” for Remove and Replace on all OCSD frames and covers to be junked. The frame and cover at the top of the photo belongs to the City of Fullerton.

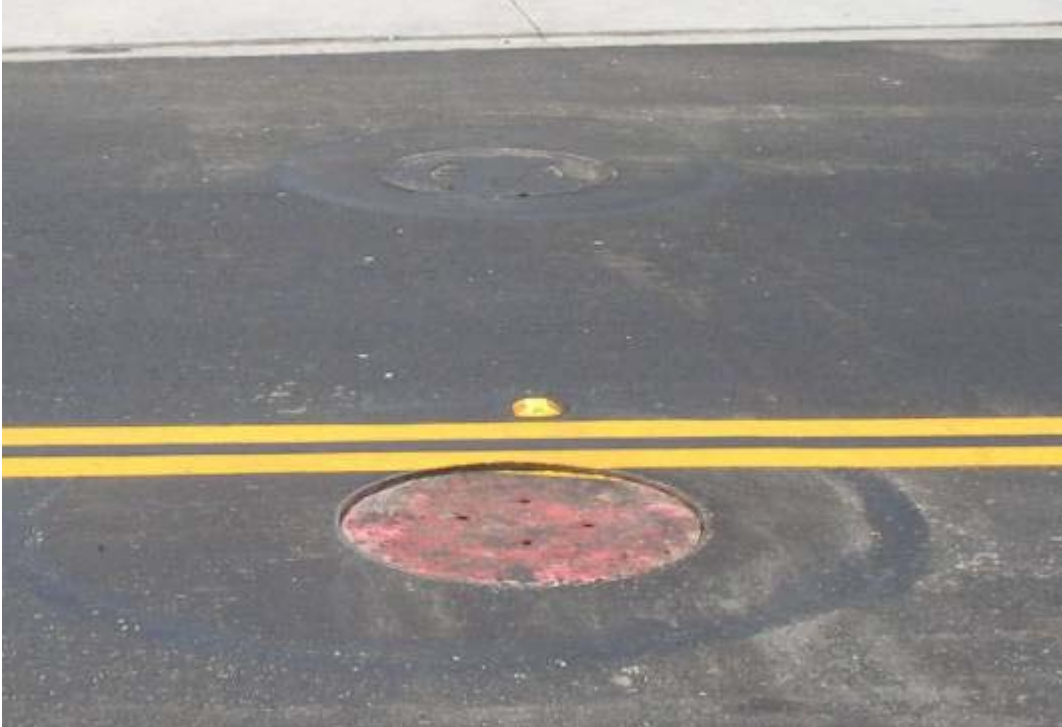
Figure 5 – Street-overlay complete (OCSD new frame and cover shown at top)

Figure 5 shows the City of Fullerton’s frame and cover after the street-overlay is complete. The frame and cover is still red (middle of photo) and well worn (the lid sags below the frame). The City of Fullerton chose not to have the contractor replace their worn frames and covers. OCSD’s frame and cover (top of photo in Figure 5) is brand new and flush with street.

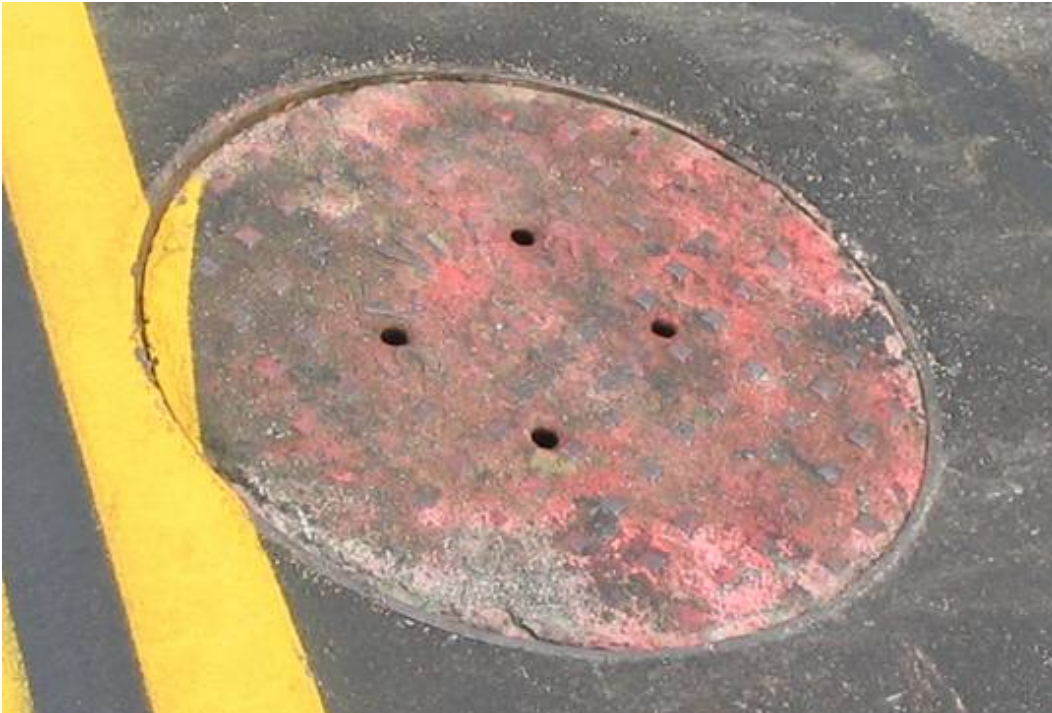
Figure 6 – Worn City of Fullerton frame and cover

Figure 6 is a close up of the City of Fullerton’s worn frame and cover. As you can see, the cover sits well below the frame.

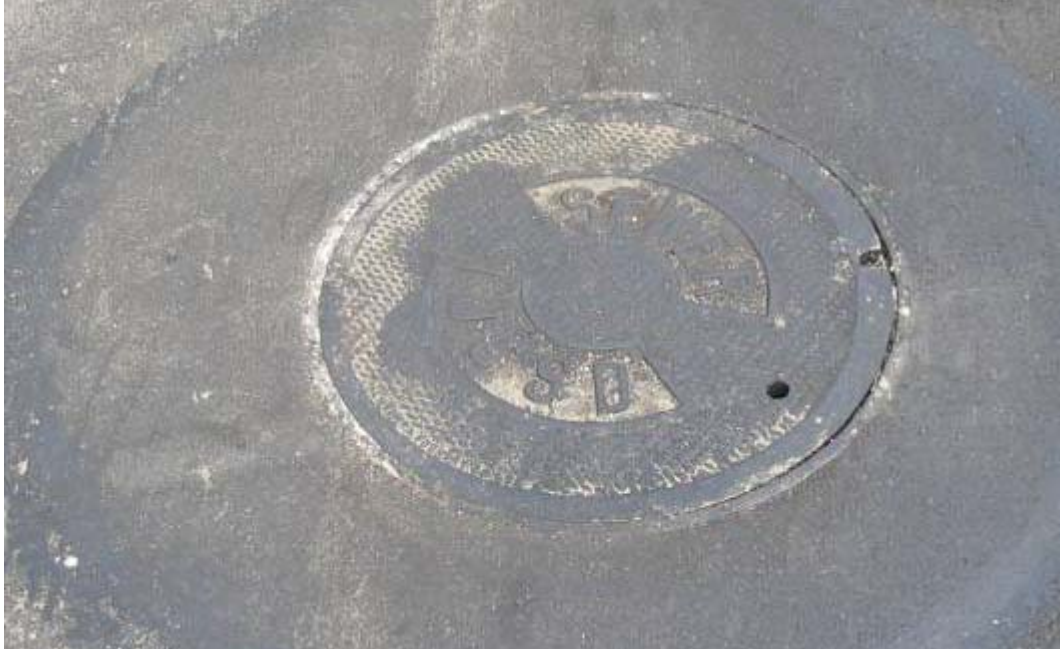
Figure 7 – New OCSD frame and cover after street-overlay is complete

Figure 7 shows OCSD’s new frame and cover close up. The old generic cover was replaced with one bearing OCSD.

We all benefit when a worn cover is replaced with a new. Contractors prefer to raise new rather than old and worn material because it is easier to do and there is less risk of material failure. In fact, contractors do not charge OCSD for the handling and storage of the new frame and cover or the disposal of the old. OCSD benefits because our construction crew does not have to replace the worn frame and cover. The public benefits because traffic is disrupted at one time, during the street-overlay, and not afterwards by OCSD. Plus the public gets a smooth and safer ride.

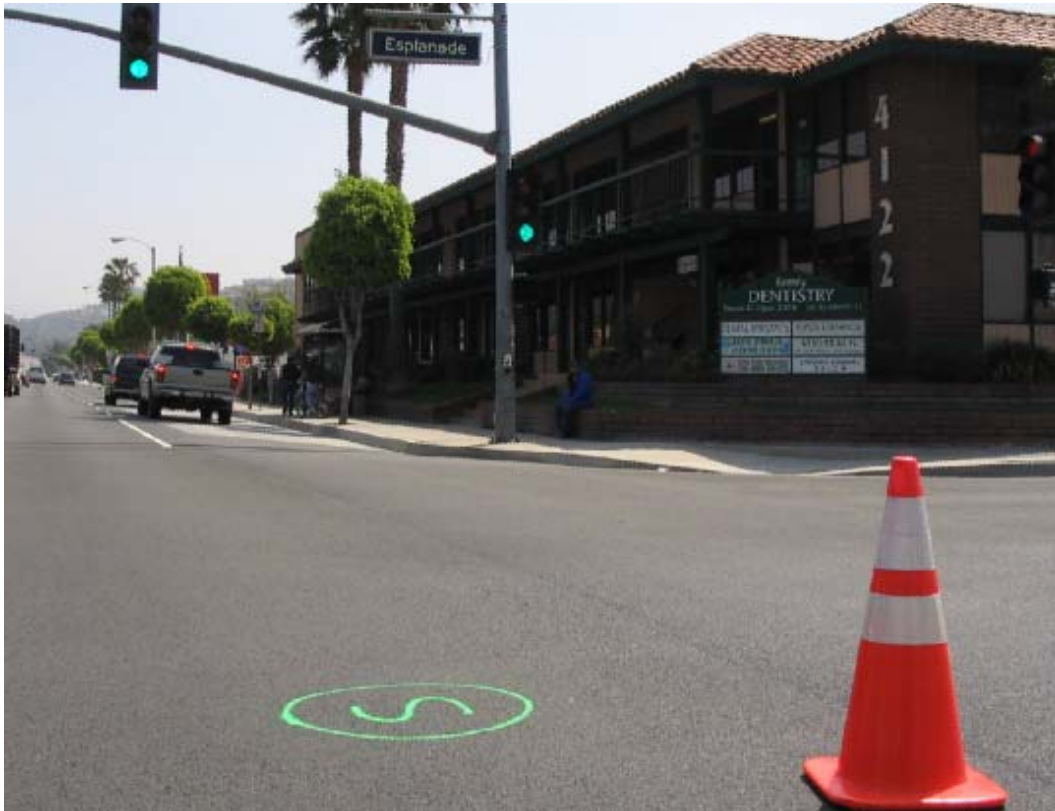
Figure 8 – Buried manhole structure at Chapman and Esplanade

Since we provided the Chapman subcontractor with 16 new frames and covers, he felt obligated to return the ones he did not use. He told me he had 5 left over and asked me when I could come and pick them up. I instead proceeded to Chapman to discover what had gone wrong with our manhole count. Fortunately, we were armed with mobile GIS that showed the location of all our utilities, including manholes, relative to our current position. After a short drive, we discovered that five consecutive manhole structures along our 12-inch sewer line were still buried (two of the five buried manholes are shown in Figures 8 and 9). After identifying their location with mobile GIS and a metal detector, we marked the spot with a green circle and “S” for sewer (see bottom of photos).

We now routinely check for buried manhole structures after street-overlay work. All five buried manhole structures were raised to grade by the subcontractor. Figure 10 shows the subcontractor standing next to the raised manhole structure at the intersection of Chapman and James. If this had not been caught, our construction crew would have spent two days raising the five buried manhole structures along a very busy Chapman street.

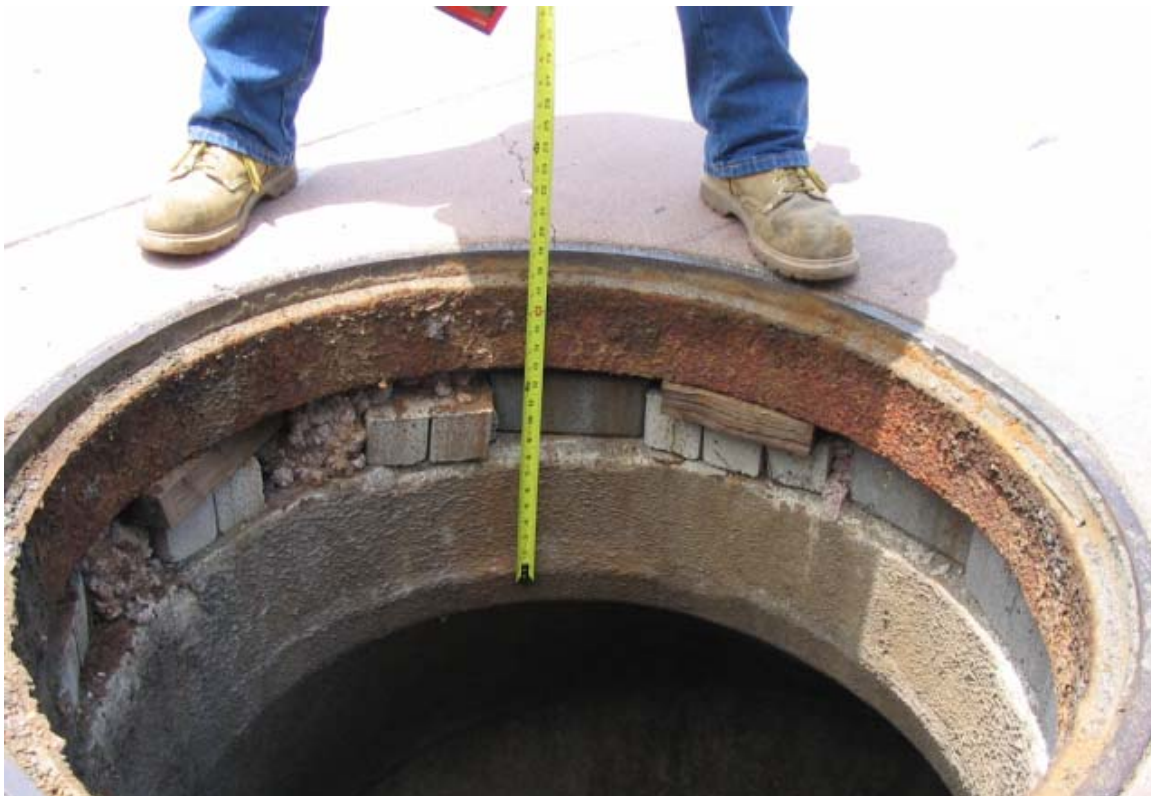
Figure 11 – Wood used to support frame; settling and surface cracks are visible

The second thing that can go wrong is bad workmanship or work that is not on par with our standards. Figure 11 shows a frame supported by miscellaneous construction materials including wood (its no surprise cracks are forming on the surface). Figure 12 shows a similar deal except it looks like the contractor did not have an intact grade ring so he used pieces of a broken grade ring to support our frame. He didn't even bother to fill the joints or provide a clean finished concrete surface. Figure 13 shows the same manhole in Figure 12 after the contractor completed his repair work. We kindly confronted the contractor, and he apologized and made a speedy repair. Again our goal is to get quality work but to do this we have to partner with the contractors. Our hope is as we develop relationships that include accountability, the contractors will work per our specifications and not try to cut corners.

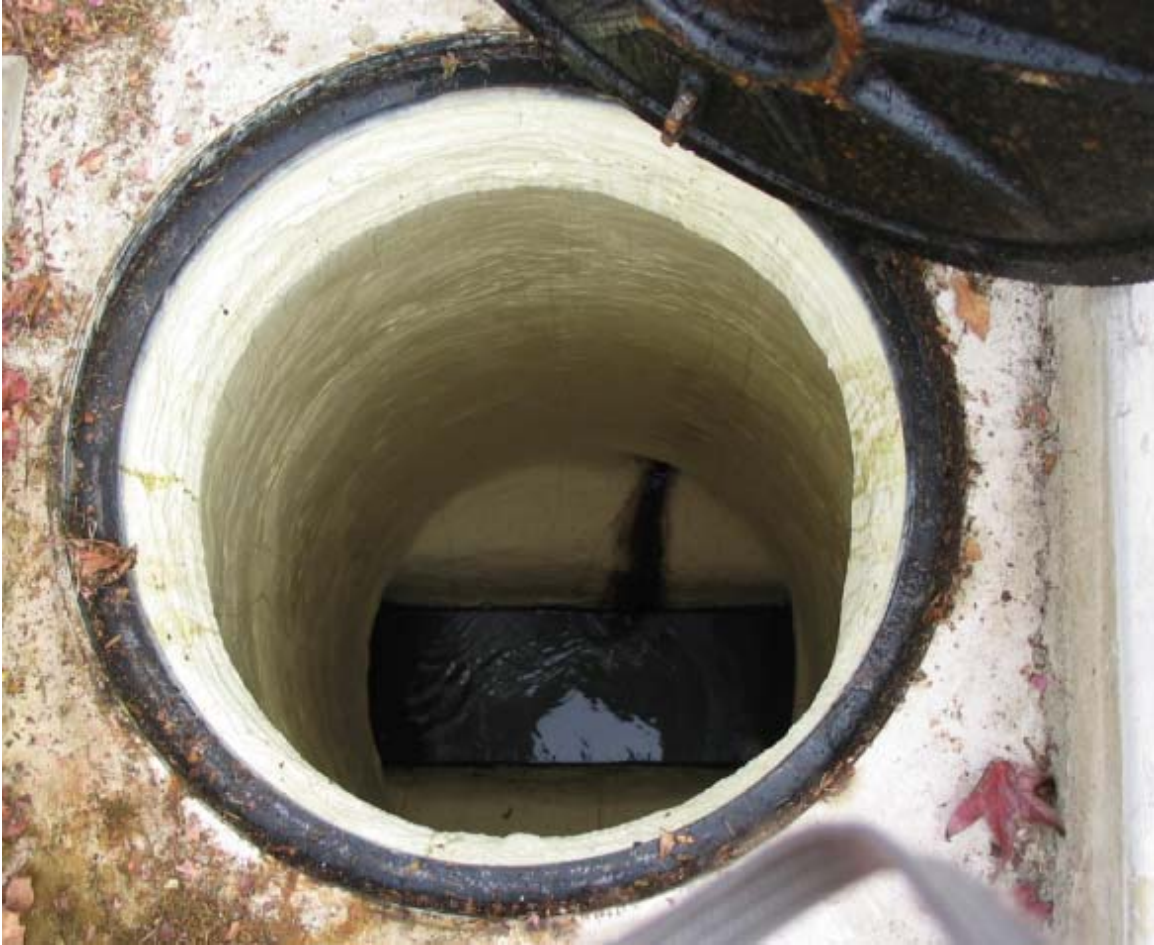
Figure 14 – Polyurethane coated manhole structure

Manholes with protective wall coatings complicate matters during street-overlay work because care must be taken to minimize damage to the coating when the frame and cover is removed. Figure 14 shows a polyurethane coated manhole structure; the true structure is made out of brick. Without going into too much chemistry, coatings are there to protect the manhole concrete structure from corrosion. Yes, under the right septic conditions, concrete will corrode and turn into a weak paste. The coating acts as a barrier between the concrete and the chemicals that attack the concrete. If the coating or barrier is damaged (i.e., pin hole puncture, crack, tear, etc.) the underlying concrete is left without protection and its condition will deteriorate over time.

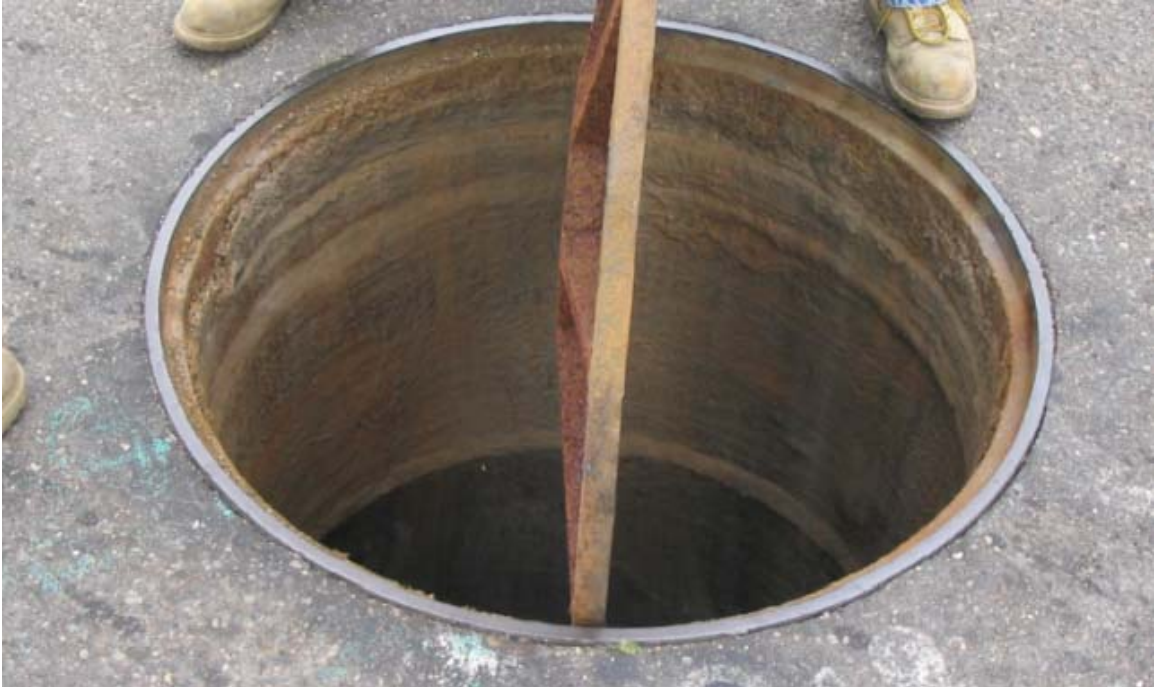
Figure 15 - Polyurethane coated manhole structure in Dyer Rd.

If the frame and cover of a coated manhole is removed, the coating will be disturbed leaving the concrete susceptible to corrosion. Figure 15 shows another polyurethane coated manhole on Dyer Road that has been in service for many years. Figure 16 shows the same manhole after the frame and cover was raised to the new grade of the street. The contractor was overly aggressive in peeling back the protective coating so he could remove the frame and cover. In fact, the coating is in such disrepair it is in danger of collapse and could fall into the channel and cause a blockage. This manhole was flagged for immediate repair and the contractor was confronted. Thanks to the before photo we know the damage was not a preexisting condition. The after photos even show fresh concrete clinging to the peeled back coating proving that the coating failure happened during and not after the contractor completed his work.

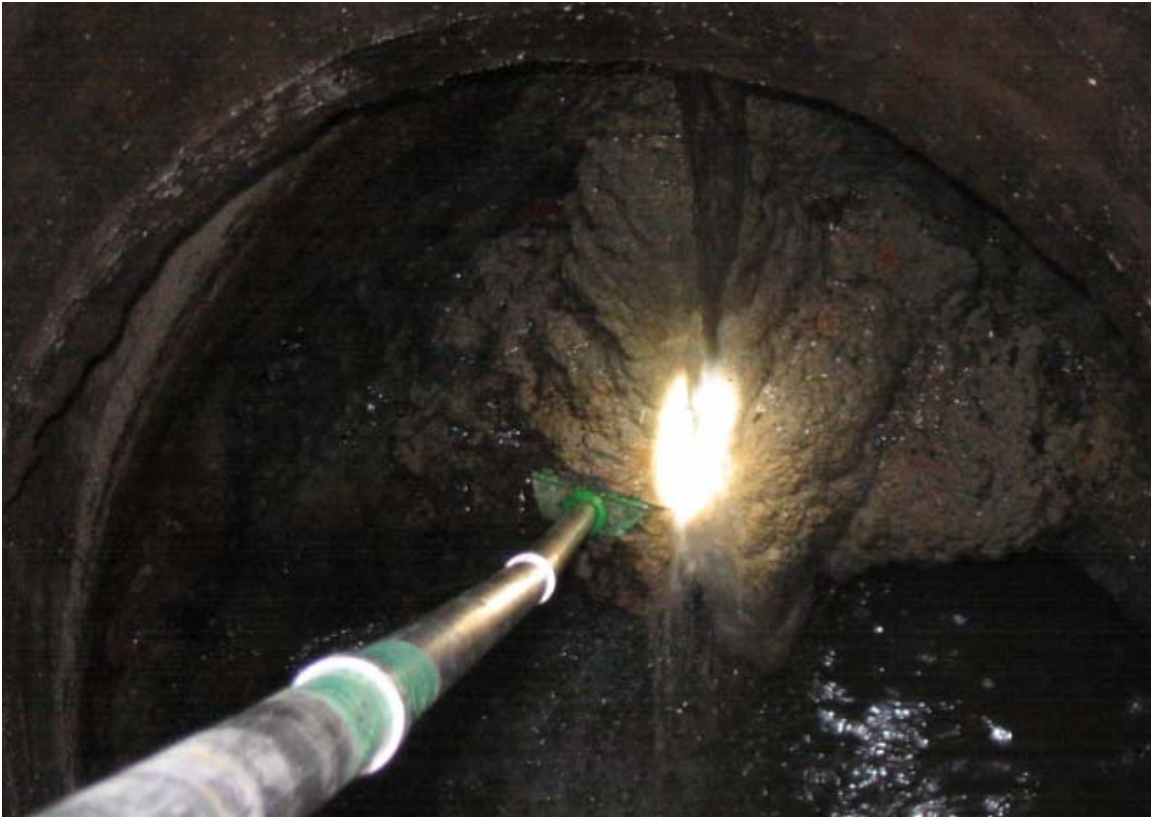
- FOG (Figure 17)
- Roaches (Figure 18)
- Debris (Figures 19 and 20)
- Coating Problems from past and untracked street-overlay projects (Figure 21)
- Cracked lids (Figure 22)

Figure 17 – Crew breaks solid grease into small pieces

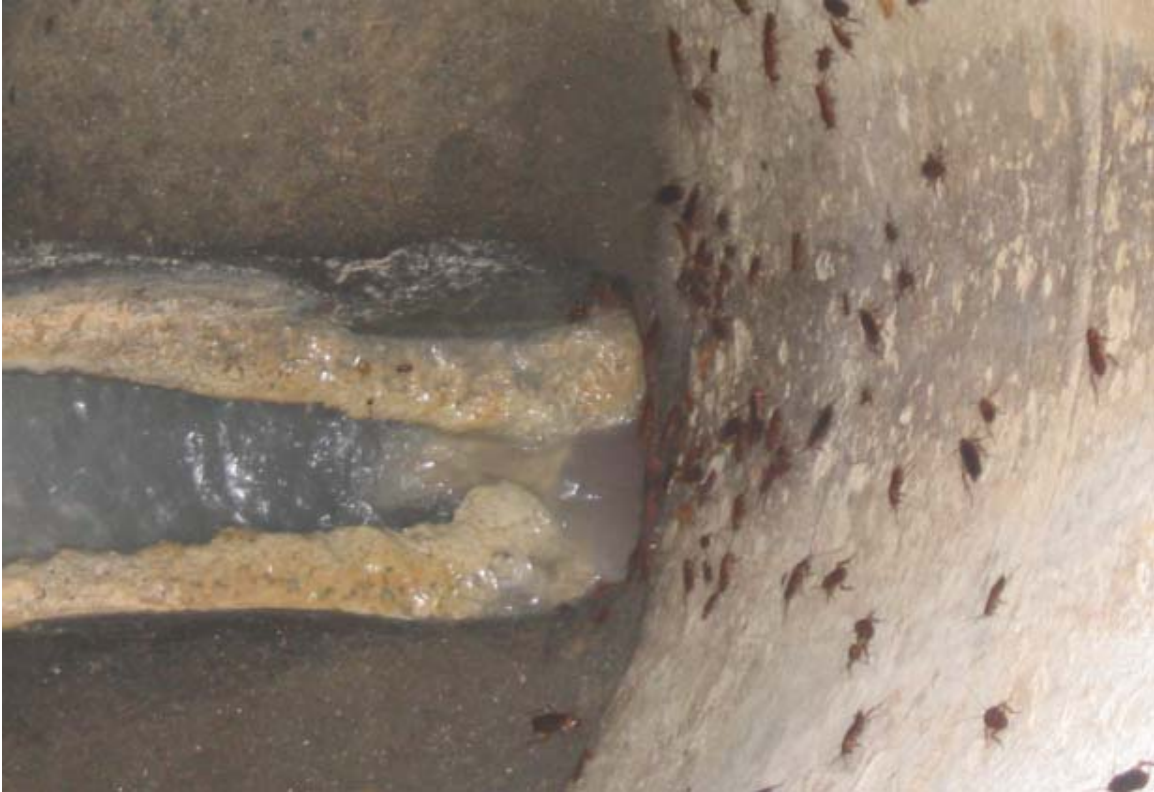
Figure 18 – Roaches and grease

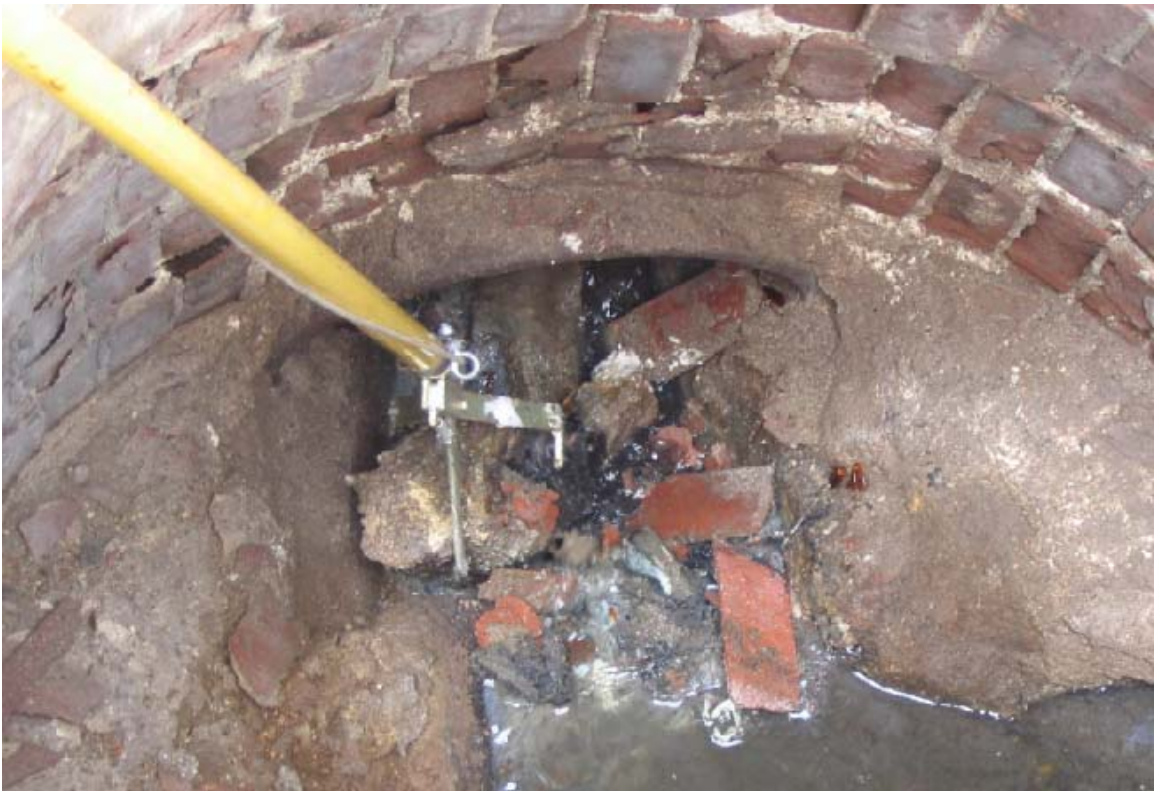
Figure 19 – Debris restricting flow

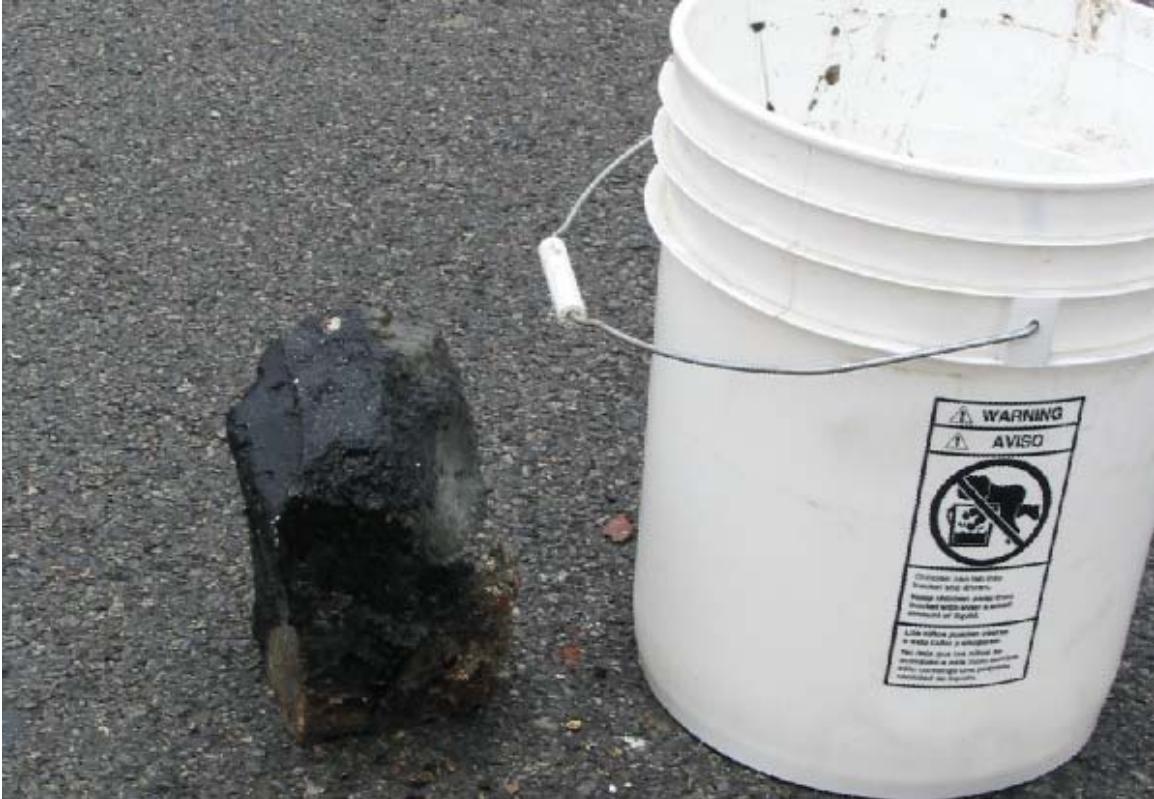
Figure 20 – Debris from Figure 19 removed

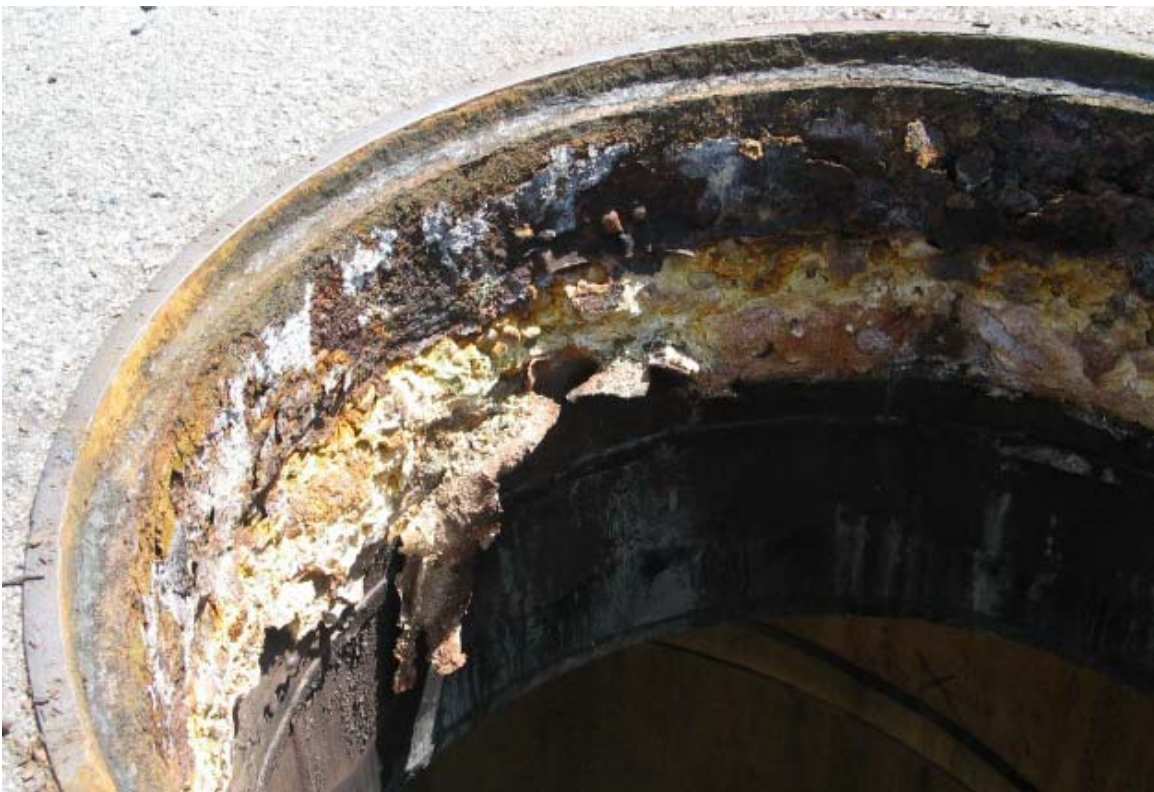
Figure 21 – Failed PVC coating as the result of prior street-overlay

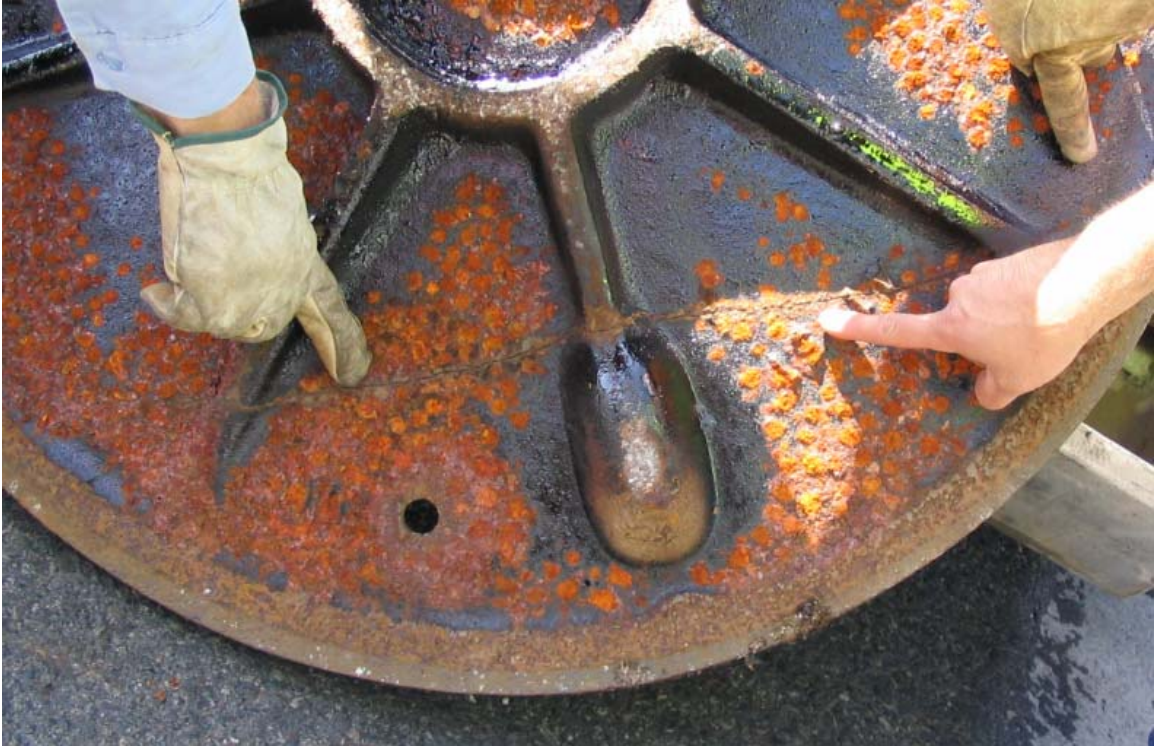
Figure 22 – Cracked cover replaced by crew
