GIS Analyses of the Landslides in 2004, Mid Niigata, Japan

Abstract: In 2004, heavy rainfalls and intensive earthquakes triggered numberless landslides in Mid Niigata, Japan. Using ArcInfo9.1, we have analyzed and compared in distribution, related to geology and geomorphology, between the two events. As the results, we have found that the landslide density, and geologic facies where the landslides are concentrated, are remarkably different.

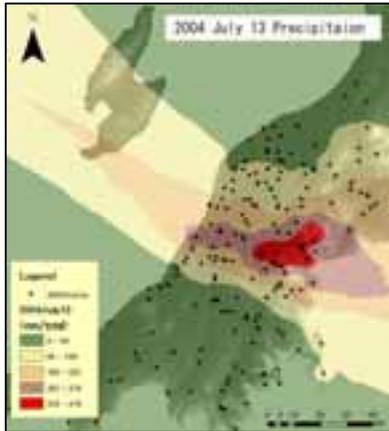
Fig. 2 Using GIS precipitation contour map of 2004 July 13 in Mid-Niigata region.

According to Ushiyama (2004), the rainfall began in the evening of July 12, 2004 and reached its peak in the early morning of July 13. Fig. 2 presents the precipitation contour map on July 13, showing the areas where flooding and landsliding. Within 1250 km² area, the Tochio and Kariyatagawa area obtained the maximum rainfalls of the one day. The one day rainfall of AMEDAS station in Tochio City was recorded to be 421mm.

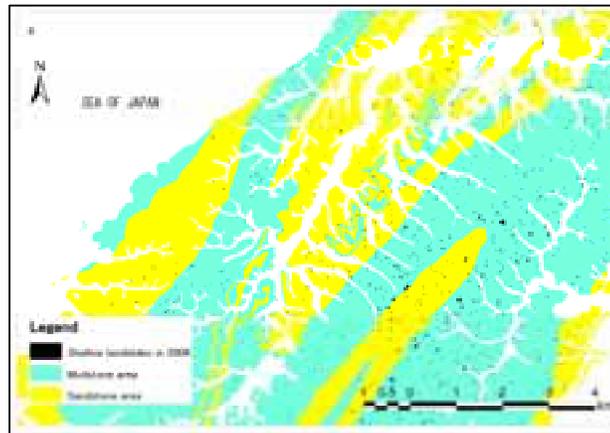
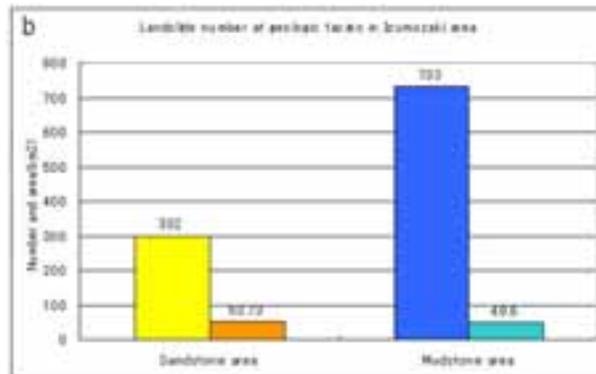
Fig. 4: a: July 13 landslide distribution on the outline geologic map, b: bar graph showing the landslide numbers in the sandstone and mudstone area (modified from Kobayashi et al., 1993, using GIS), and areas of the sandstone and mudstone.

Mid Niigata Region is composed of hilly mountains of 200-600 m in elevation. On the whole, many straight ridges (for instances, Nishiyama hills in the west and Higashiyama hills in the east) are arranged in directions of NNE-SSW. These ridges are controlled by geological folds and faults in the same directions. Geological lithofacies are composed of Cenozoic mudstone and sandstones (Fig.4a) both of which make up relatively hard Teradomari Formation of Miocene in the lower, and soft mudstone and siltstones of Pliocene to Pleistocene. In addition, old deep-seated landslides are abundantly distributed in the gentle dipping stratum areas (Fig. 3). Relationship between the recent landslides and geology, has revealed that, in Izumozaki area, most of them are concentrated in steep slopes which are diagnostic of quadrangle-patterned drainage systems along the NNE-SSW trending ridges (Fig. 3). Most of the landslides are concentrated in the mudstone-rich zone rather than sandstone- rich zone in the Nishiyama hills (Izumozaki area; Fig. 4a, b) although the areas occupied by the sandstone and mudstone are nearly the same (Fig. 4b).

We are discussing the comparison between the two events as the following ; 1) The 7.13 landslides do not necessarily coincide with the old deep-seated landslides provided from Web Site of NIED (<http://www.bosai.go.jp/e/earth/earth.html>). Most of the 7.13 landslides are small in scale and shallow-seating characteristics. They are distributed in steep slopes geomorphologically and in steep dipping areas of the strata of the sediments (Fig. 3). In addition, they are lithologically found in the mudstone-rich zone rather than sandstone-rich zone (Fig. 4a, b). 2) The distribution of the 10.23 landslides coincided with the old deep-seated

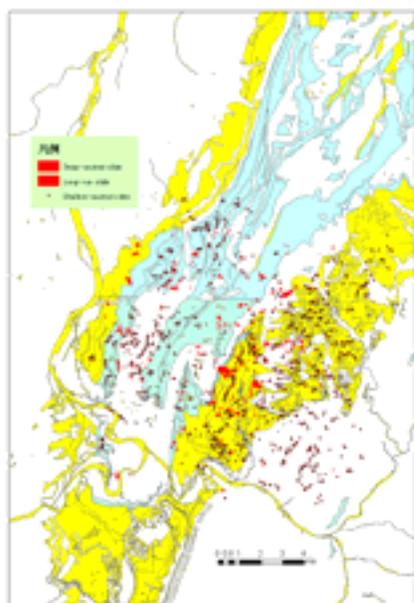
Fig. 5: Map showing the distribution of the landslides by the 10.23 earthquakes, mudstone-rich zone(Yamakoshi area)

These main shocks and associated aftershocks triggered many landslides (Chigira and Miyagi, 2006) which are counted to be more than 4400 sites (Sekiguchi and Sato, 2006). They include variable type of landslides. Our aerial photograph interpretation and field researching have revealed that the landslides are classified into the following three types, 1)deep-seated landslides, 2)flow-type landslides, and 3)shallow-seated landslides (Yamagishi et al., 2005). The deep-seated landslides totally ten landslide dams particularly along the Imogawa River which run in the central part of the Yamakoshi Area (Fig. 5a).

By the earthquakes, many landslides were induced (Fig.5), because the earthquake area are characteristic of variable slopes in the hills and mountains, and of many paddy fields and ponds.

GIS analyses have revealed that geologically most of the landslides took place in the sandstone-rich zone rather than mudstone-rich zones (Figs. 5, 6; Yamagishi et al., 2005), and that as shown in Fig. 7, relationship exists between the distribution of the landslides, and topographic and geological features of the Yamakoshi area. Namely, Fig. 7 map shows that most of the landslides are distributed more or less steep slopes, geomorphologically, but large-scale ones are concentrated in more gentle dipping strata area.

landslides shown by NIED. Most of the deep-seated earthquake-induced landslides are distributed in the gentle slope geomorphologically, and gentle dipping strata area geologically (Fig. 7). In addition, they are mostly distributed in the sandstone-rich zone rather than mudstone-rich zone (Figs. 5 and 6). However, most of the shallow-seated landslides are also the steep slopes (Fig. 7).

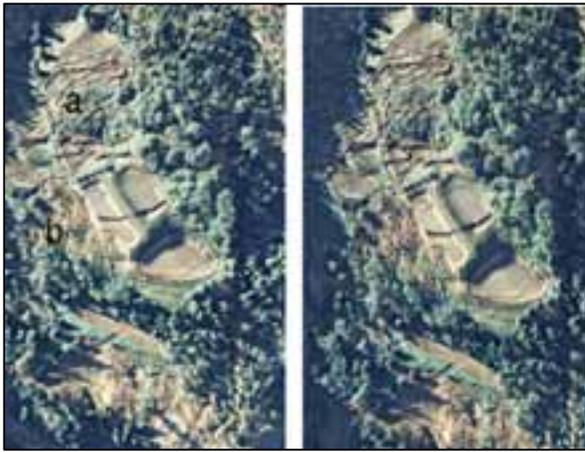
Fig. 8 Stereo-paired photograph showing cracking patterns due to the earthquake. Notice that one (a) is crossing the ponds and the other is arranged

fields are showing variable patterns. One is crossing vertically or obliquely the elliptical or polygonal shape of the fields as shown in Fig. 8a and the other is arranged along the ponds and paddy fields (Fig. 8b). Most of them are regarded as tensional cracks due to gravitational slipping during the shaking. Some of the landslide did not moved long probably due to scarcity of water (Fig.8b). However, the other landslide moved long with fluidity due to much water mixing from ponds (Fig. 9).

in 2004 many ponds as well as the paddy fields were broken by the earthquakes as shown in Figs. 8 and 9. In particular, the cracking and landsliding of the ponds are believed to be accelerating the damages due to flowing by mixing with water. Therefore, in order to confirm it, we have been analyzing the landslides /cracking on the ponds/paddy fields. We classify the patty fields and ponds using DMC images taken by Asia Air Survey Co. Ltd. The criteria of the recognition are mostly shapes and coloring due to

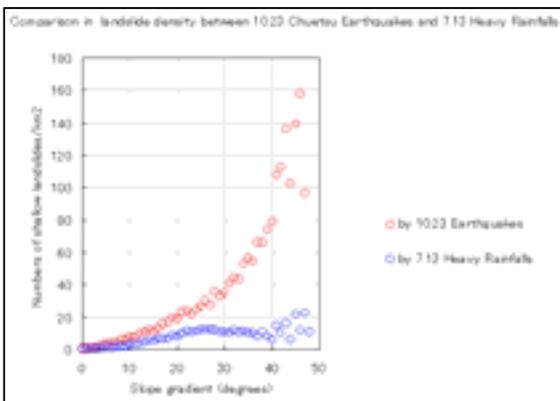
Fig. 10 Comparison in landslide density (landslide number /km²) with the slope gradients between the 1023 Earthquake landslides and 7.13 rainfall landslides.

the two events (Fig.11). As the results, in case of the landslide density (numbers of the landslides/ km²) of the 10.23 landslides, increases with the slope gradient, while, the density of the 7.13 landslides keep almost constant with the slope gradient (Fig. 10). The relationship of landslide density to slope curvatures has been revealed as that the density at any curvatures induced by the earthquakes, are larger that by the heavy rainfalls (Fig. 11).

The most important factors affecting the both of the landslides are geomorphic slopes, and the shallow landslide density against slope gradients and curvatures are larger by the earthquakes than heavy rainfalls (Figs. 10 and 11).

Finally, particularly on shallow-seated landslides, we have compared using GIS in the landslide density against slope gradients (Fig. 10) and relationship to curvatures between
