Bond Release Geodatabase for a surface coal mine in Wyoming

Anna Krzyszowska-Waitkus
Wyoming Department of Environmental Quality

Project Objectives:

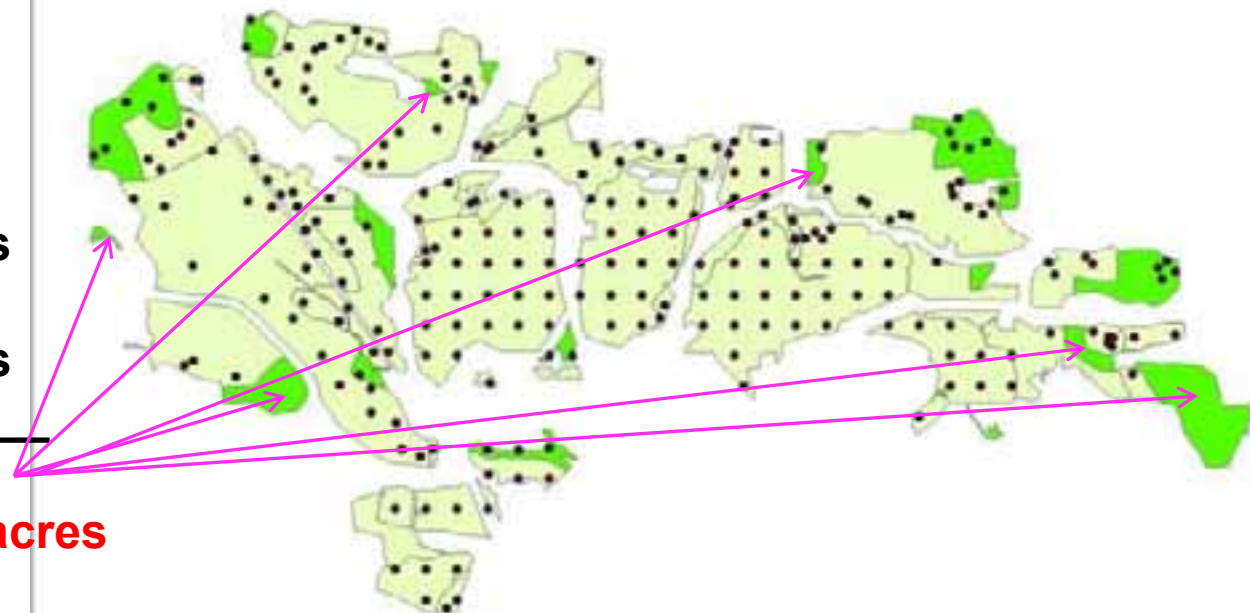
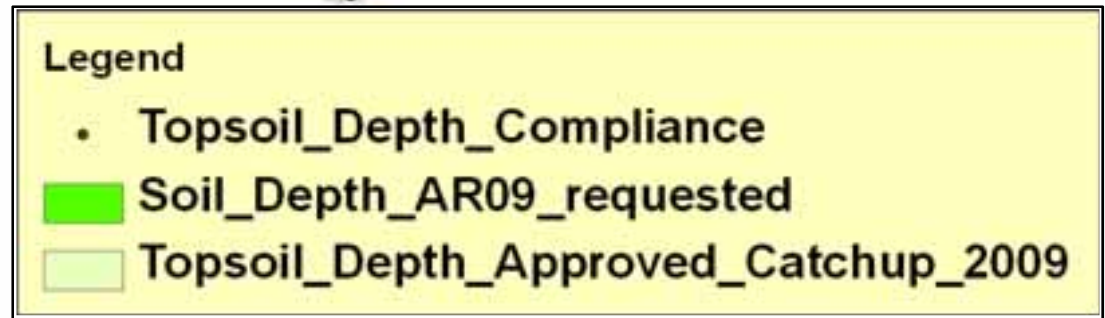
Bond Release Verification of the topsoil depth feature class

Using Geodatabase to compare:

- ◆ Topsoil polygons already approved
- ◆ Topsoil polygons requested for approval
- ◆ Topsoil depth points verified in the field

Requested - 654 acres

Verified - 403 acres

Additional verification needed - **251 acres**

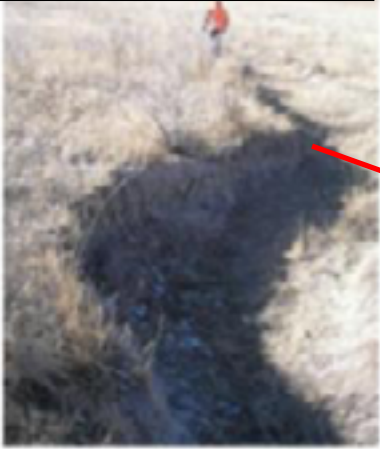
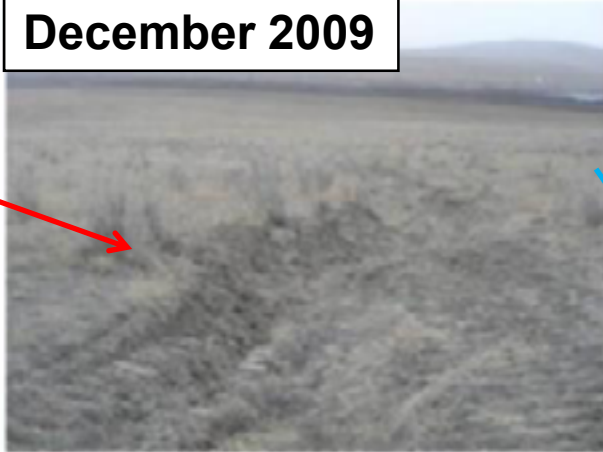
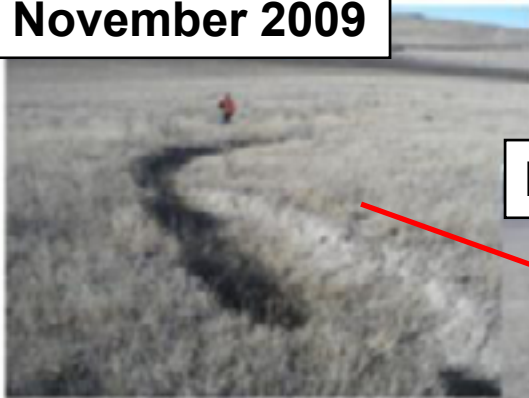
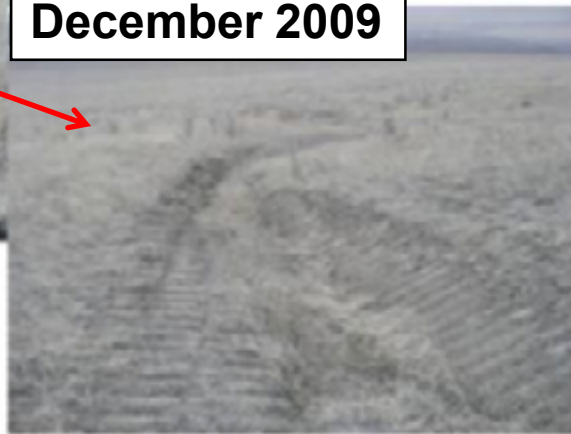
Photo No. 6 Looking at the gully located in the north eastern portion of the Antaresa Mast area.

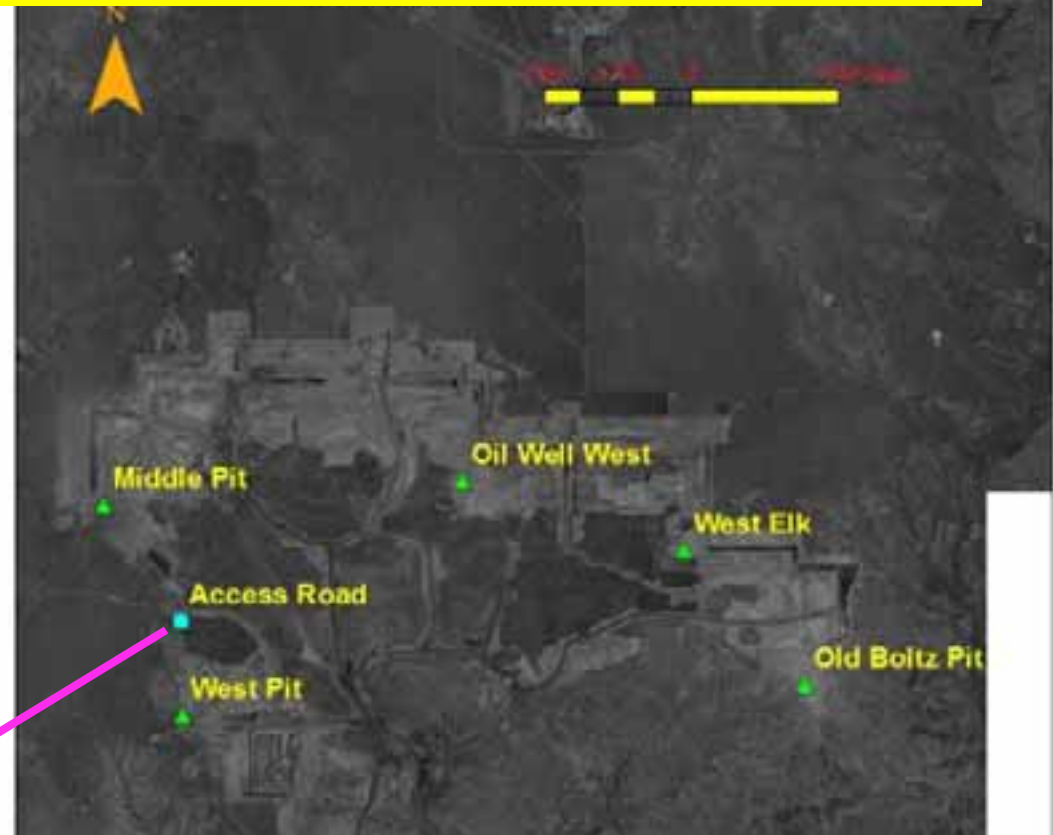
Review of mining and reclamation progress (Photo_pit) GPS location of where photographs were taken

Photographs were taken from the same six GPS location sites throughout the years. The progress of mining and reclamation activities was compared with the existing permit.

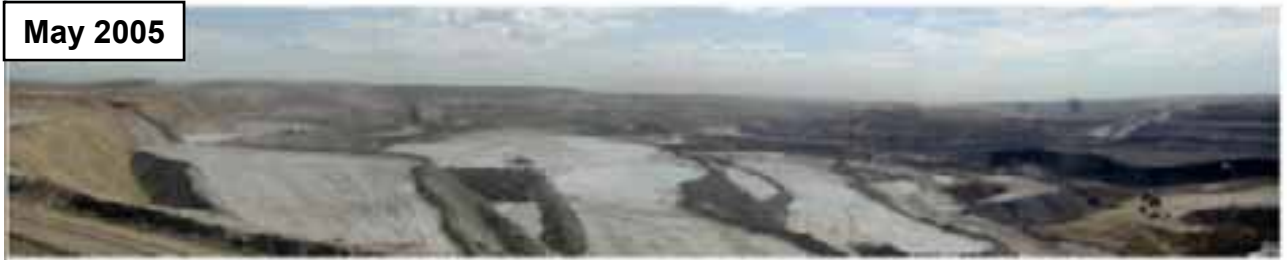
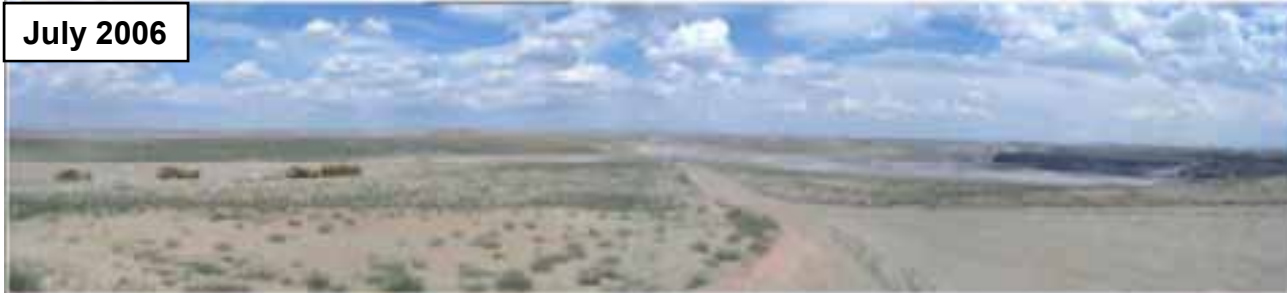
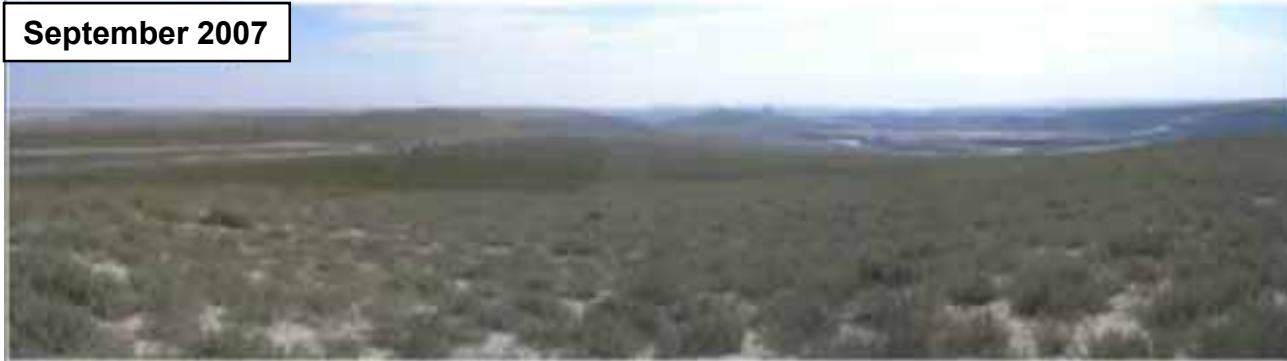
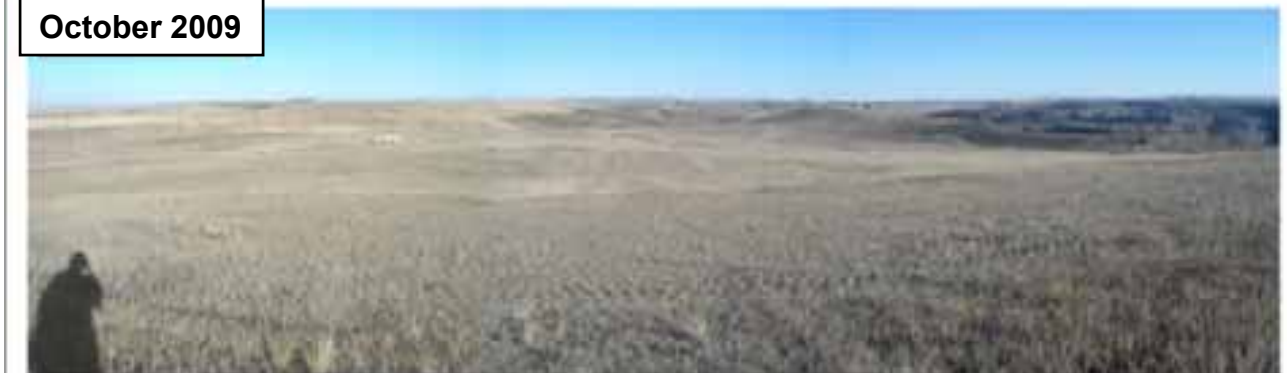
Access Road - Photo_pit

View of the
reclamation
progress over
several years in the
northern portion of
the Western Pit

An example of the documented progress is shown for the “Access Road” GPS site, on the next slide.
