GPS & GIS for Hurricane Debris Removal

City of Miami
Miami, Florida

June 19, 2007

ESRI UC 2007

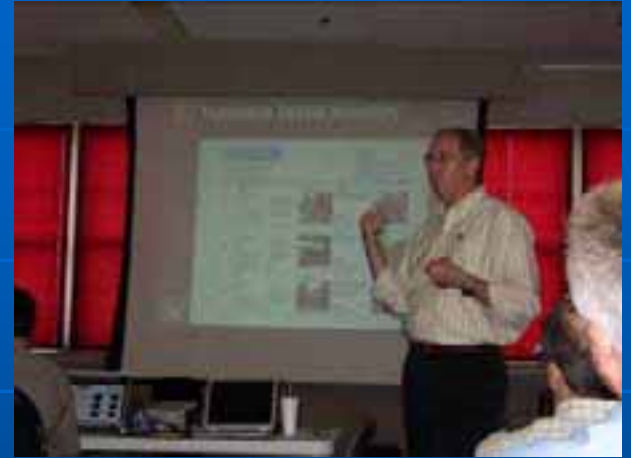
- Trained 4 two-person field crews on inventory methodology and mobile GIS
- Crews equipped with laptop, GPS device, and digital camera
- Inventory consisted of field data collection, followed by nightly database synchronization

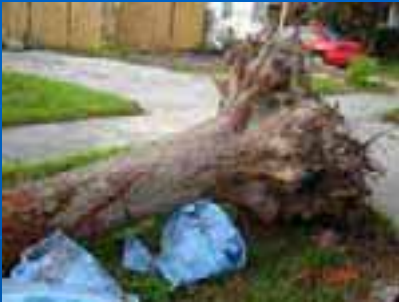
- **Fallen Trees**

■ Citywide (in road right-of-way)	0760
■ Parks	0340
■ Total	1100

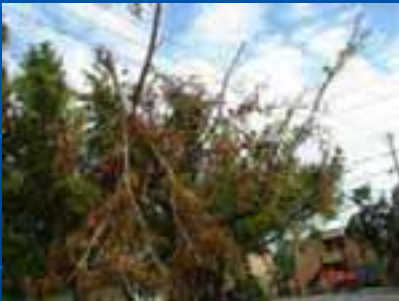
- **Trees with Hanging Limbs**

■ Citywide (in road right-of-way)	6166
■ Parks	0653
■ Total	6819

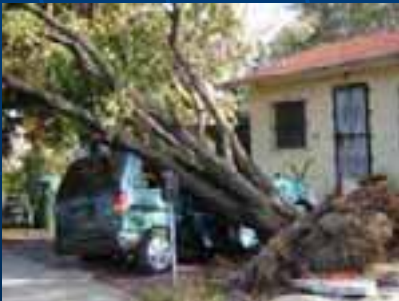
- **Property Damage**

■ Citywide (in road right-of-way)	87
■ Parks	05
■ Total	92

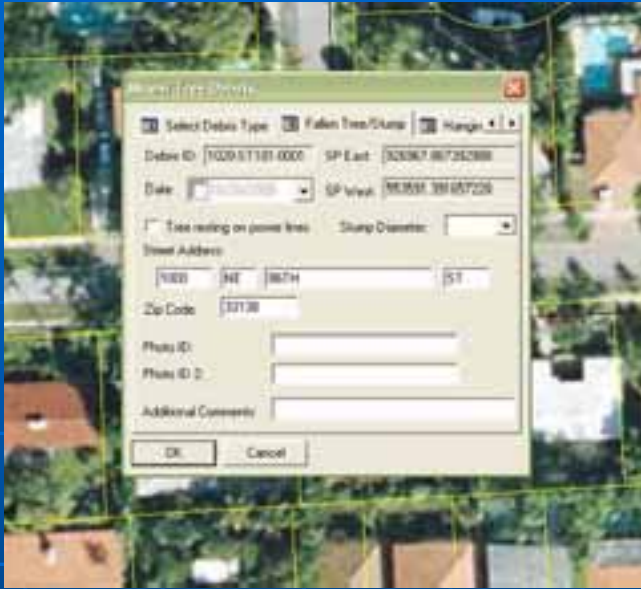
Database Processing

- Generating and maintaining comprehensive tree debris database

- Office staff managed master GIS database, workflow included:
 - merging individual uploads into one comprehensive debris database
 - Address matching (performing spatial join)
 - Checking for potential duplicate records
 - Picture matching
 - Screening of records for FEMA Eligibility
 - Screening of comments for additional information
 - Calculating lat/long coordinates
 - General QA/QC

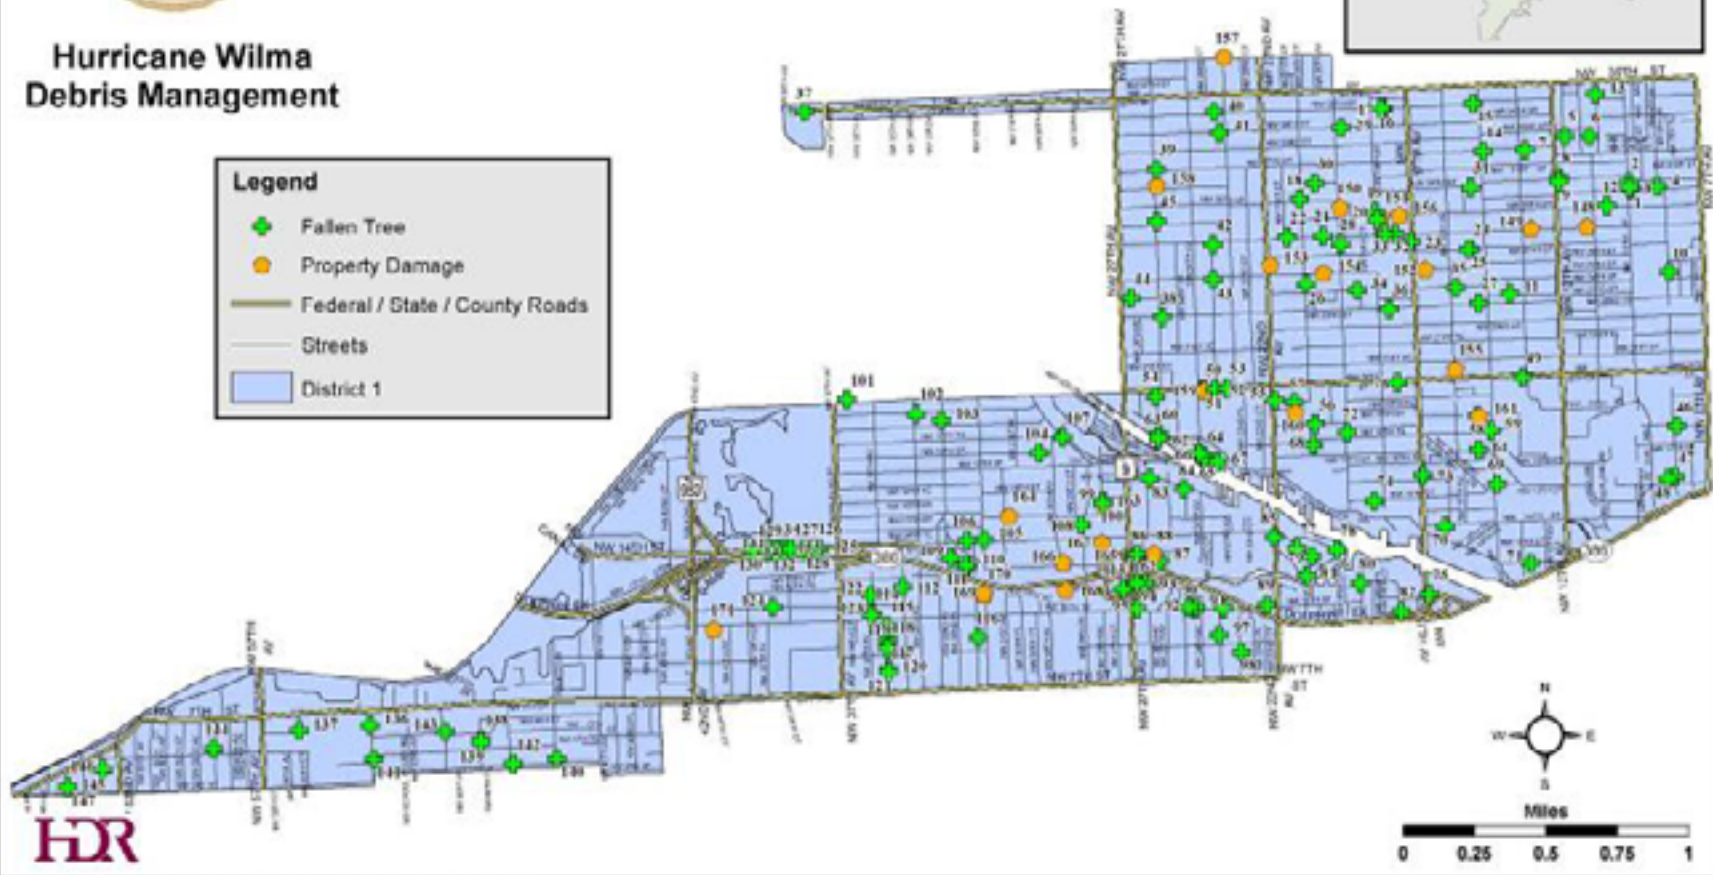
Hurricane Wilma
Debris Management

Citywide Fallen Tree
and Property Damage
District 1

- Green diamond: Fallen Tree
- Orange circle: Property Damage
- Thick yellow line: Federal / State / County Roads
- Thin grey line: Streets
- Blue shaded area: District 1

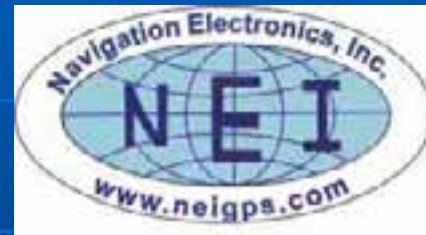
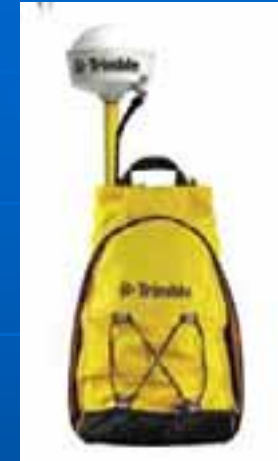
- Trimble GeoXH handheld with TerraSync software:

- Total # of structures collected: 35
- Fire Hydrants – 4
- Bus Benches – 3
- Catch Basins/Inlets – 16 (City)
- Catch Basins/Inlets – 2 (FDOT)
- Trees – 10
- Nature Trail – 1 mile
- Accuracy:
 - Vertical: from 0.6 feet (8 inch) to 4.5 feet
 - Horizontal: from 0.4 feet to 2.8 feet

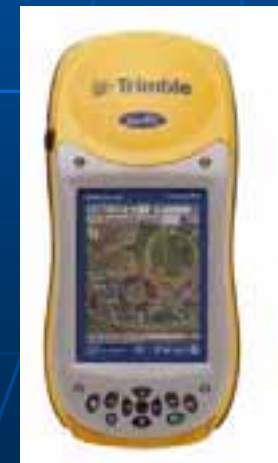
- Trimble ProXRS backpack with Recon and ArcPad

- 7.0 software:

- Total # of structures collected: 27
- Fire Hydrants – 3
- Bus Benches – 2
- City Storm Water Catch Basins/Inlets – 12
- Trees – 10

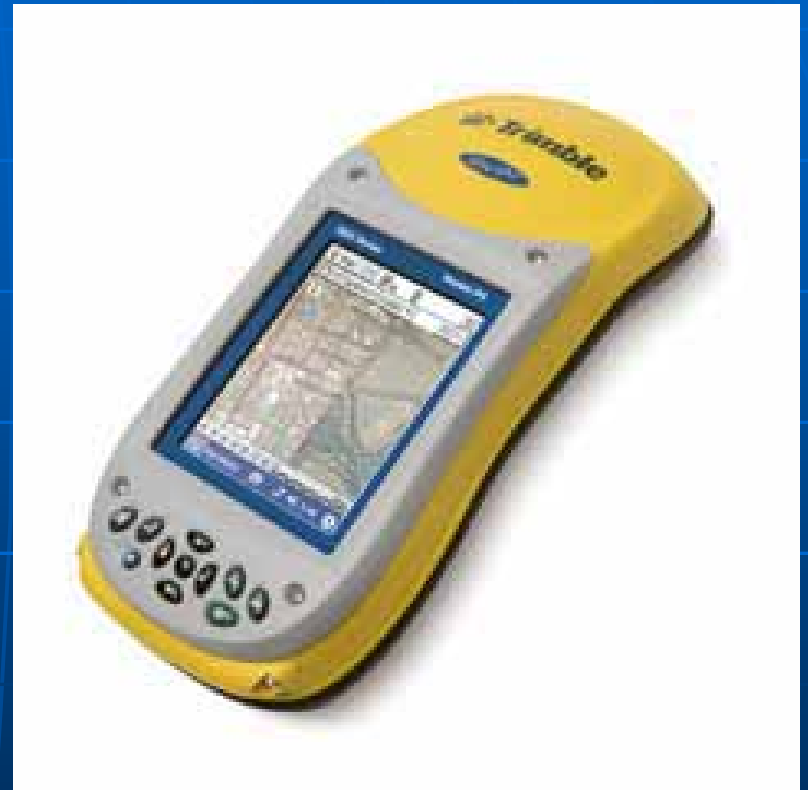
- Trimble Geo XM
 - 1 – 3 meter GPS accuracy real time and Post Processing (PP)
 - Accuracy suitable for asset management (benches, news racks, bus stops, payphones, fire hydrants, trees...)
 - Price: \$ 2,335 Hardware only
 - Software & Hardware Bundle Price: \$ 3,150 (includes ESRI ArcPad & Trimble GPScorrect software)

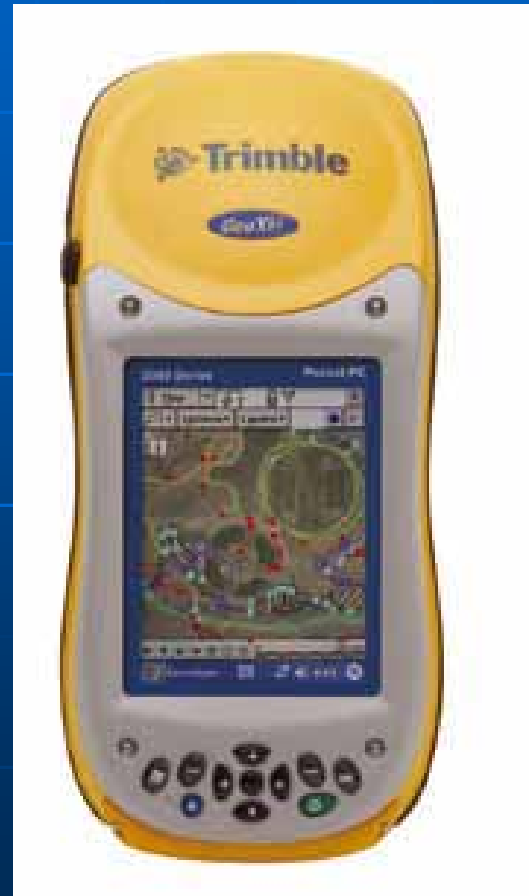
■ Trimble Geo XH

- Sub-meter GPS accuracy in the field (sub 30cm Post Processed {PP})
- Accuracy suitable for storm water infrastructure & asset management (catch basins, manholes, outfalls...)
- Hardware Price: \$ 4,765.
- Hardware & software Bundle Price: \$ 5,350 (includes ESRI ArcPad & Trimble GPSCorrect software)

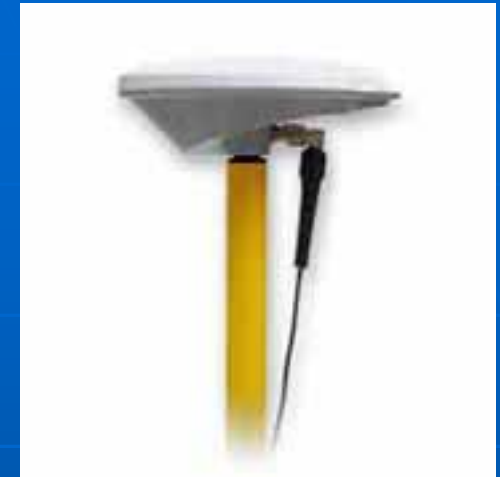
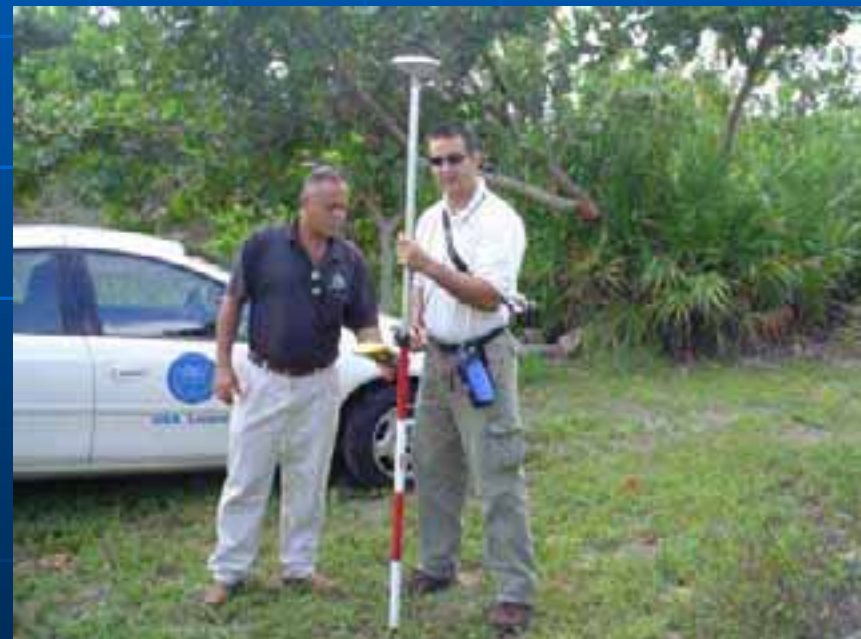
Zephyr Antenna & Pole

- Why do you want this?
- 'Canyon & Canopy' effect
 - Assists in collecting in Urban canyon aka 'Downtown' and in Tree Canopy – Coconut Grove
- Antenna \$2000
- Pole \$235
- Bracket \$175

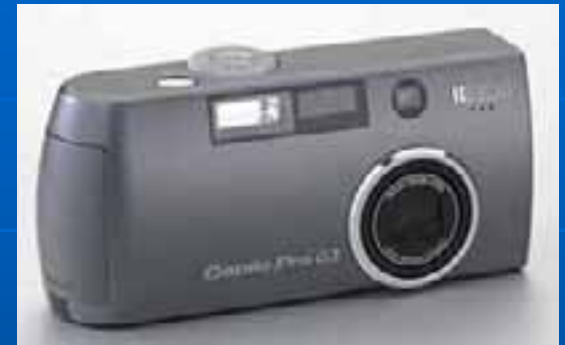
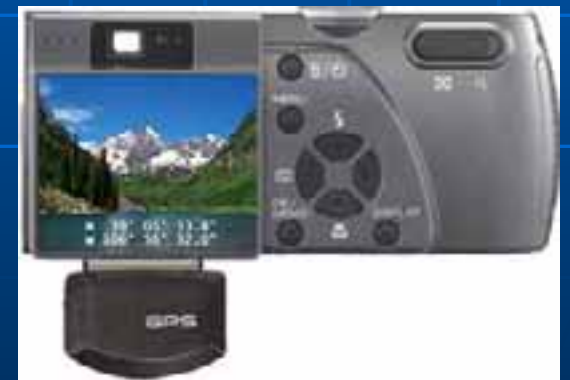
- Ricoh Pro G3 GPS Camera
 - Requires Compact flash WI-FI Card
 - Price \$870.00 (camera)
 - Speeds data collection by documenting actual condition of asset (tree)

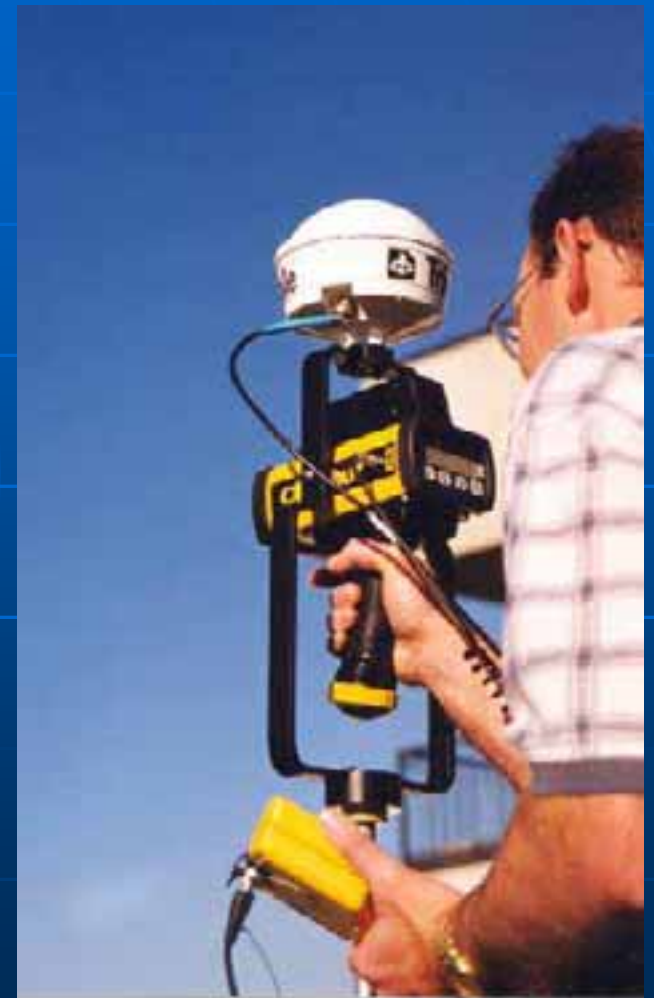
Lasercraft Contour Laser Rangefinder

- Why do you need this?
 - Measures heights of buildings, trees
 - Can collect many assets you may not be able to reach physically
 - Across canals, streams & rivers
 - Construction or industrial sites that are fenced, hazardous, or inaccessible
- \$4,195 Rangefinder
- \$200 Yoke Assembly
- \$145 Bipod for Laser Pole

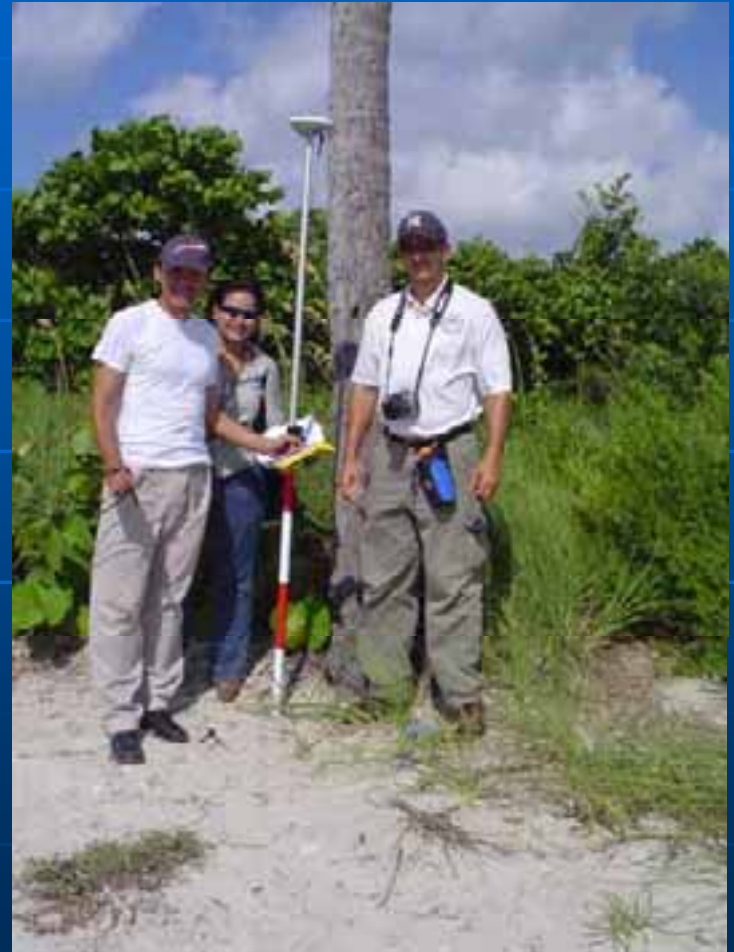
- GPS Data Collection on Virginia Key
 - Collection of rare and endangered trees and shrubs on Virginia Key
 - Documentation of the habitat restoration project
 - NOAA Grant to The Parks Department
 - Started Data collection in July 2006 w/Geo XM

- Virginia Key
 - Shrubs
 - + <all other values>
 - Native
 - Exotic
 - Native
 - Trees
 - Native
 - Street Centerlines
 - ManBoundary
 - Man_Land_Mess
 - Water Bodies
 - 2006_miami-dade_co_3.sid
 - Man03_15_1.sid
 - AERIAL_COLOR
- Location map

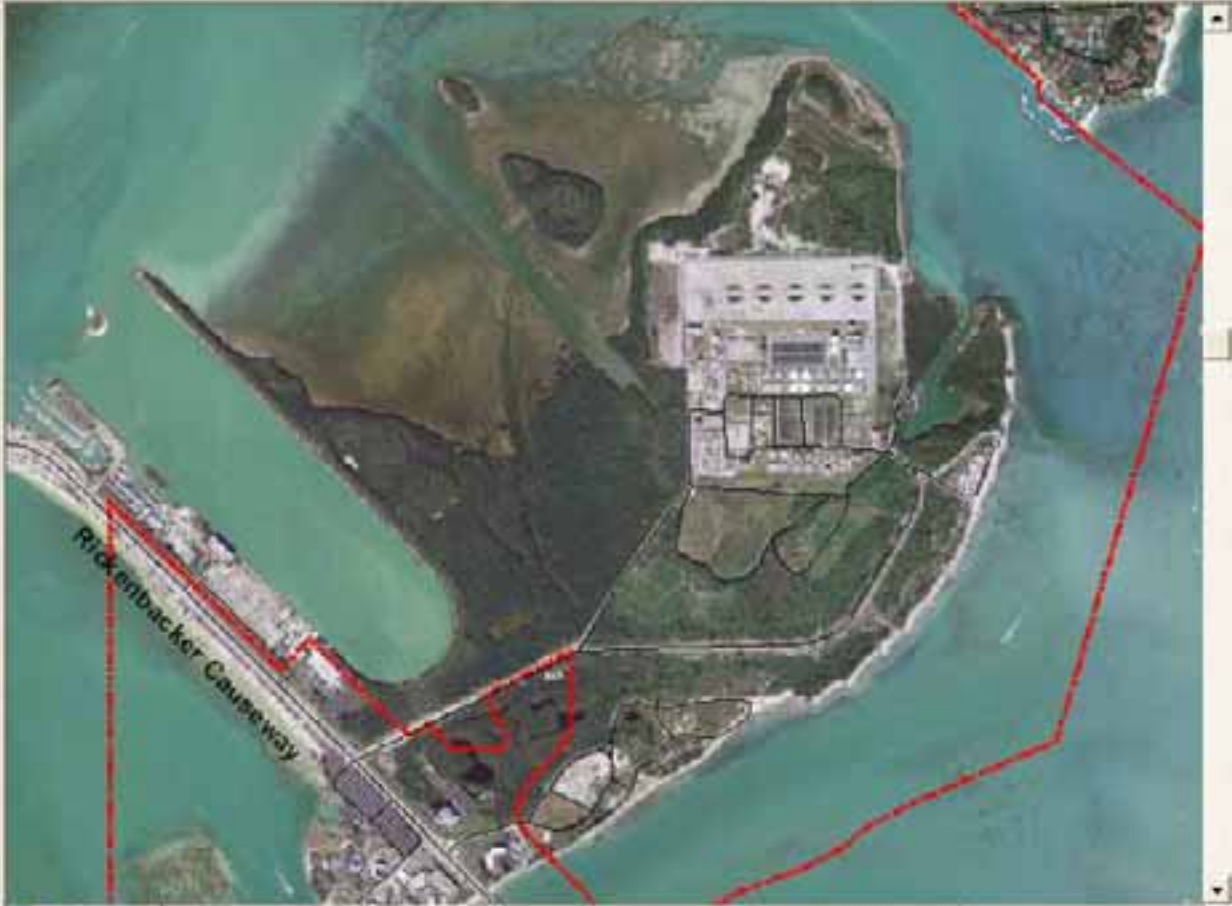
Virginia Key

- Hydrant
- GPS POINTS 2-21-06
- Fire_Hydrants1020043L
- test2
- NPDES Structures
- Furniture
- Trees
- Payphone_final
- Marlin Structures
- Street Centerlines
- NatureTrail
- Line_gen
- Road
- ammover
- amrail
- MS4_Pipes
- Water Bodies
- Grant Boundary
- CityParcels2_2006
- MiamiBoundary
- 2006_miami-dade_co_3.sid
- MiamiR 15 1.cdl

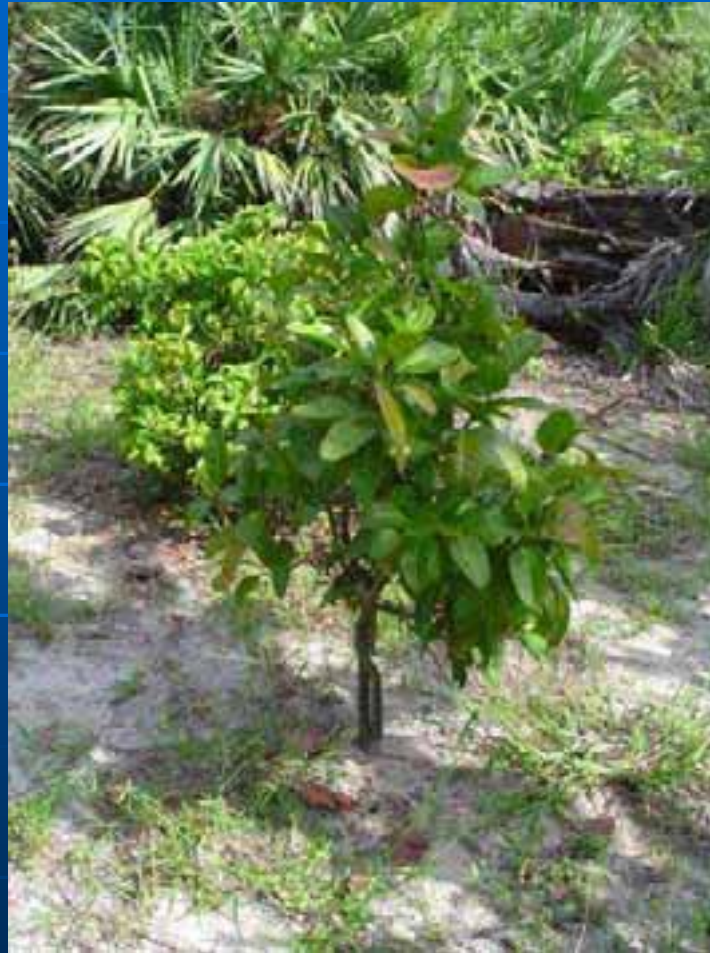
Shrubs

Common Name
Genus & Species
DBH
HT_IN
In ROW
Condition
Gender
Insp_Date
Insp_By
Flowers
Flower color
Image
Native
TAG_NO
