The Use of Image Analysis to Understand Brazil's Worst Natural Disaster

ABSTRACT

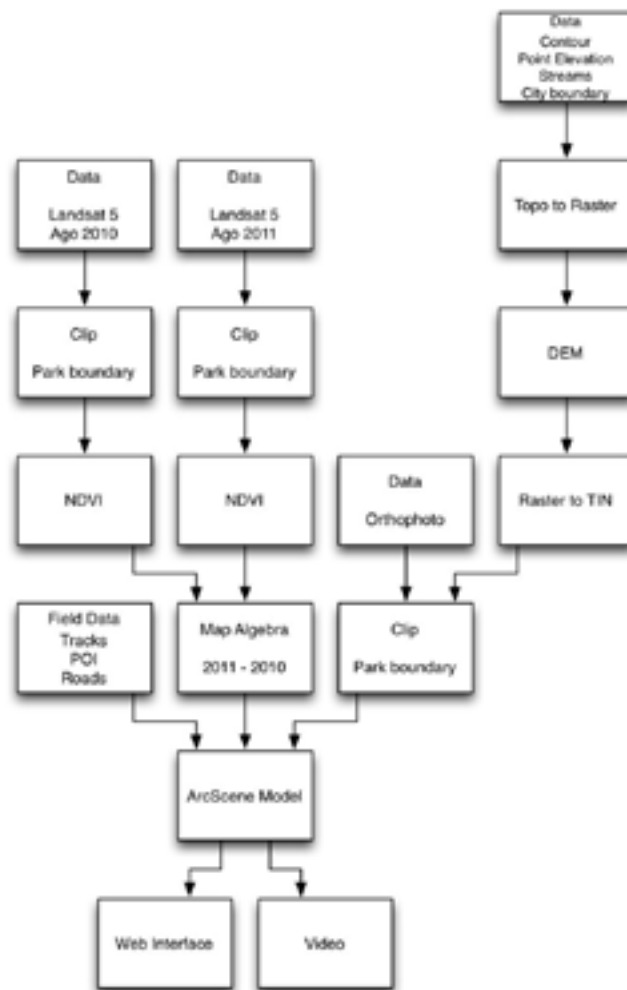
Fig 3: Methodology used, showing the sequence of data preprocessing and NDVI calculation, in parallel with the creation of the 3D model. The integrated results are presented using a Web interface.

A strong characteristic of the tragedy caused by the rains was the occurrence of landslides in many different places. Using the NDVI (Normalized Difference Vegetation Index), an indicator that shows significant results in the detection of changes in green vegetation cover caused by deforestation, fires and landslides (MOREIRA, 2013), it was possible to verify the difference observed between the months of August 2010 and August 2011. The development of the study followed the methodology represented schematically in figure 3.

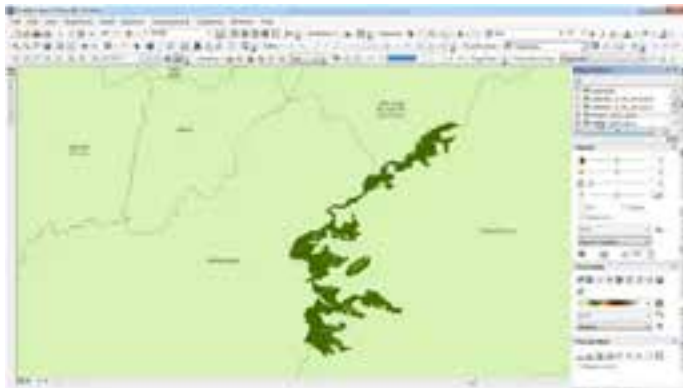
Fig 5: NDVI mapping of the PNMMT area, showing its location related to Teresópolis and neighboring counties.

The ArcMap interface with the NDVI mapping of PNMMT area using 2010 satellite image, processed with image analysis, are presented in figure 5. With the *Slider tool* it was possible to compare the difference in the vegetation coverage between the 2010 and 2011 data. The final 3D model in natural colors in a partial view of the Park area is represented in figure 6. Some details of roads, tracks and the Park boundary are also indicated.

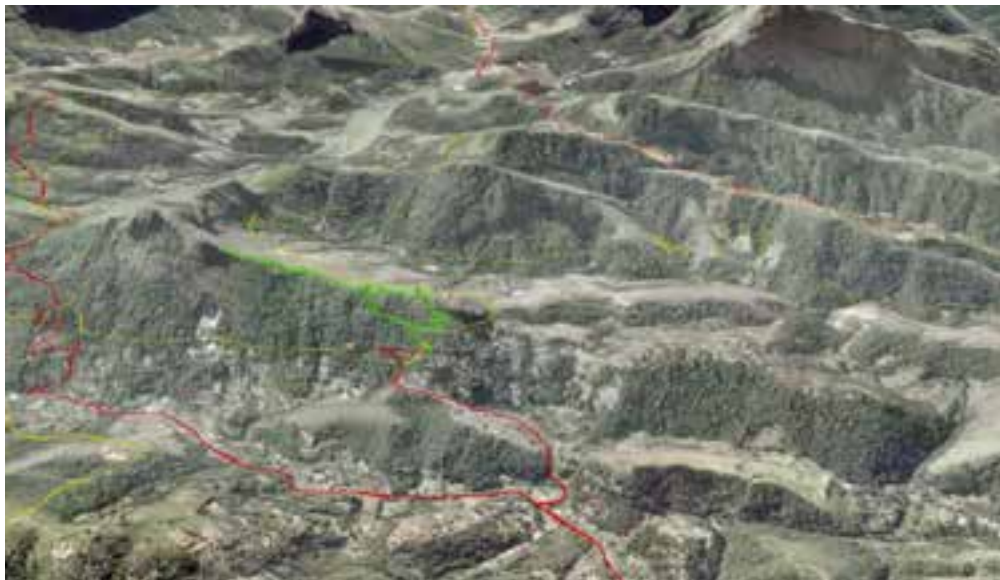
Fig 6: 3D model in natural colors highlighting roads in red, tracks in green, and the boundary of the Park in yellow.

In order to generate the virtual 3D model, a Digital Elevation Model (DEM) was interpolated using Contour, Point Elevation, Streams and City boundary data and the *Topo to Raster* tool. To compose the model, orthorectified aerial photographs of the region were placed over the generated DEM. Other data with relevant information such as access roads, tracks and points of interest acquired in field survey were also included.
