Response of the Upper Tugela River to Climate and Anthropogenic Forcing

By Simone Pretorius
Supervisor: Professor PD Sumner
University of Pretoria

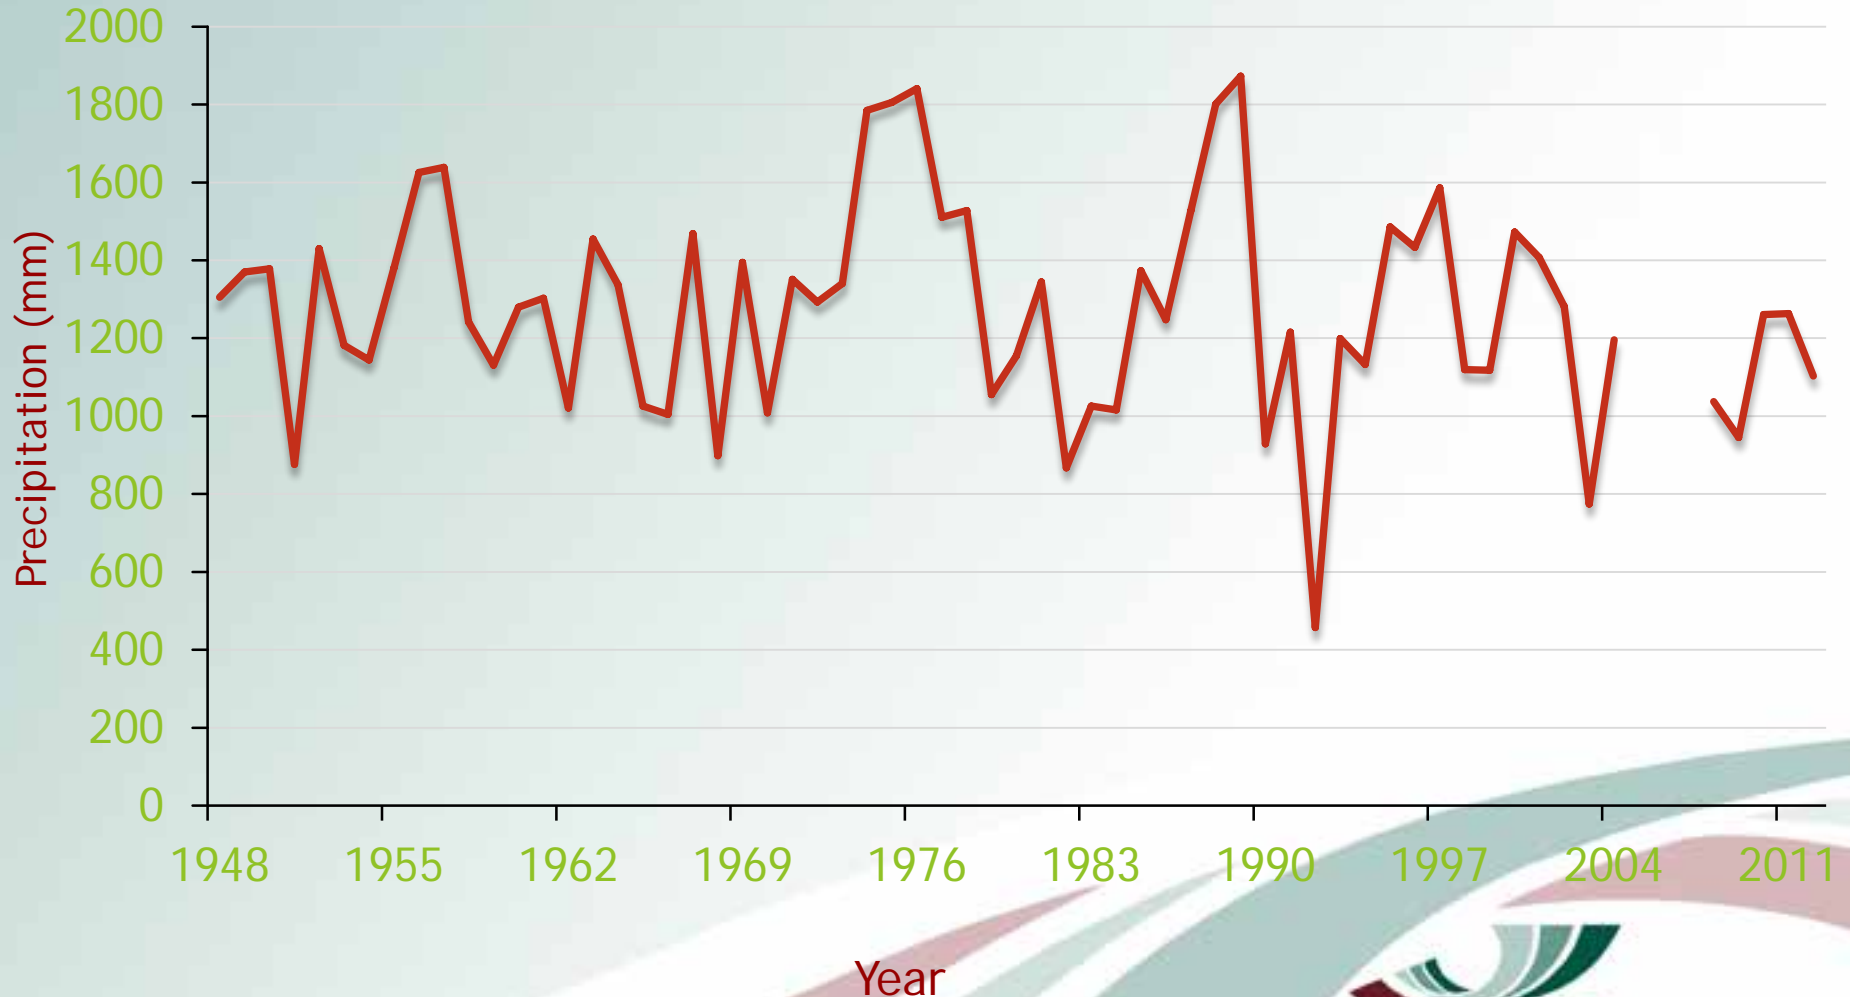
Average Annual Rainfall

Analyse rainfall data to determine any changes in average annual rainfall or the frequency and intensity of extreme events.

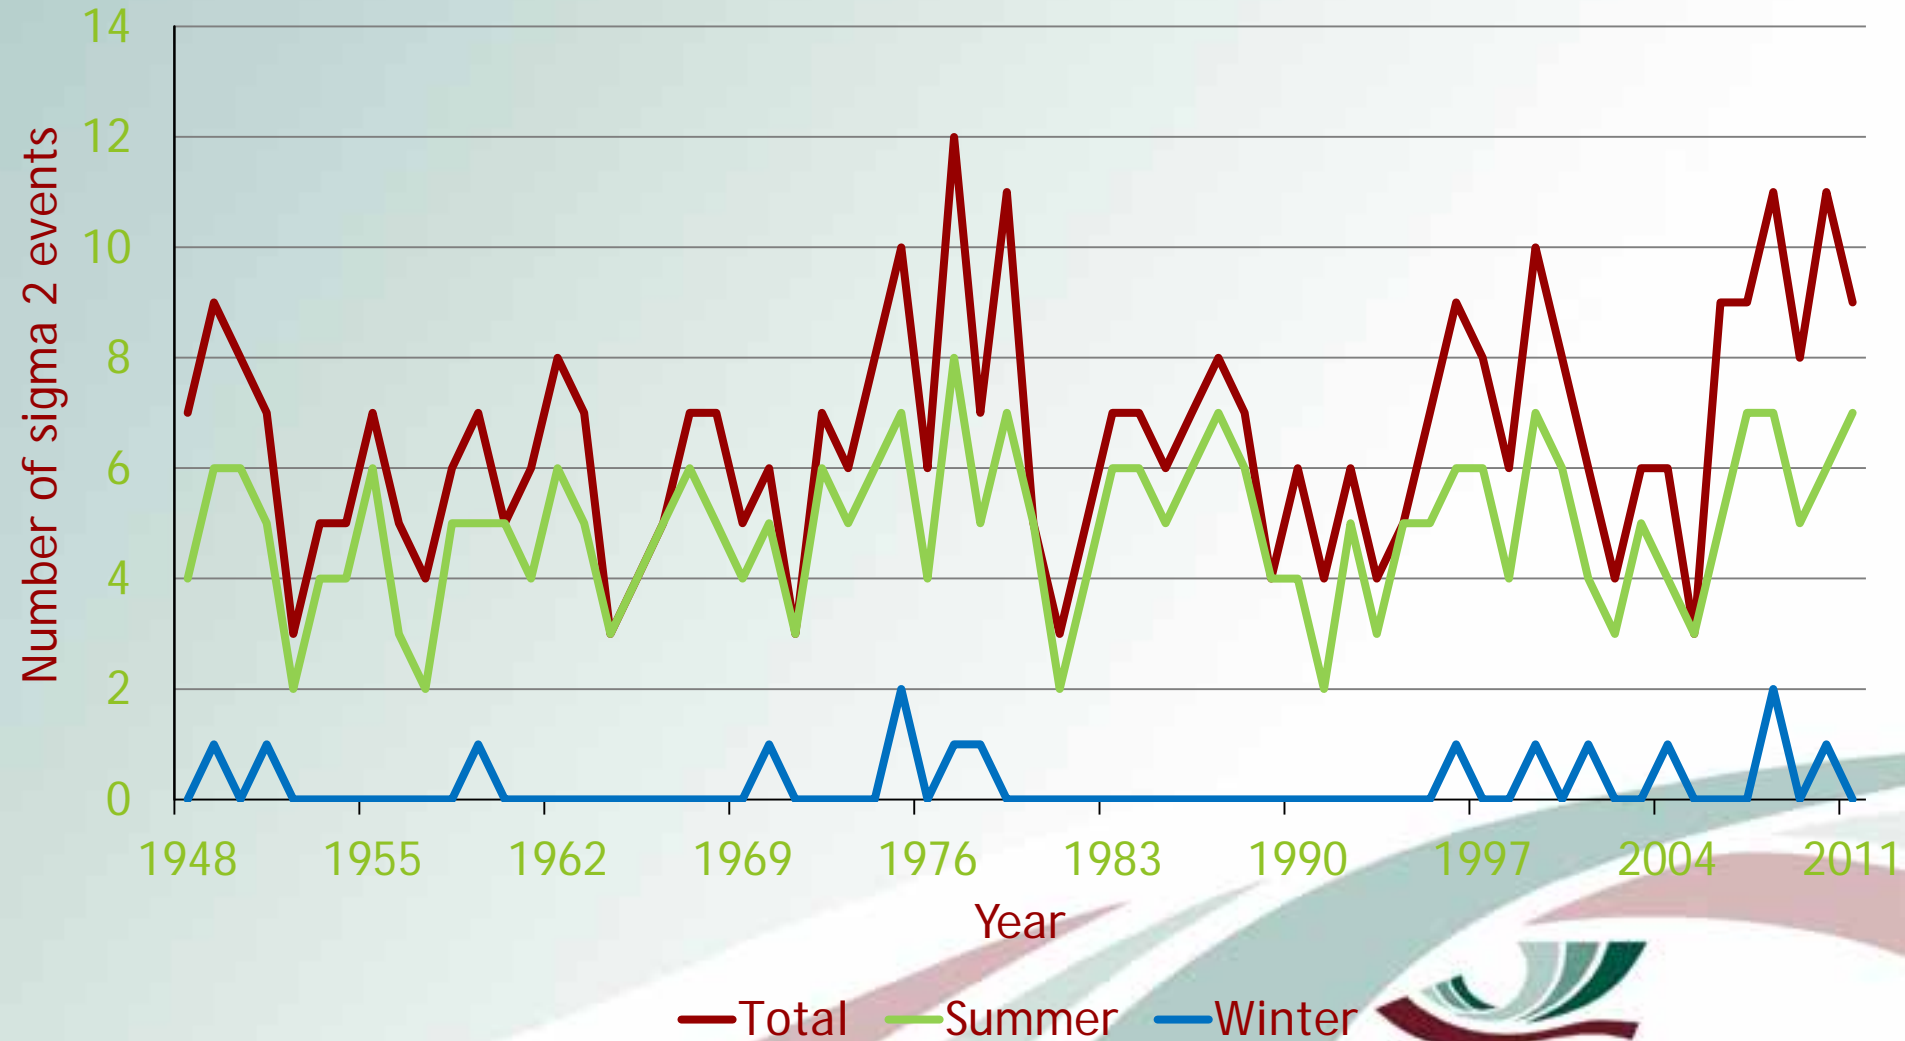
Frequency of extreme events

— Total — Summer — Winter

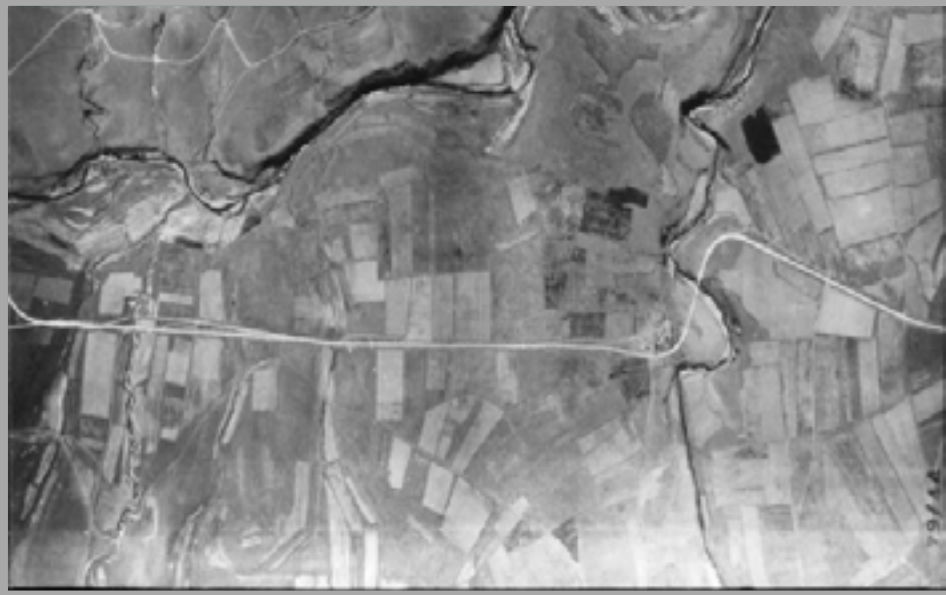
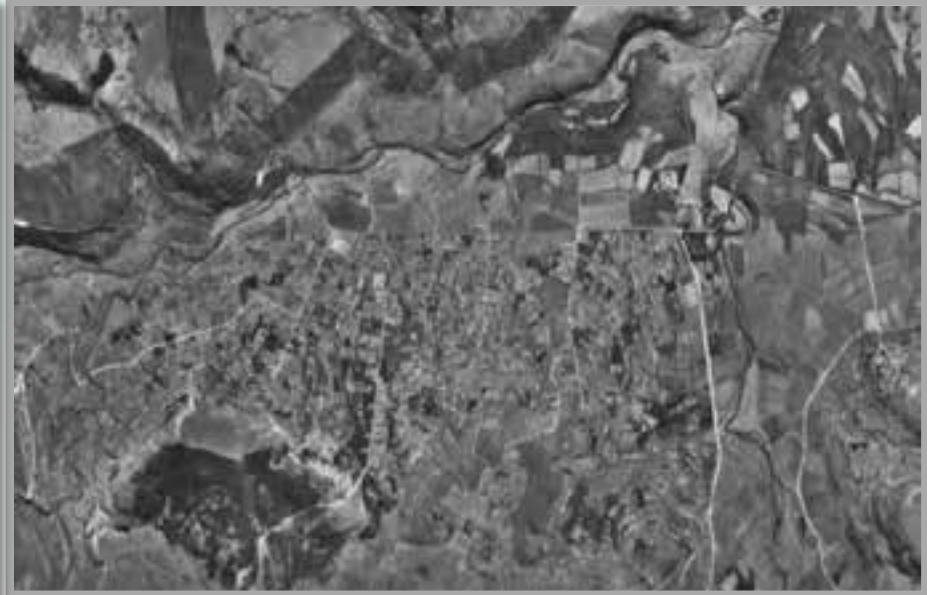
Site 2: 1944

Site 2: 2004

Changes in land use did affect the channel morphology.

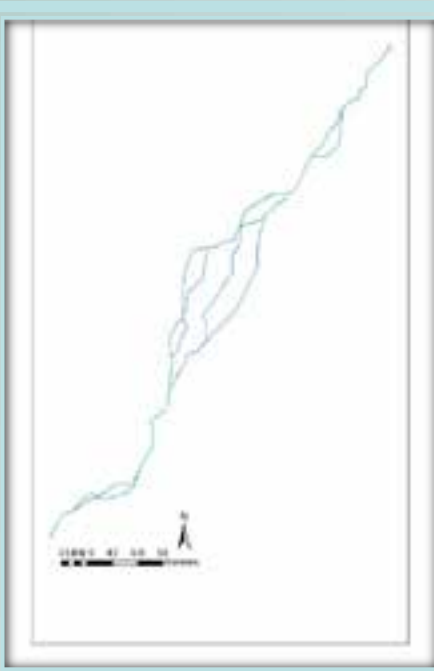
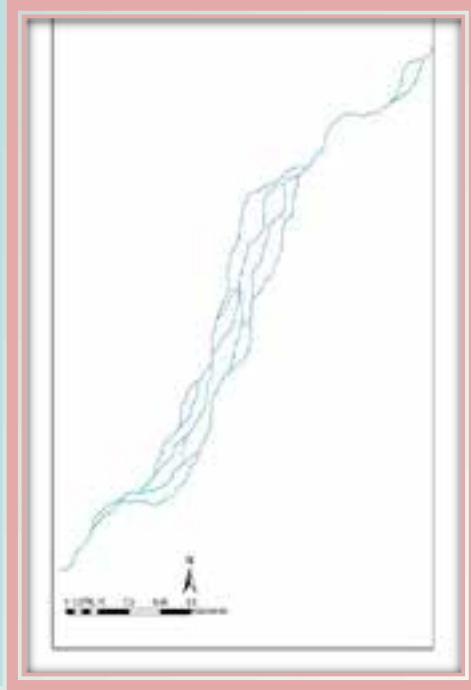
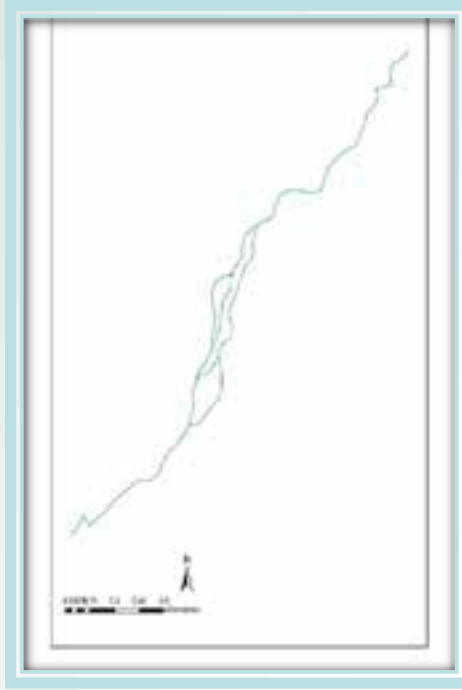
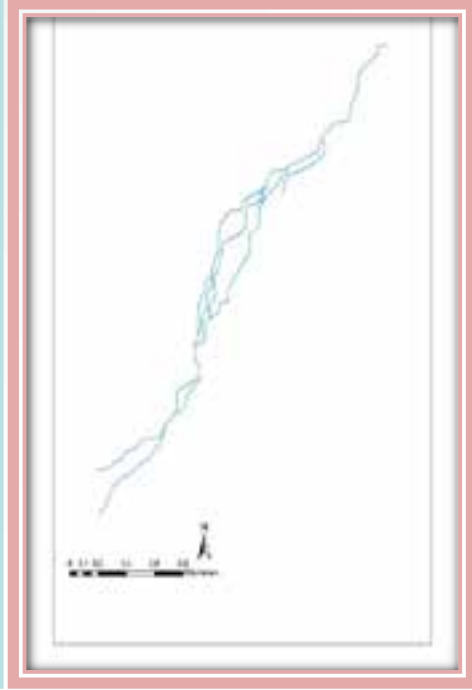
Results: Channel Morphology (Site 1)

1944

1962

1986

2004

All 3 sites showed changes although site 2 and 3 showed greater change.

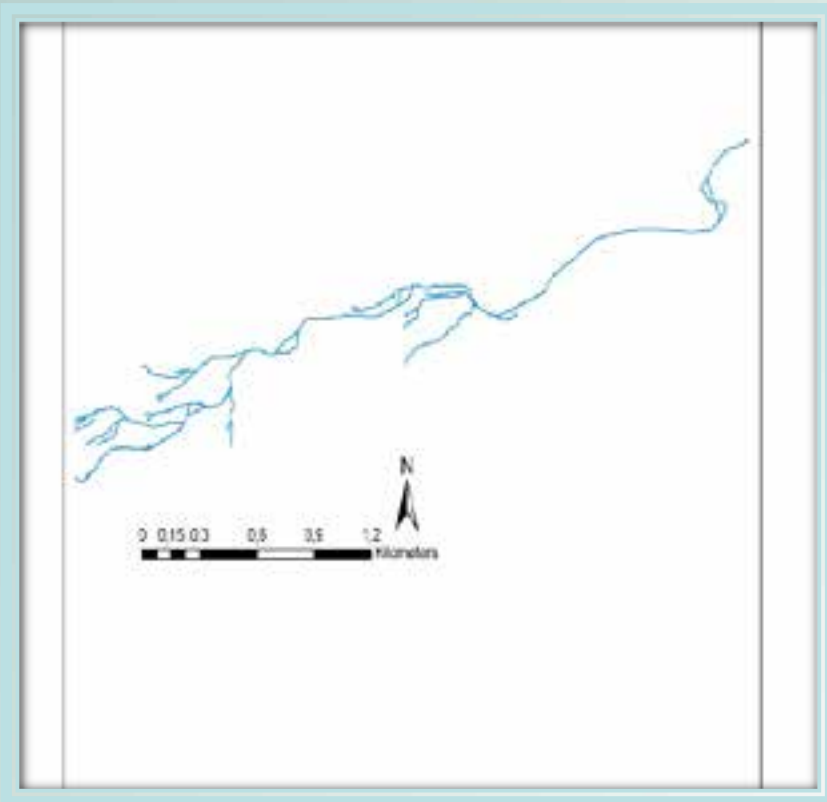
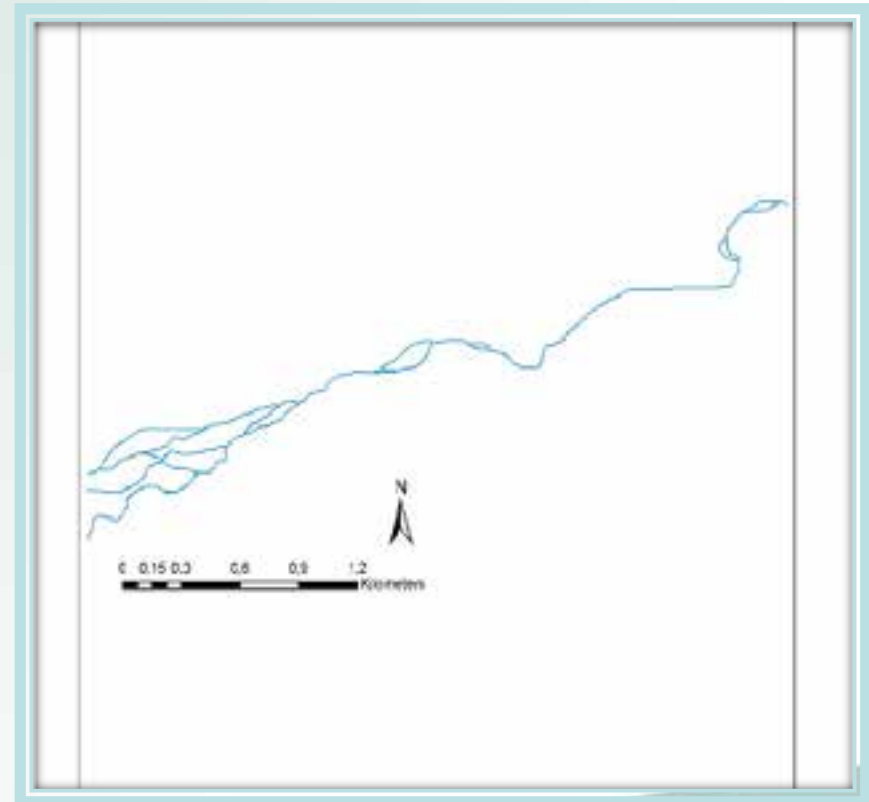
Results: River Channel Morphology (Site 2)

1944

2004

Changes reflected effects of flooding and natural channel change. However site 2 and 3 show accelerated rate of change.

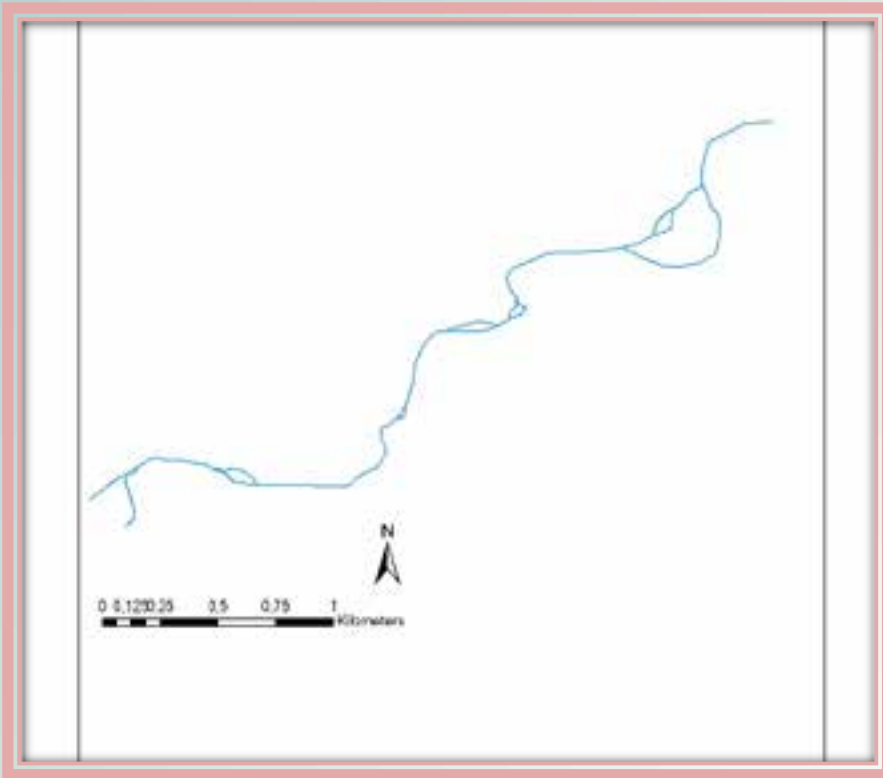
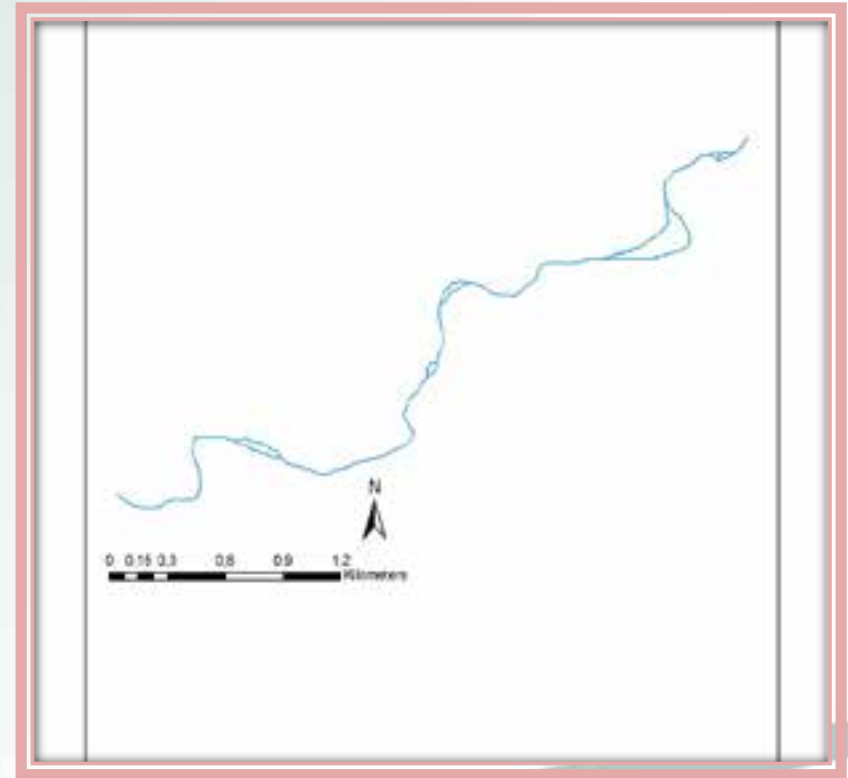
Results: River Channel Morphology (Site 3)

1944

2004
