Southeast GeoReadiness Center

Utilization of a Small Unmanned Aerial System by Naval Facilities Engineering Command Southeast

6/25/2014

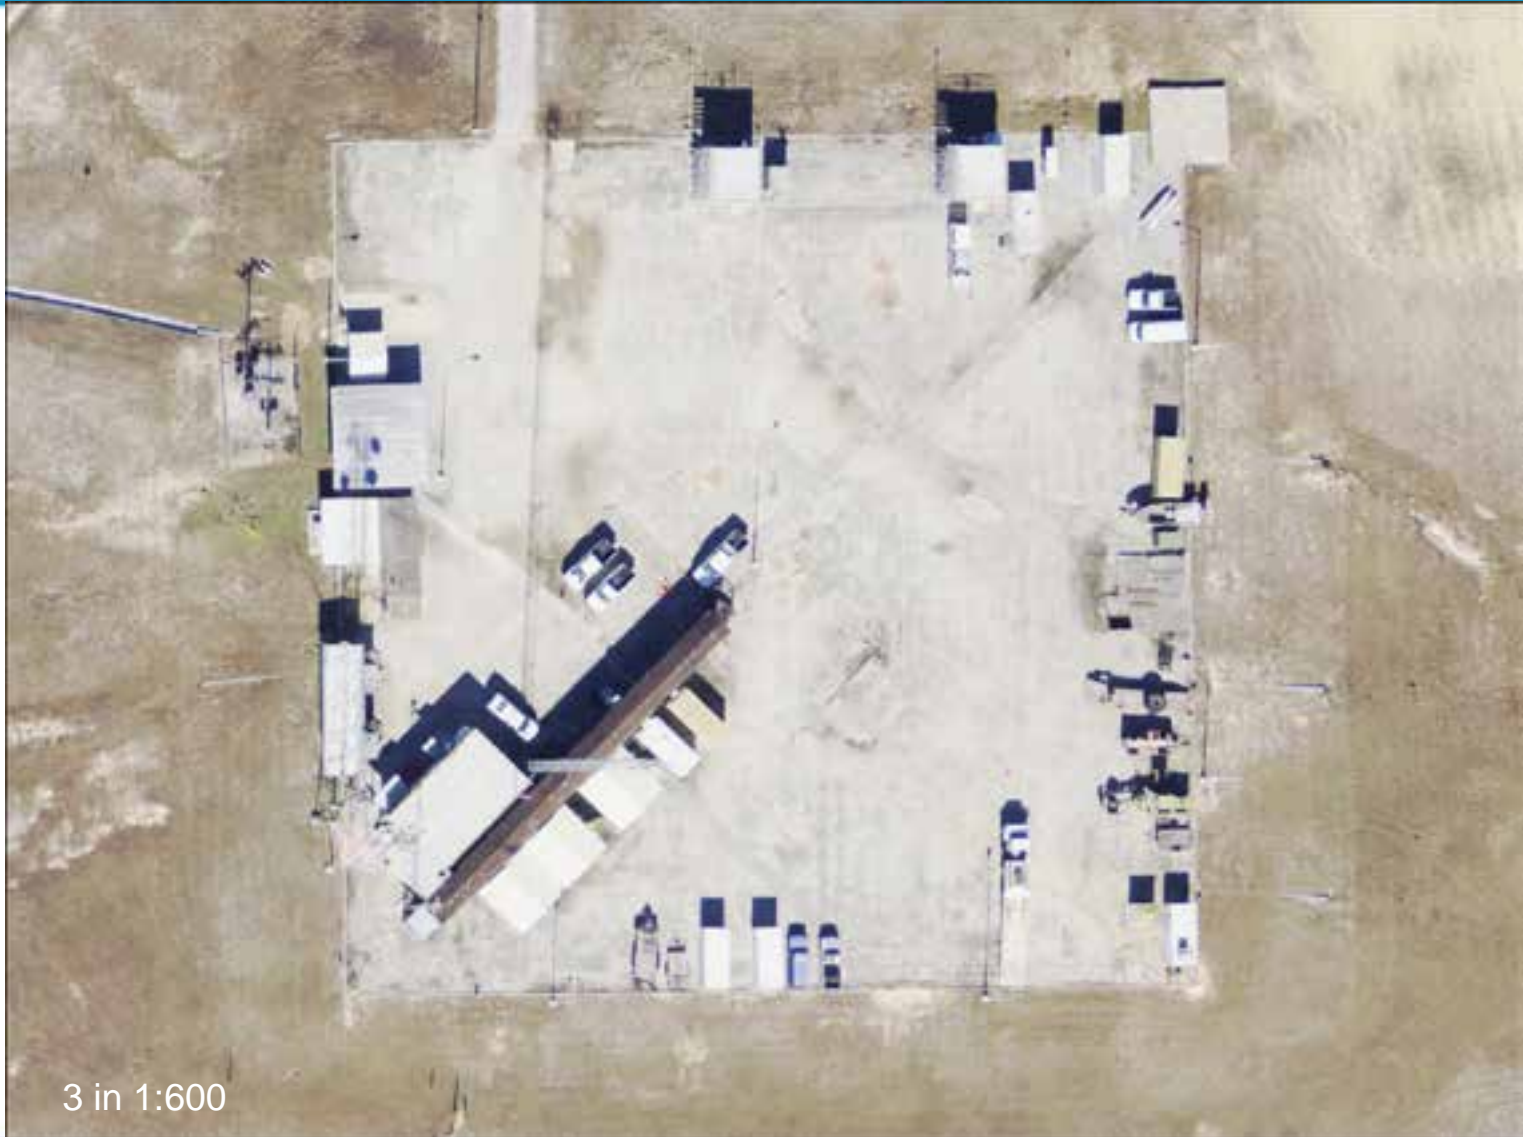
Sample Imagery

3 in 1:600

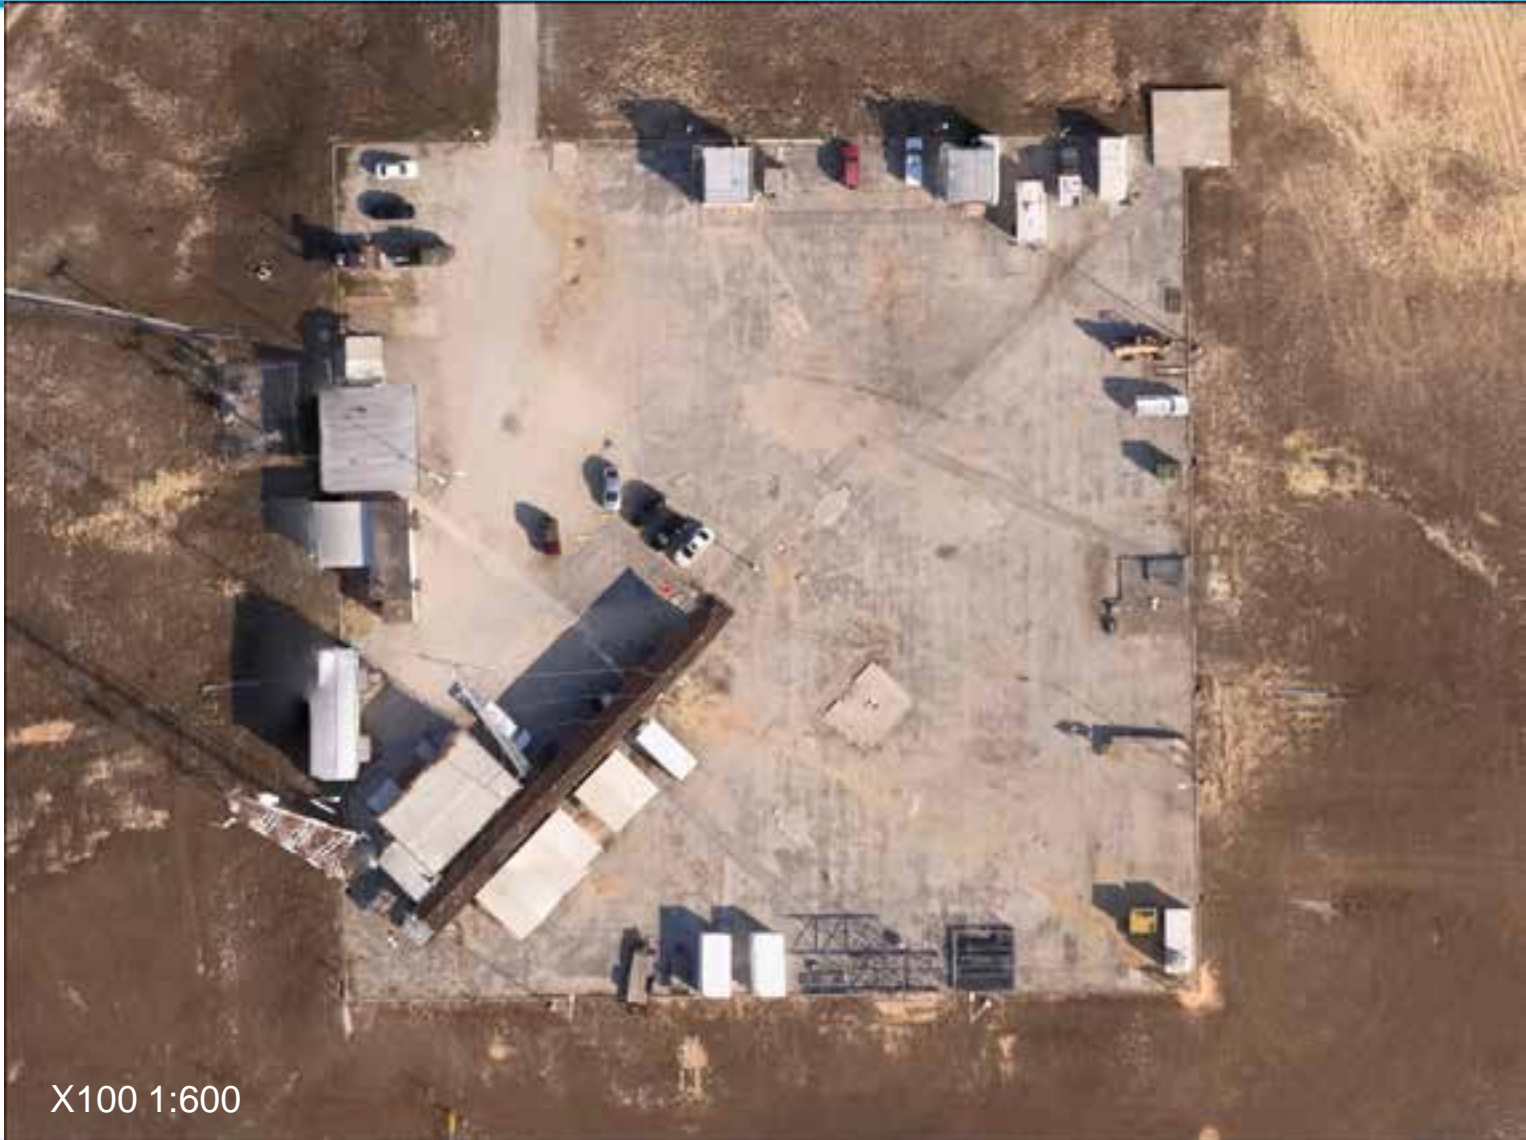
Sample Imagery

X100 1:600

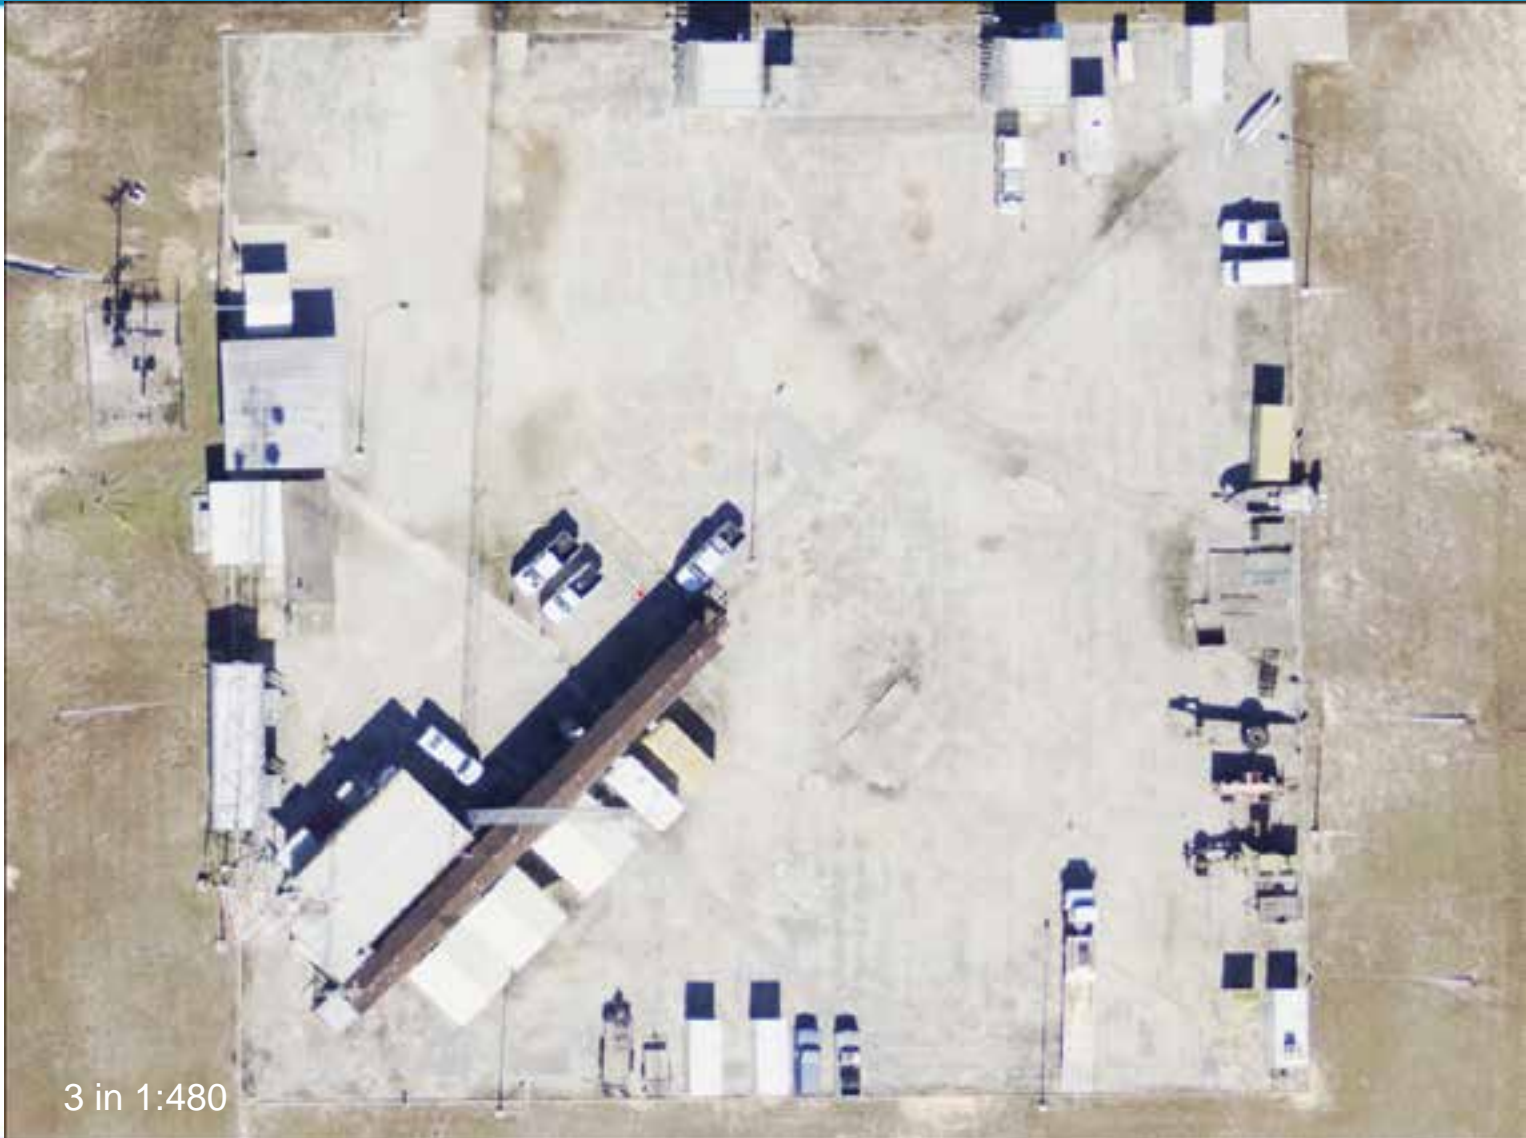
Sample Imagery

3 in 1:480

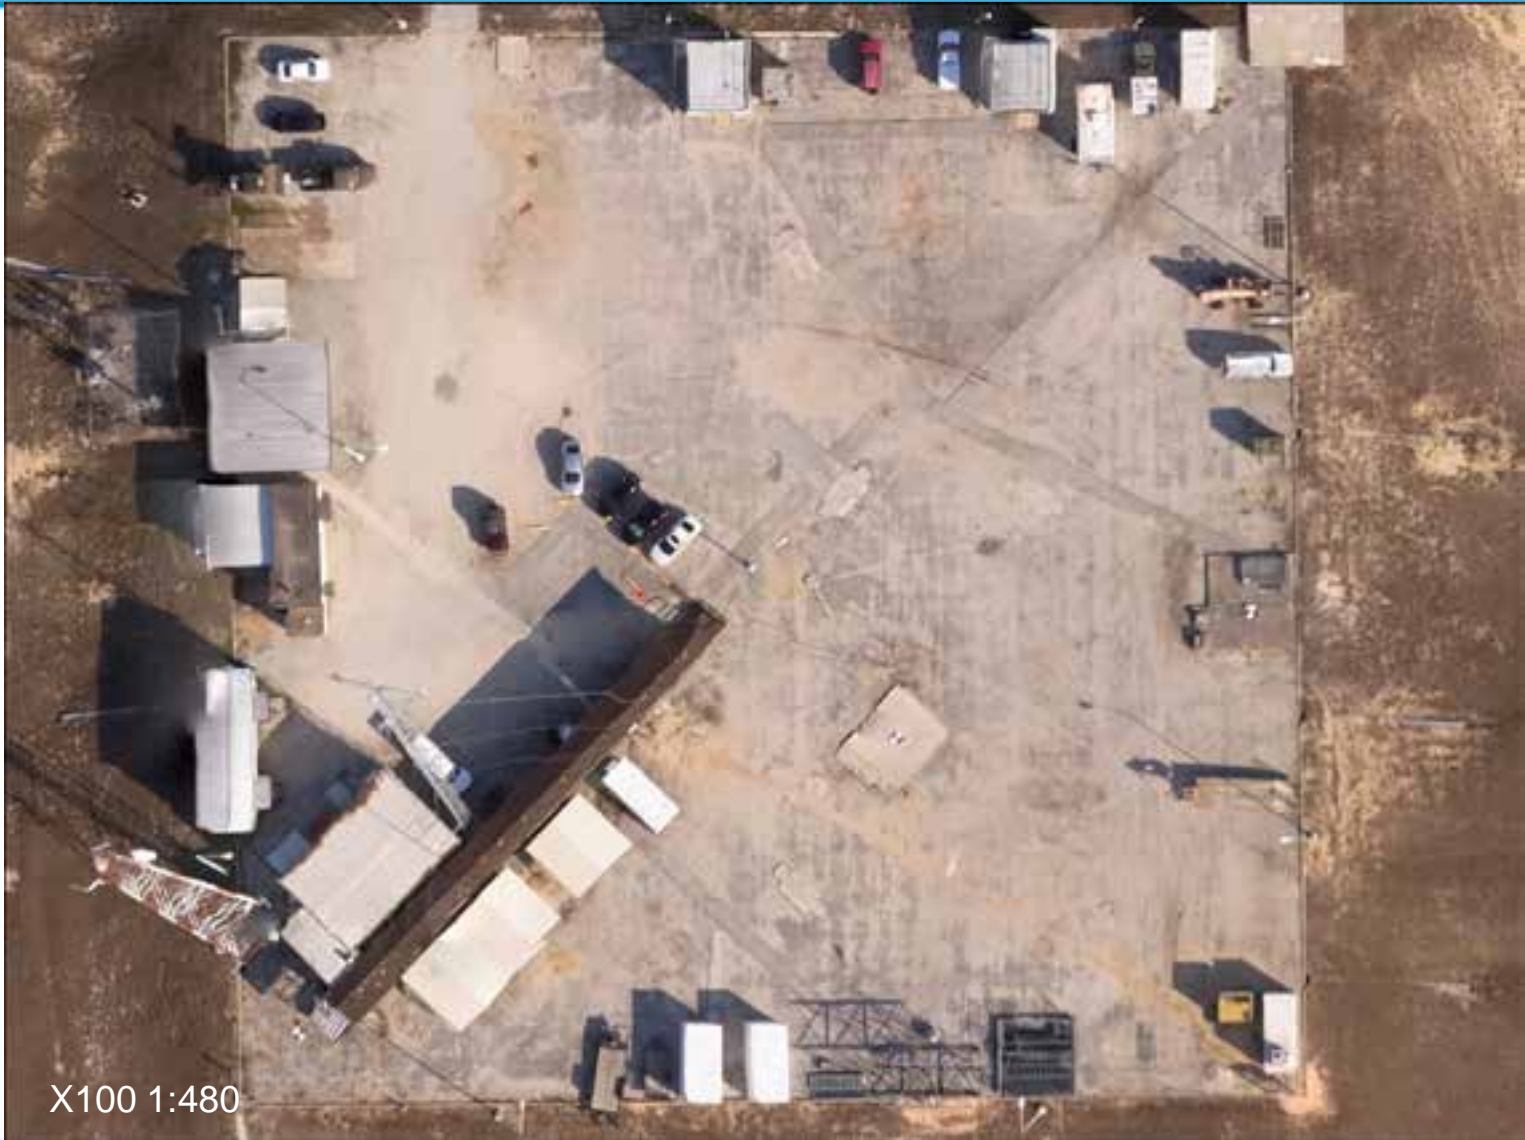
Sample Imagery

X100 1:480

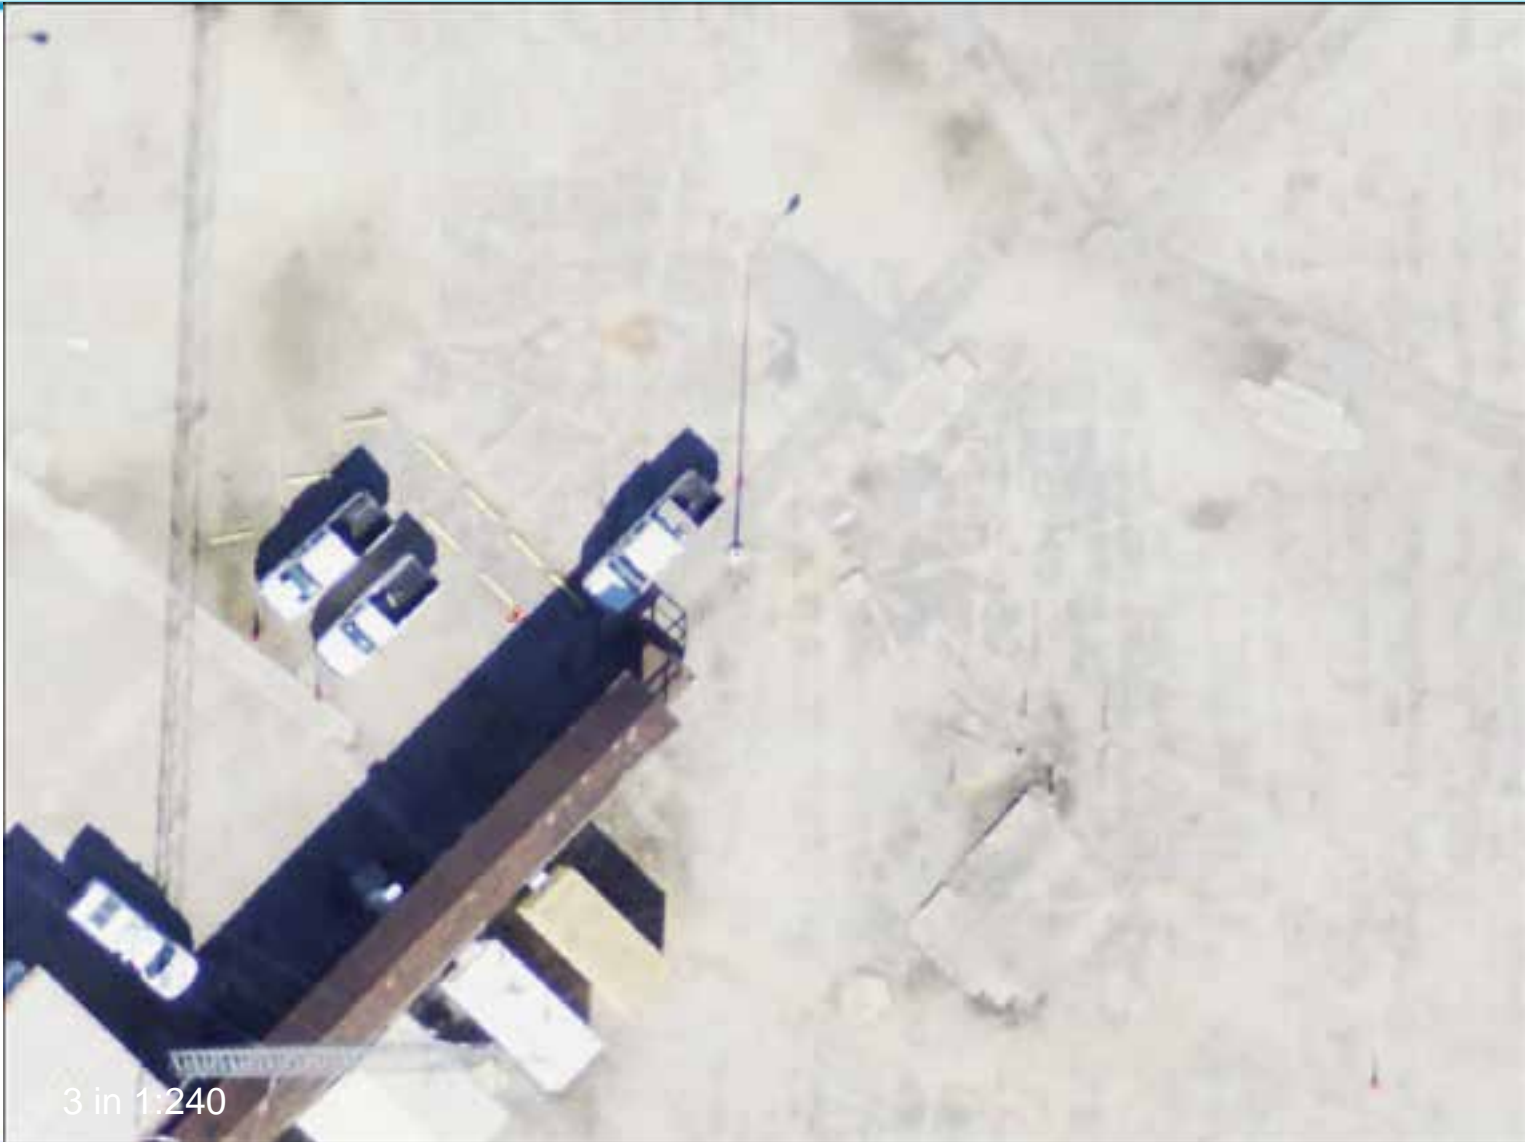
Sample Imagery

3 in 1:240

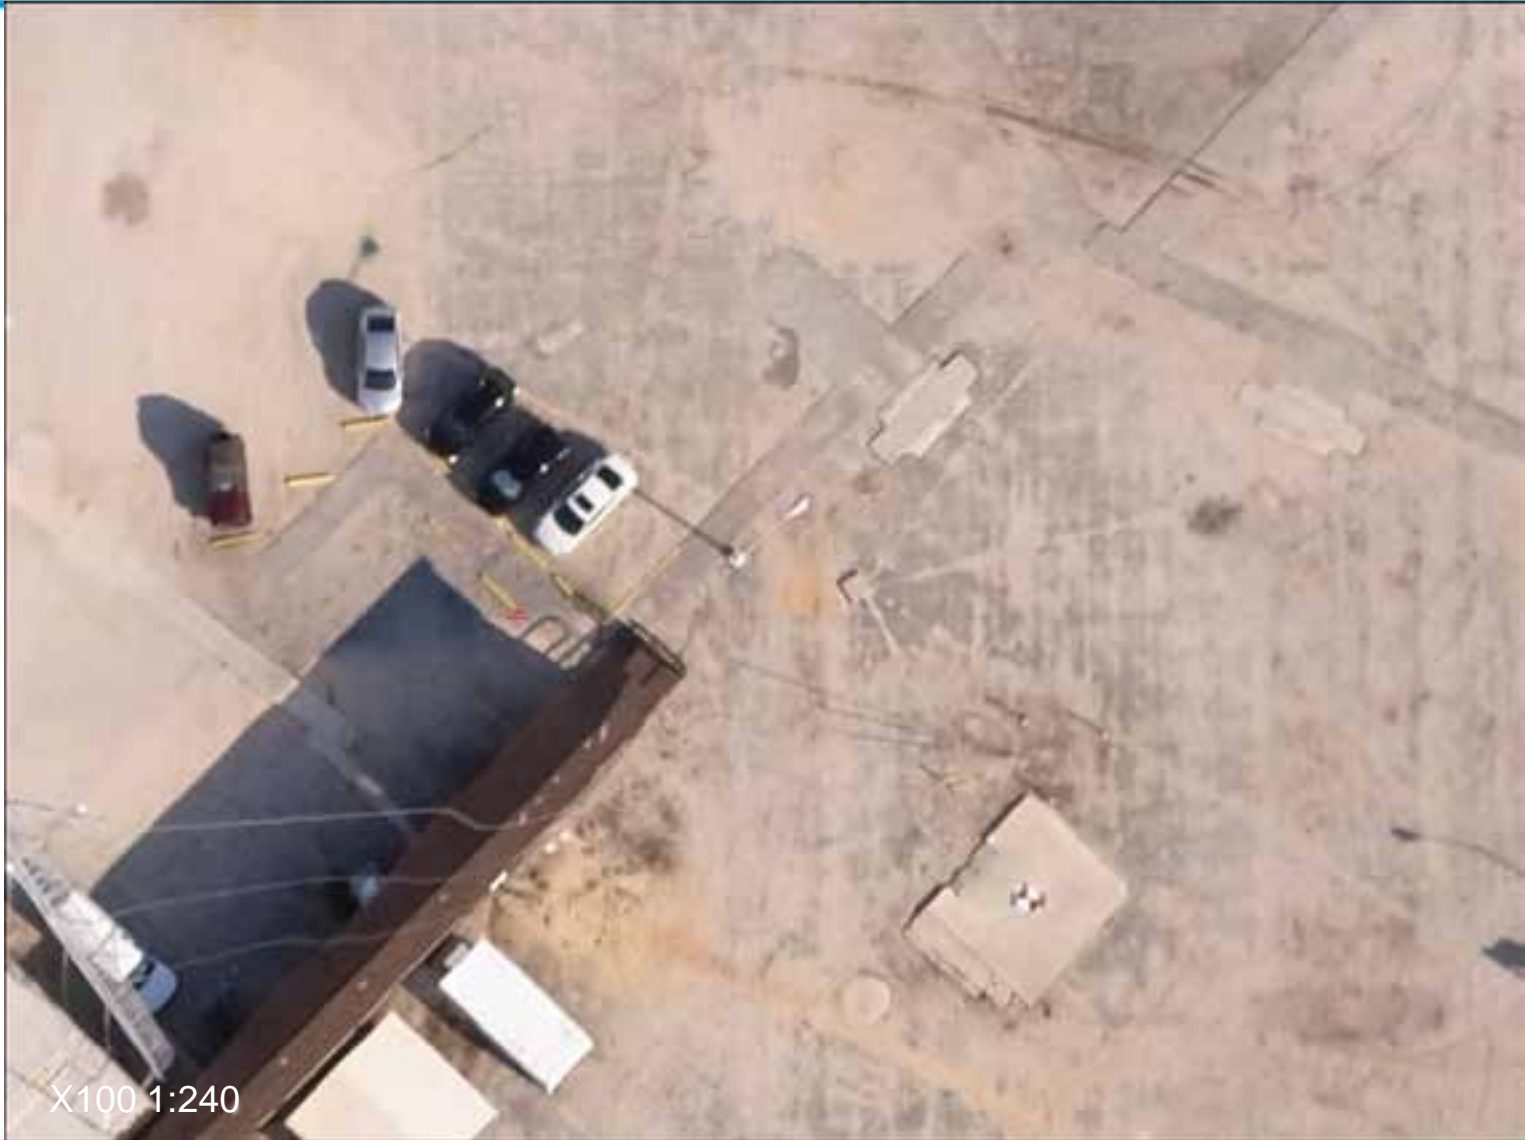
Sample Imagery

X100 1:240

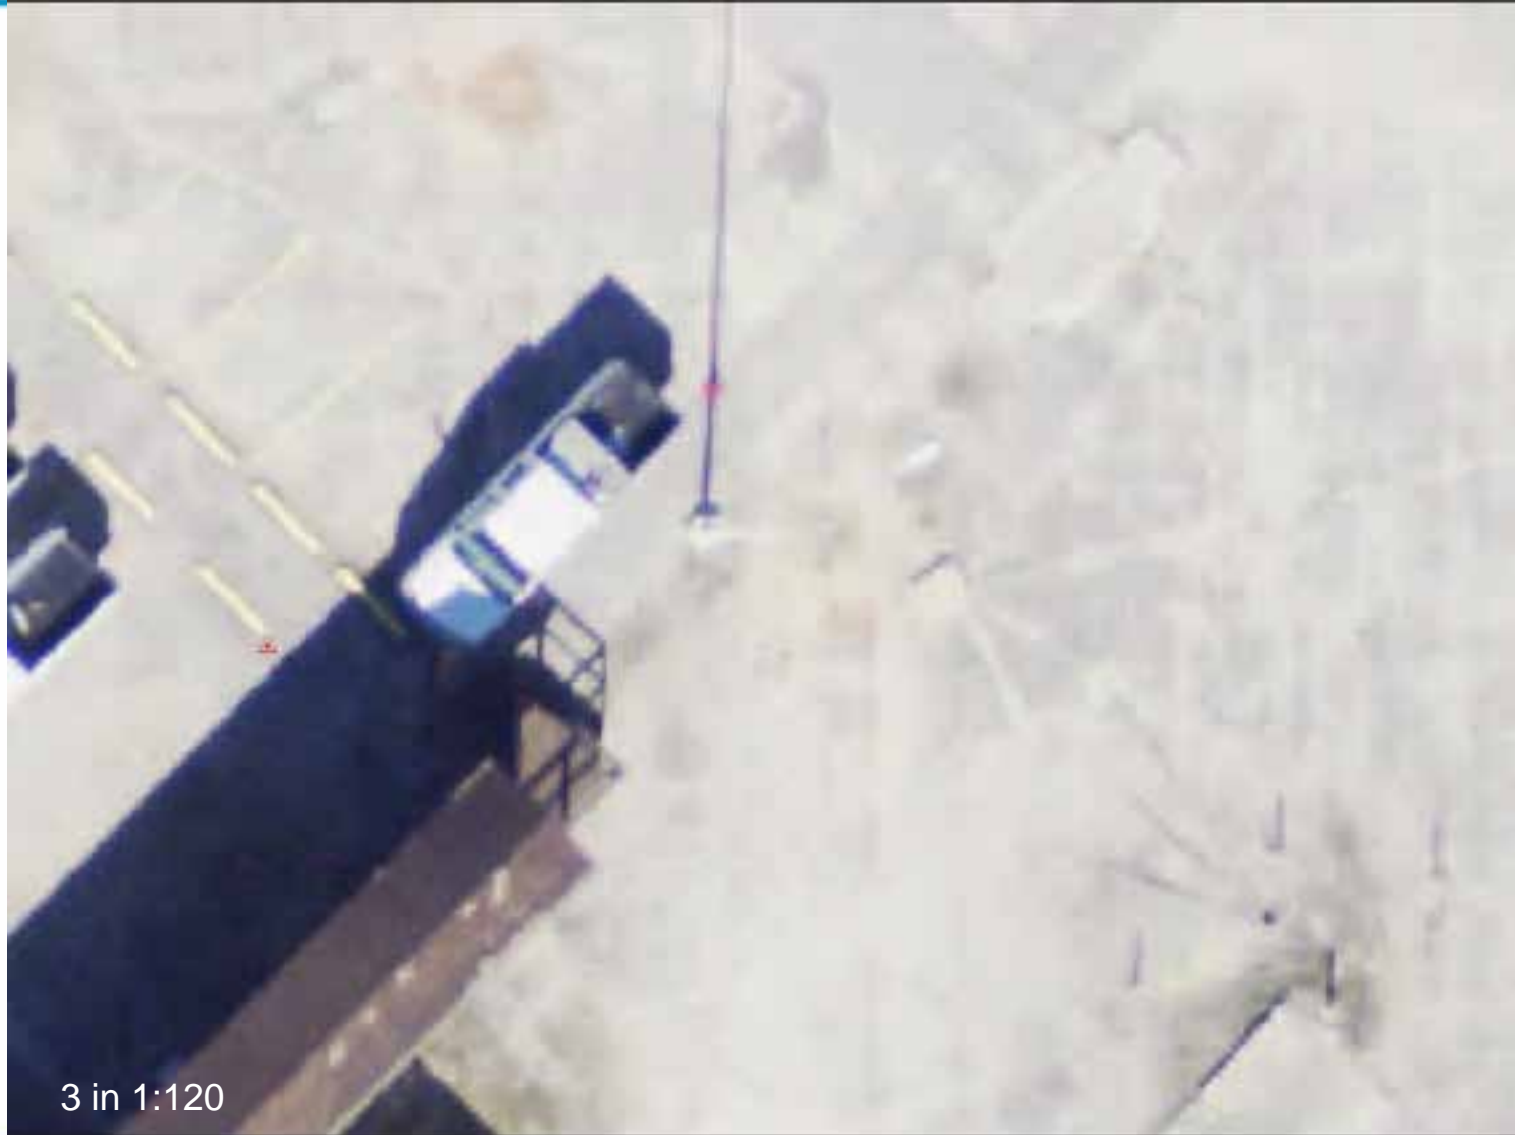
Sample Imagery

3 in 1:120

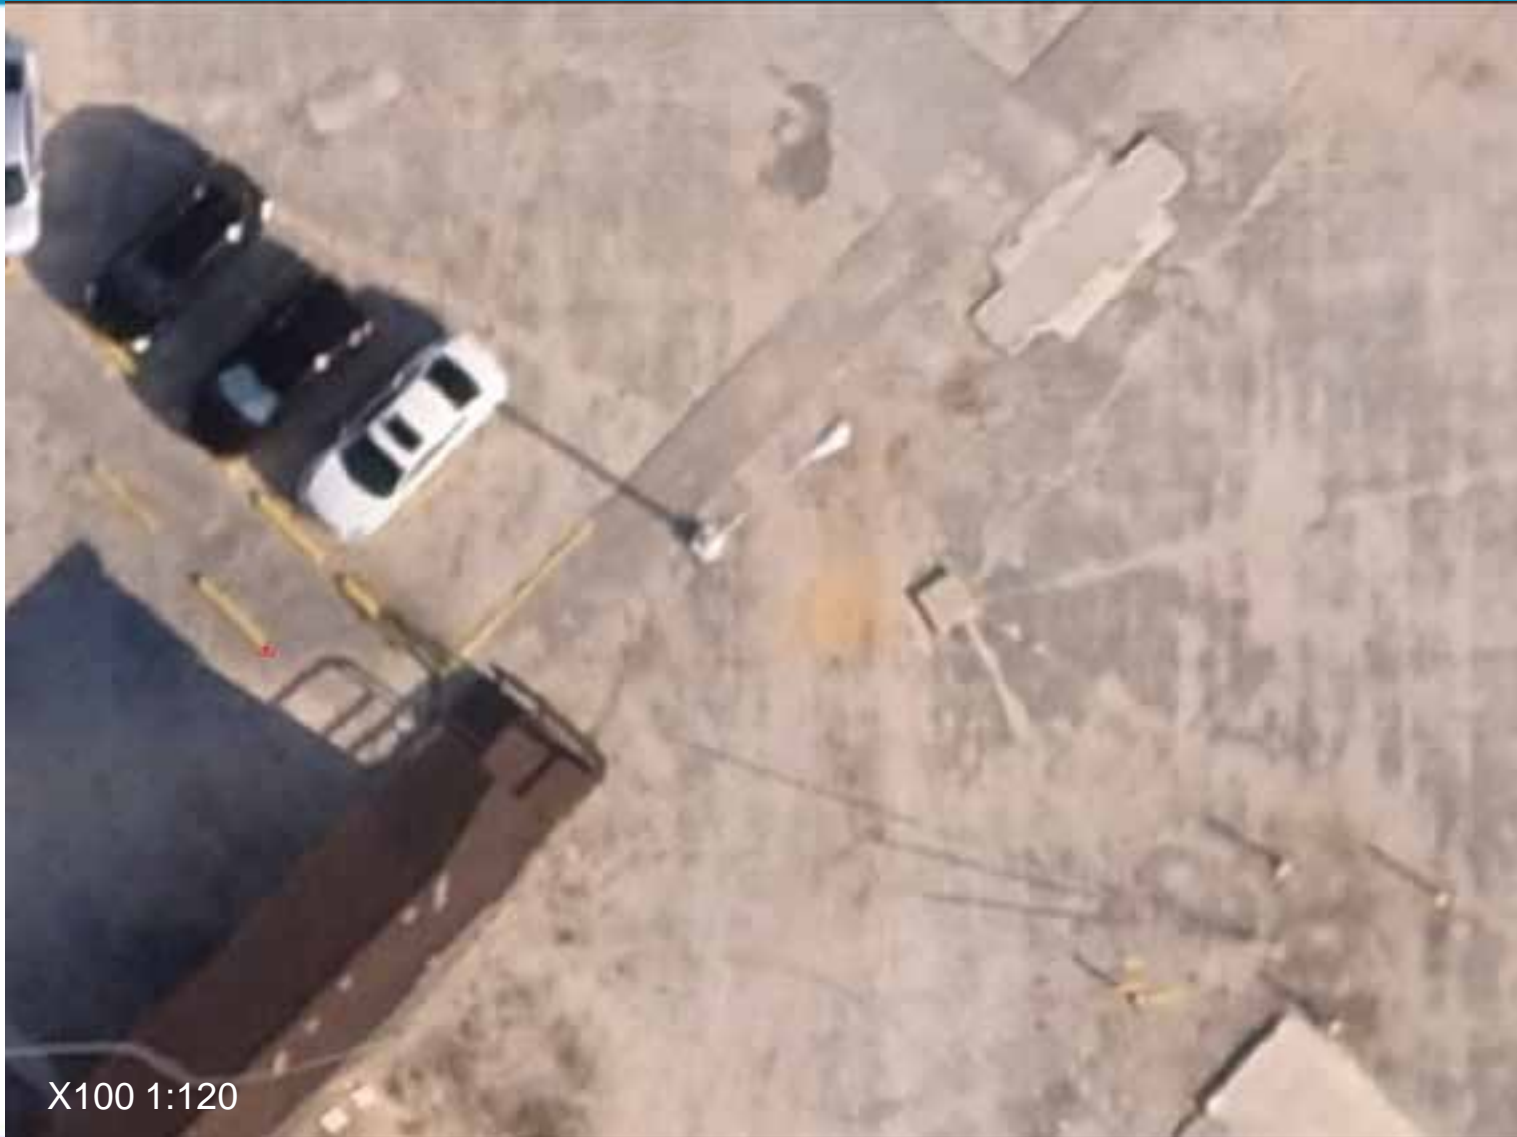
Sample Imagery

X100 1:120

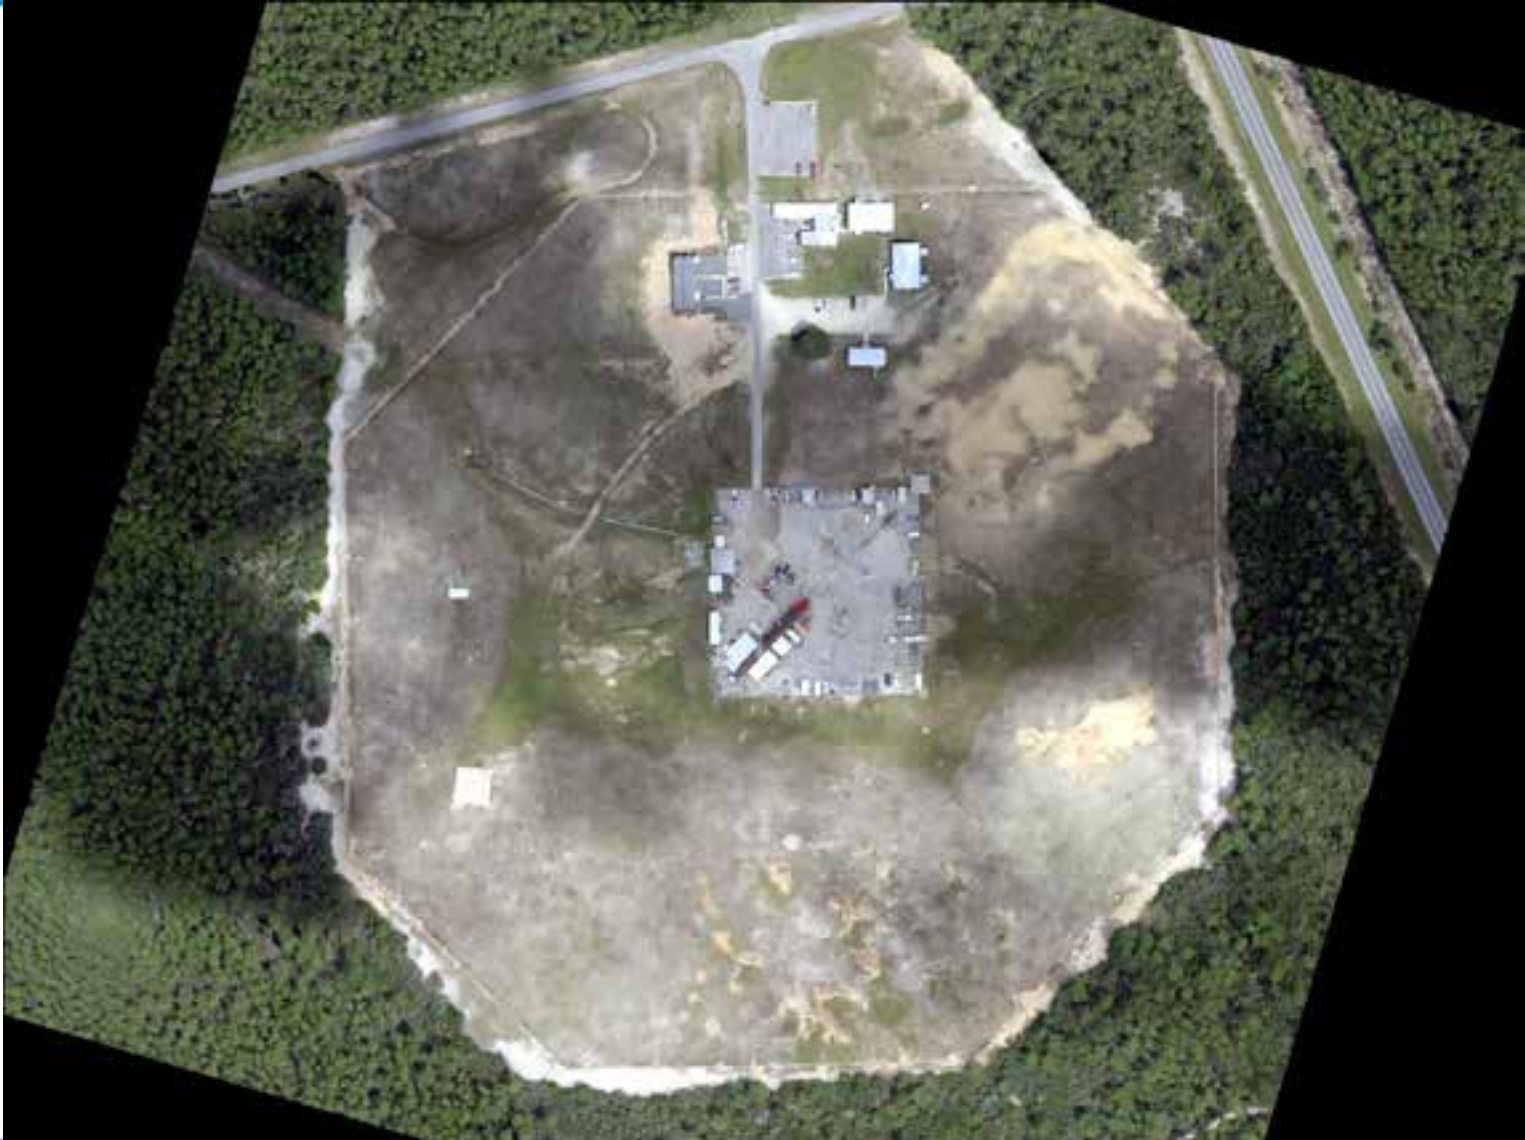
Cloud Shadows

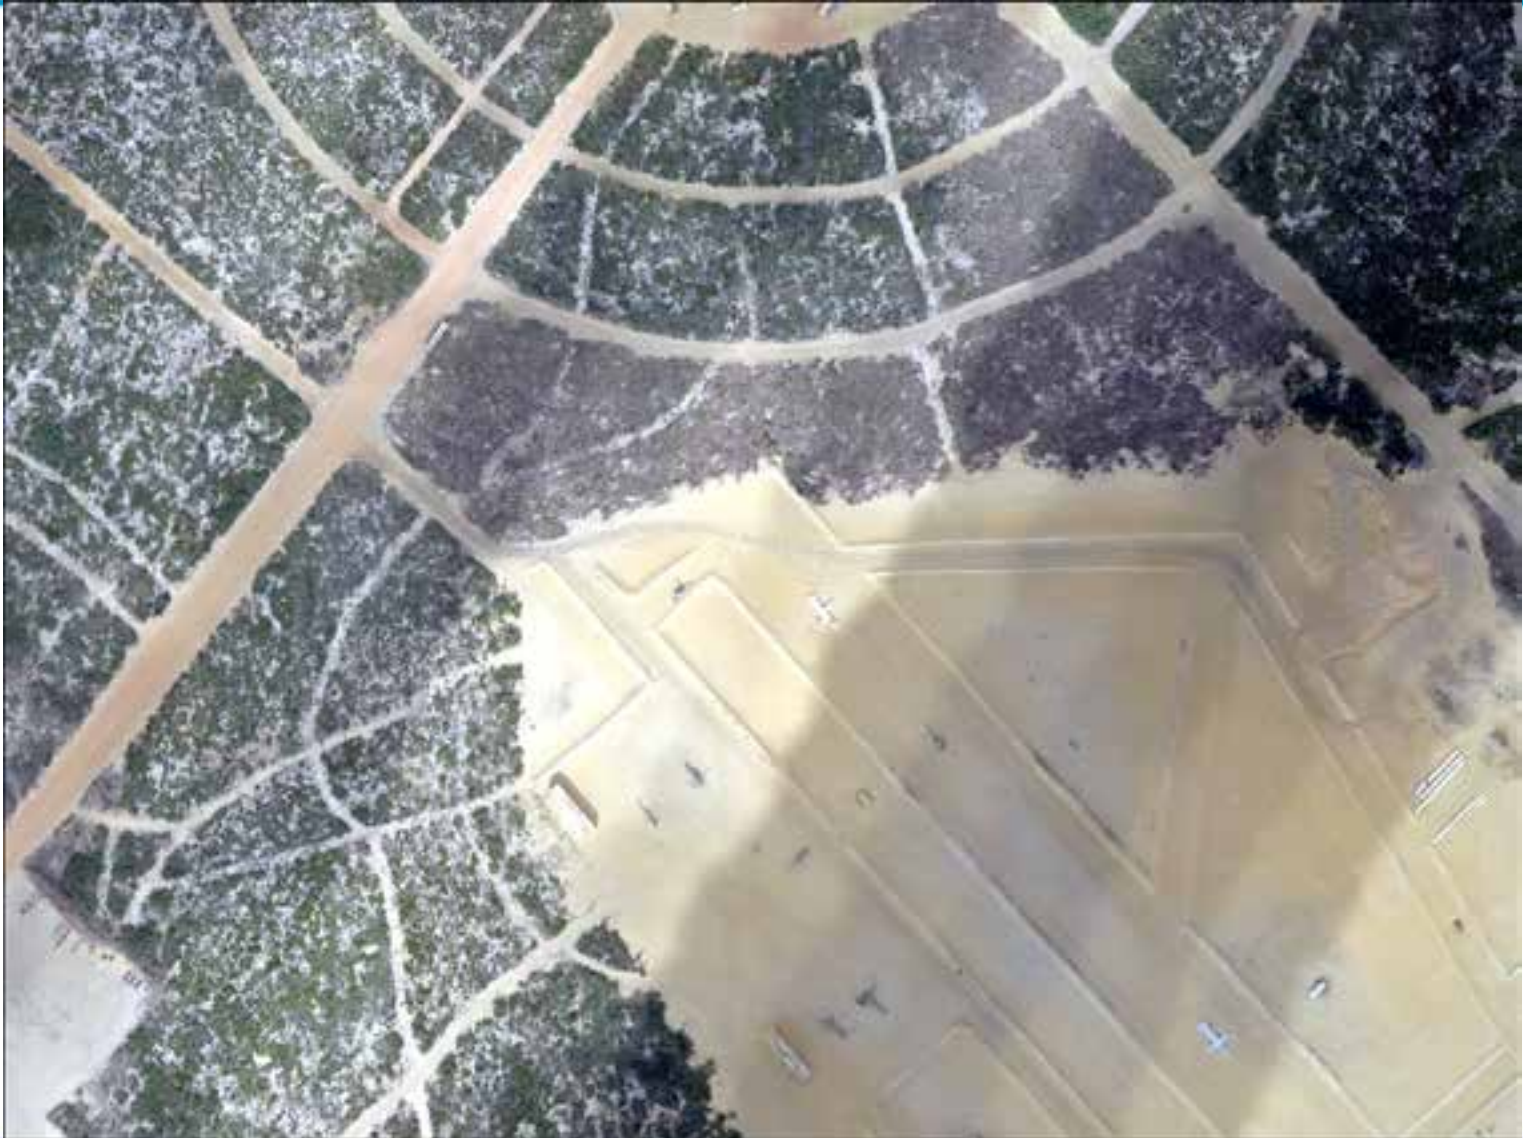
Low Cloud Ceiling

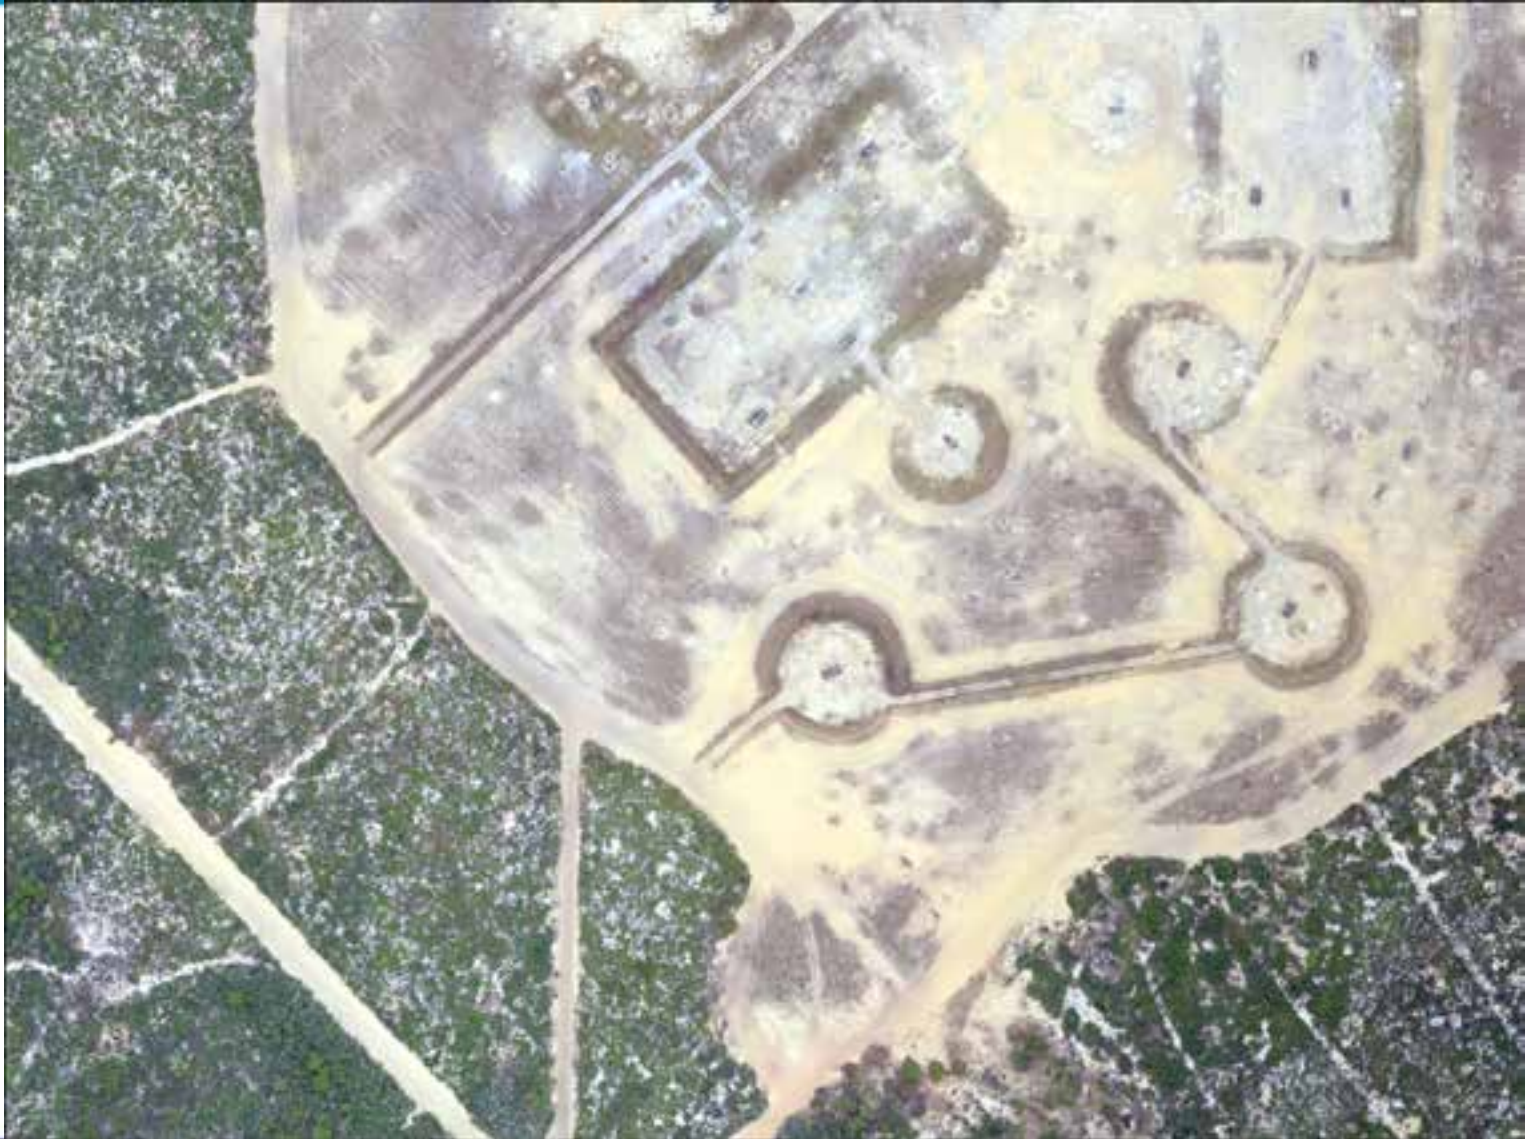
Light Rain

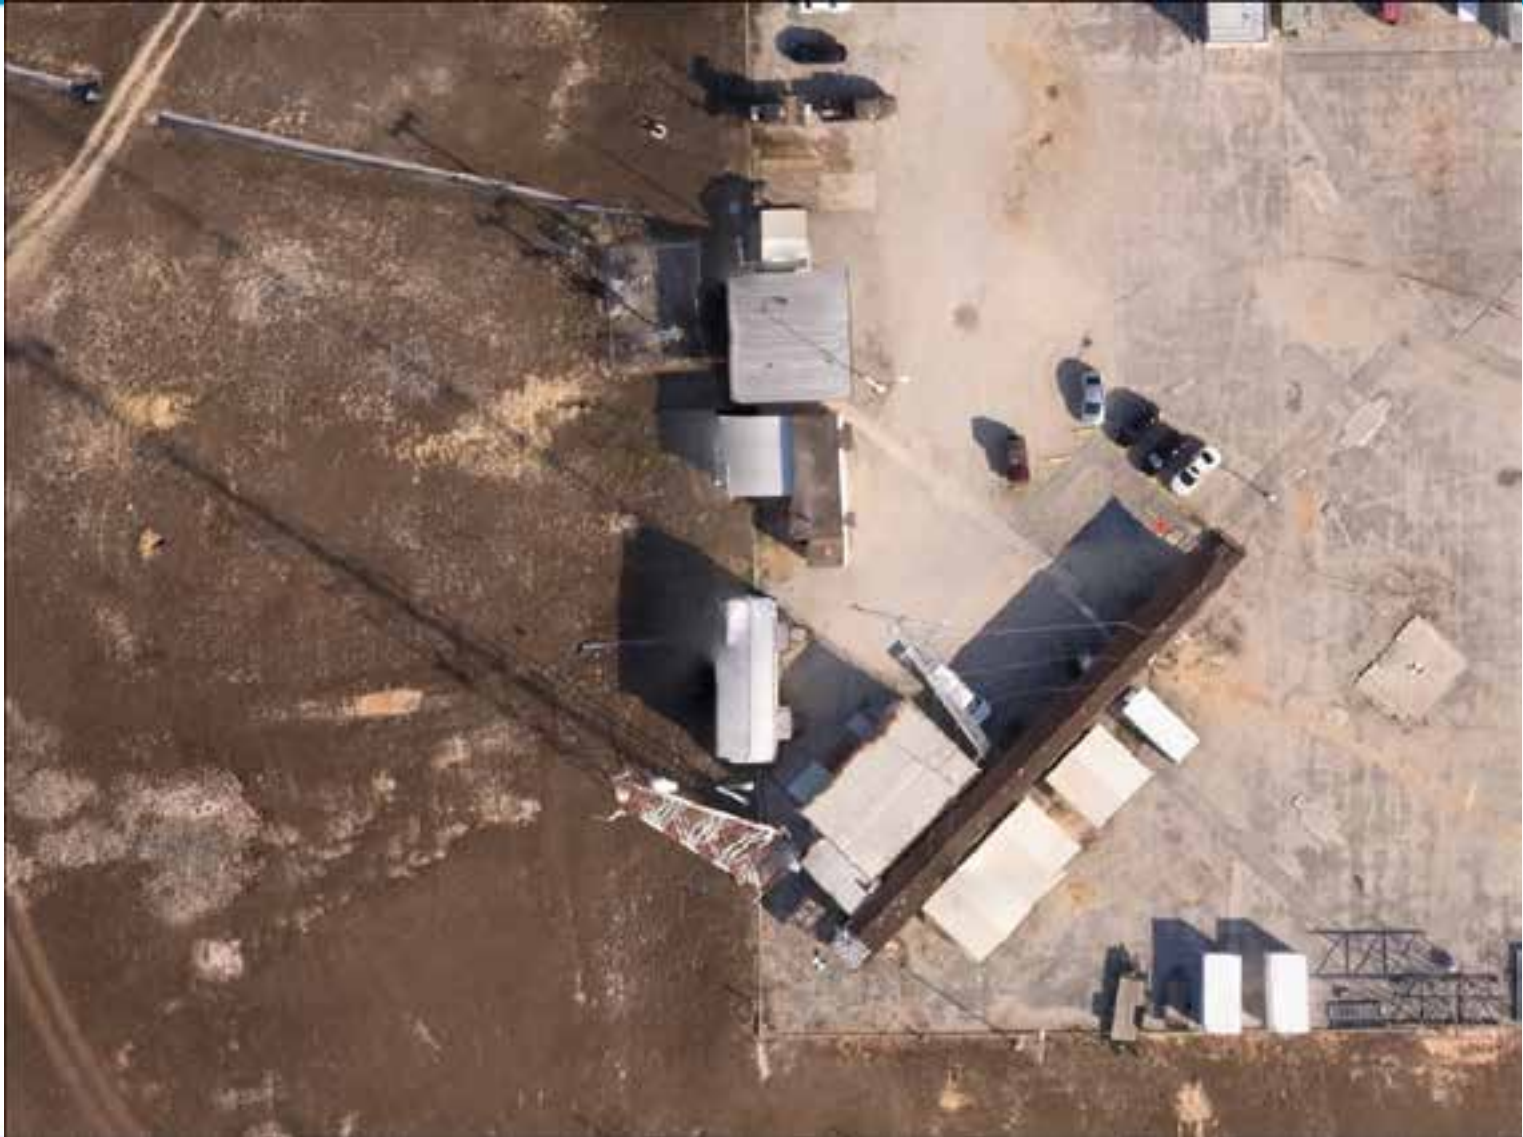
Blurs
