Southeast GeoReadiness Center

Utilization of a Small Unmanned Aerial System by Naval Facilities Engineering Command Southeast

6/25/2014

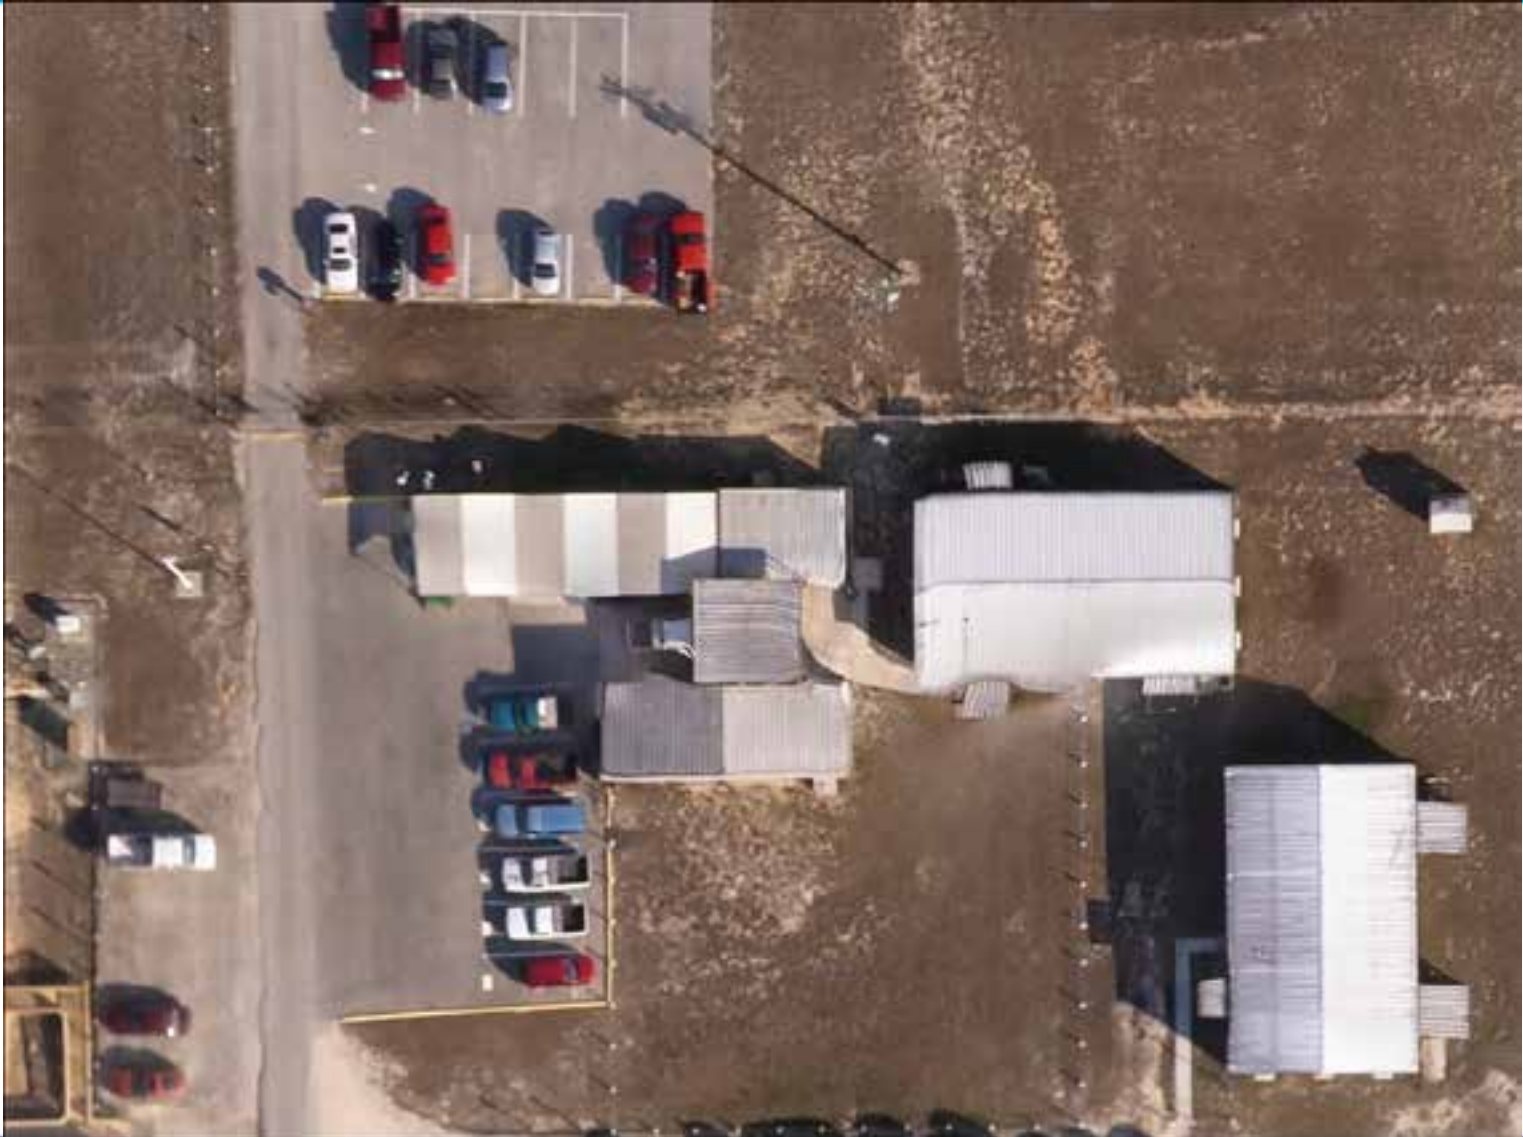
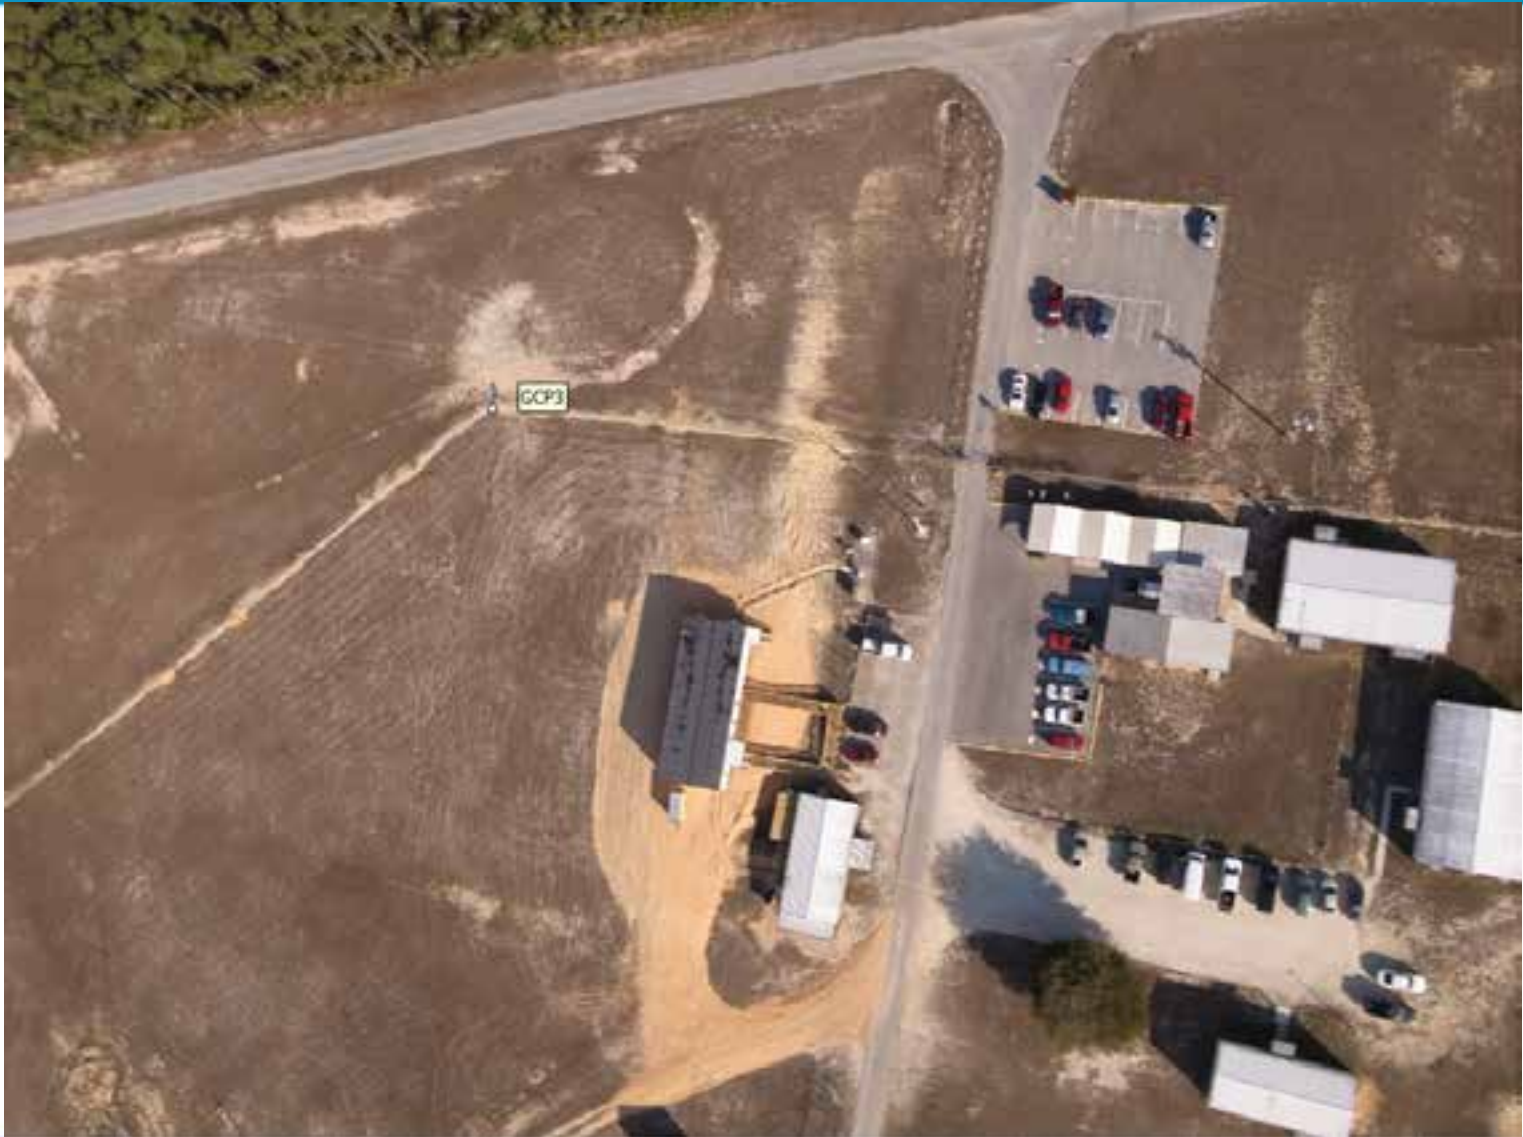
Crooked Line

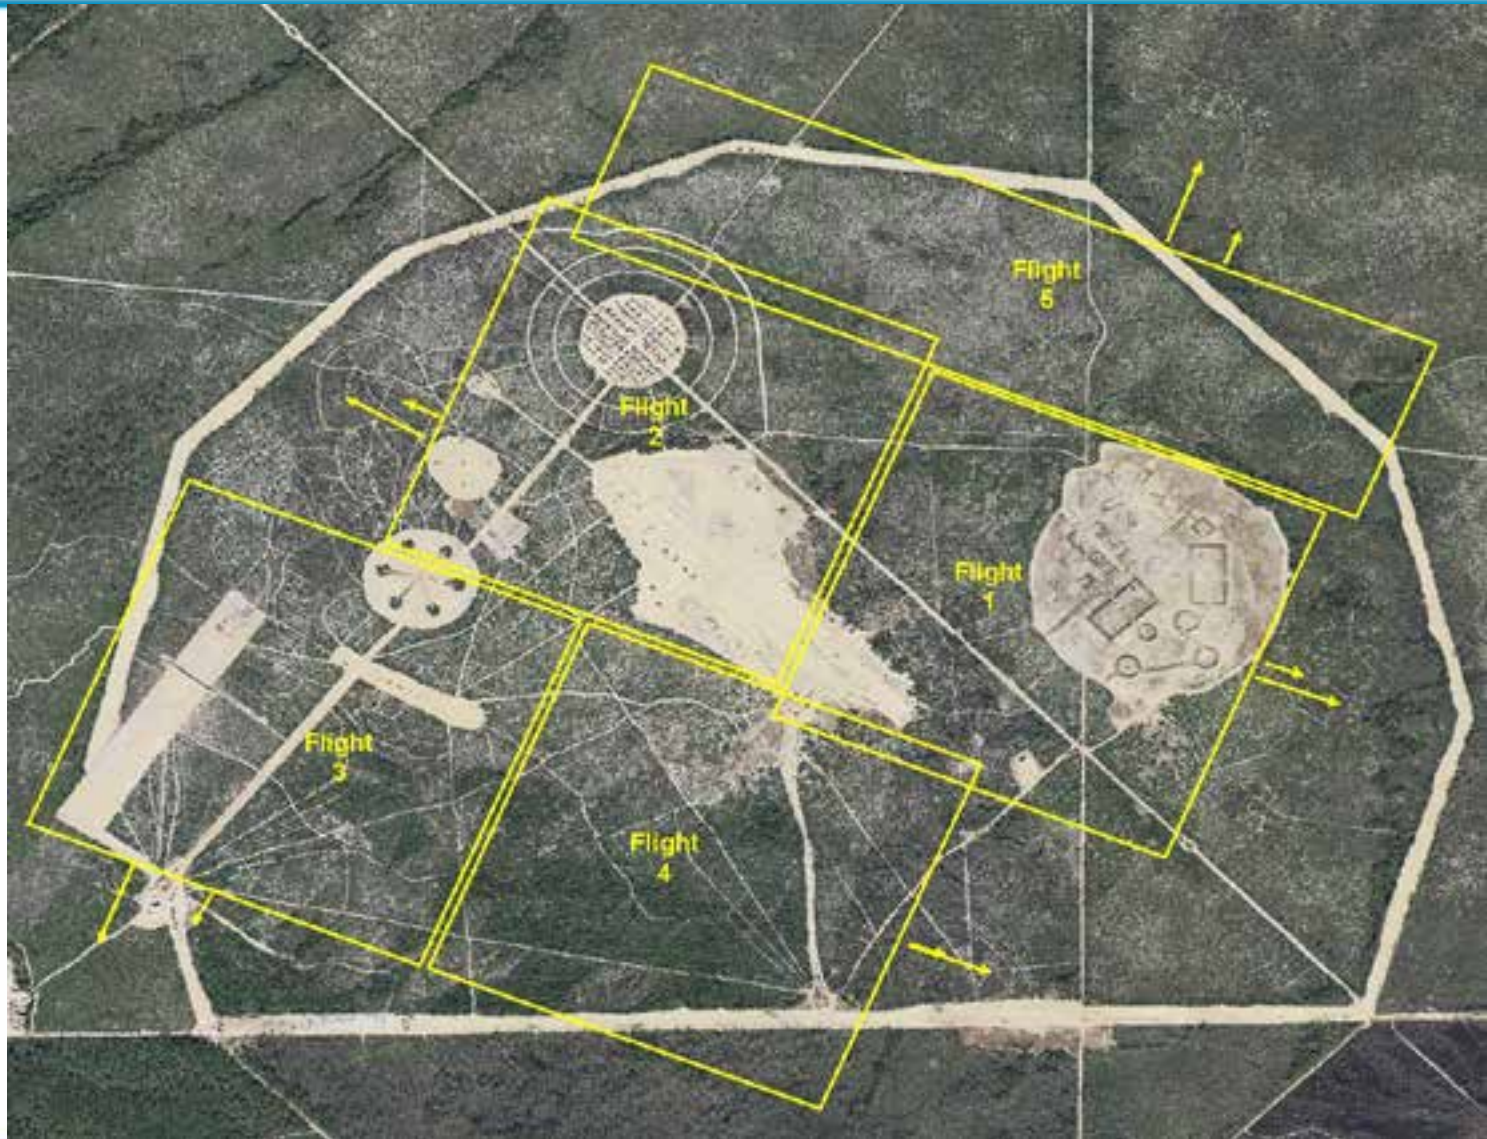
Mission Planning

Define scan area

Altitude m GSD cm

Overlap %

Scan area: 0.88 x 0.93 = 0.82 km²

An aerial photograph showing a flight path planned for a drone. The path is marked with yellow lines and arrows, forming a series of overlapping rectangular loops. Four specific flight areas are highlighted in yellow and labeled: Flight 1 (a large rectangular area on the right), Flight 2 (a large rectangular area on the left), Flight 4 (a smaller rectangular area at the bottom), and Flight 5 (a smaller rectangular area at the top). The map also shows a road network and some buildings.

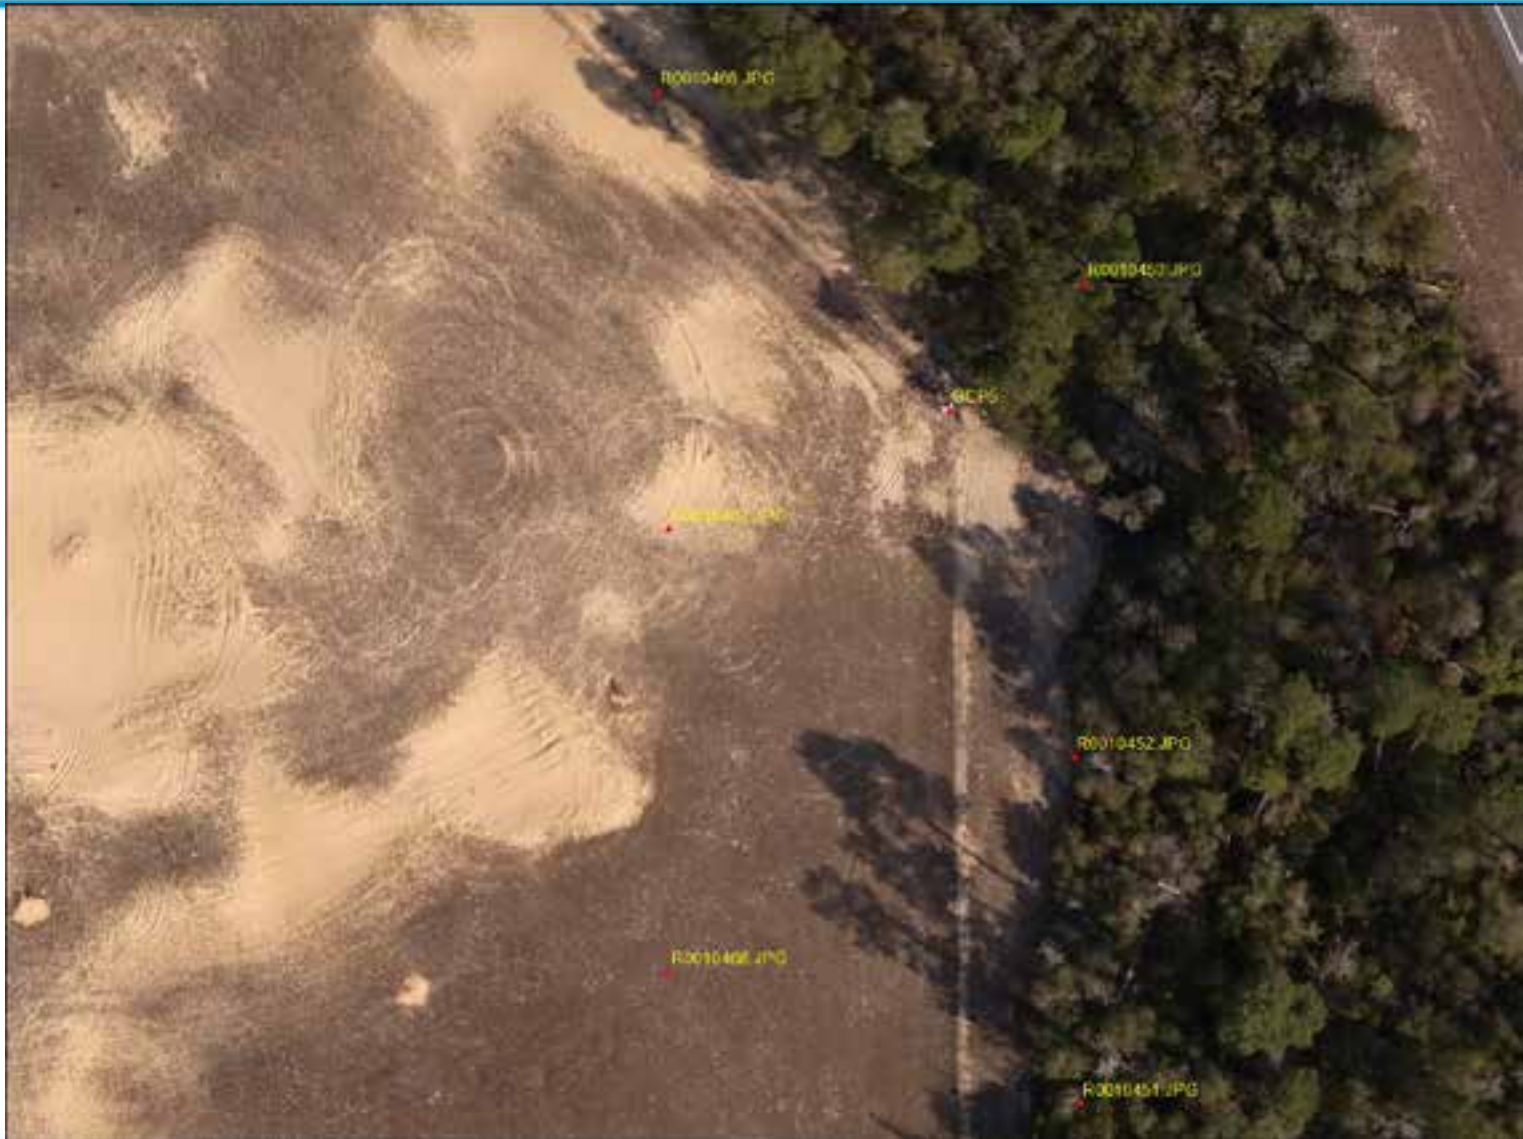
Ground Control Points

Ground Control

Markers	X/East	Y/North	Z/Altitude	Error (m)
✓ GCP1	-81.634795	29.143054	27.589180	0.000000
✓ GCP2	-81.634821	29.144588	27.337320	0.000000
✓ GCP3	-81.633809	29.145530	30.434740	0.000000
✓ GCP4	-81.631110	29.143235	35.318352	0.000000
✓ GCP5	-81.631140	29.144907	34.605845	0.000000
Total Error				0.000000

Markers	X/East	Y/North	Z/Altitude	Error
<input checked="" type="checkbox"/> GCP1	-81.634795	29.143054	27.589180	0.000
<input checked="" type="checkbox"/> GCP2	-81.634621	29.144588	27.337320	0.000
<input checked="" type="checkbox"/> GCP3	-81.633809	29.145510	30.434740	0.000
<input checked="" type="checkbox"/> GCP4	-81.631110	29.143235	35.318352	0.000
<input checked="" type="checkbox"/> GCP5	-81.631140	29.144907	34.605845	0.000
Total Error				0.000%

An aerial photograph showing a dirt road or path. A blue marker labeled "GCP5" is placed on the road. The surrounding area is a mix of dirt and green vegetation.

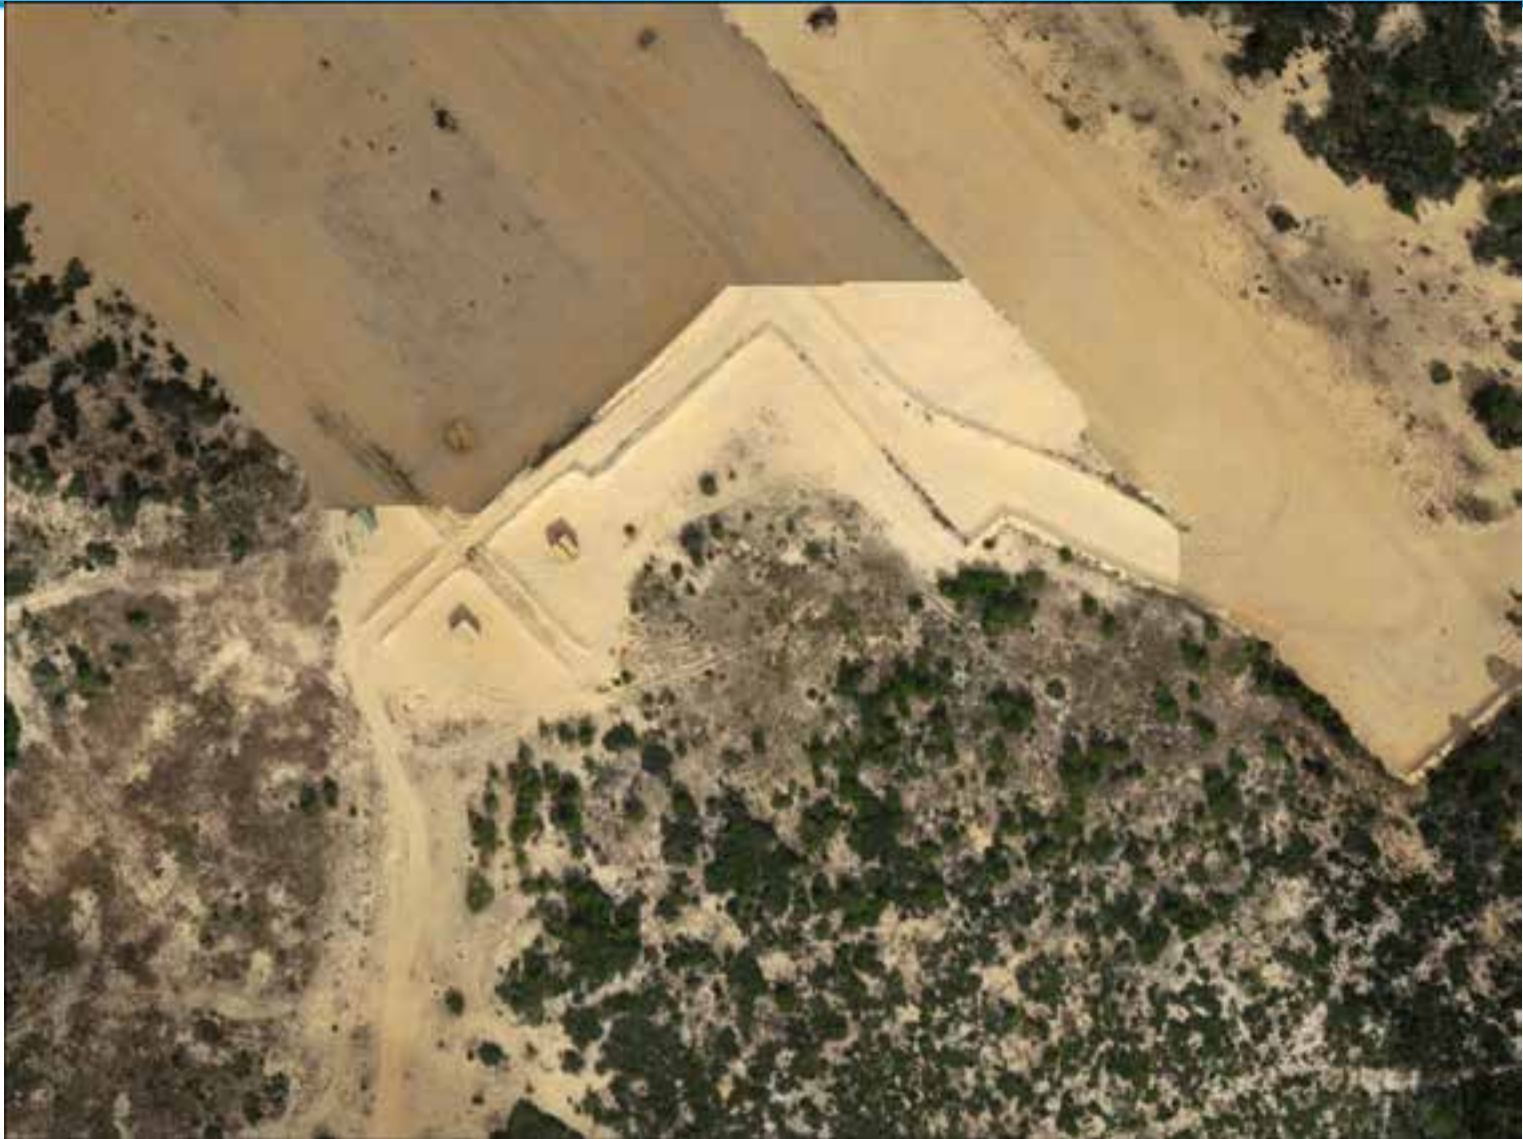
Color Balance

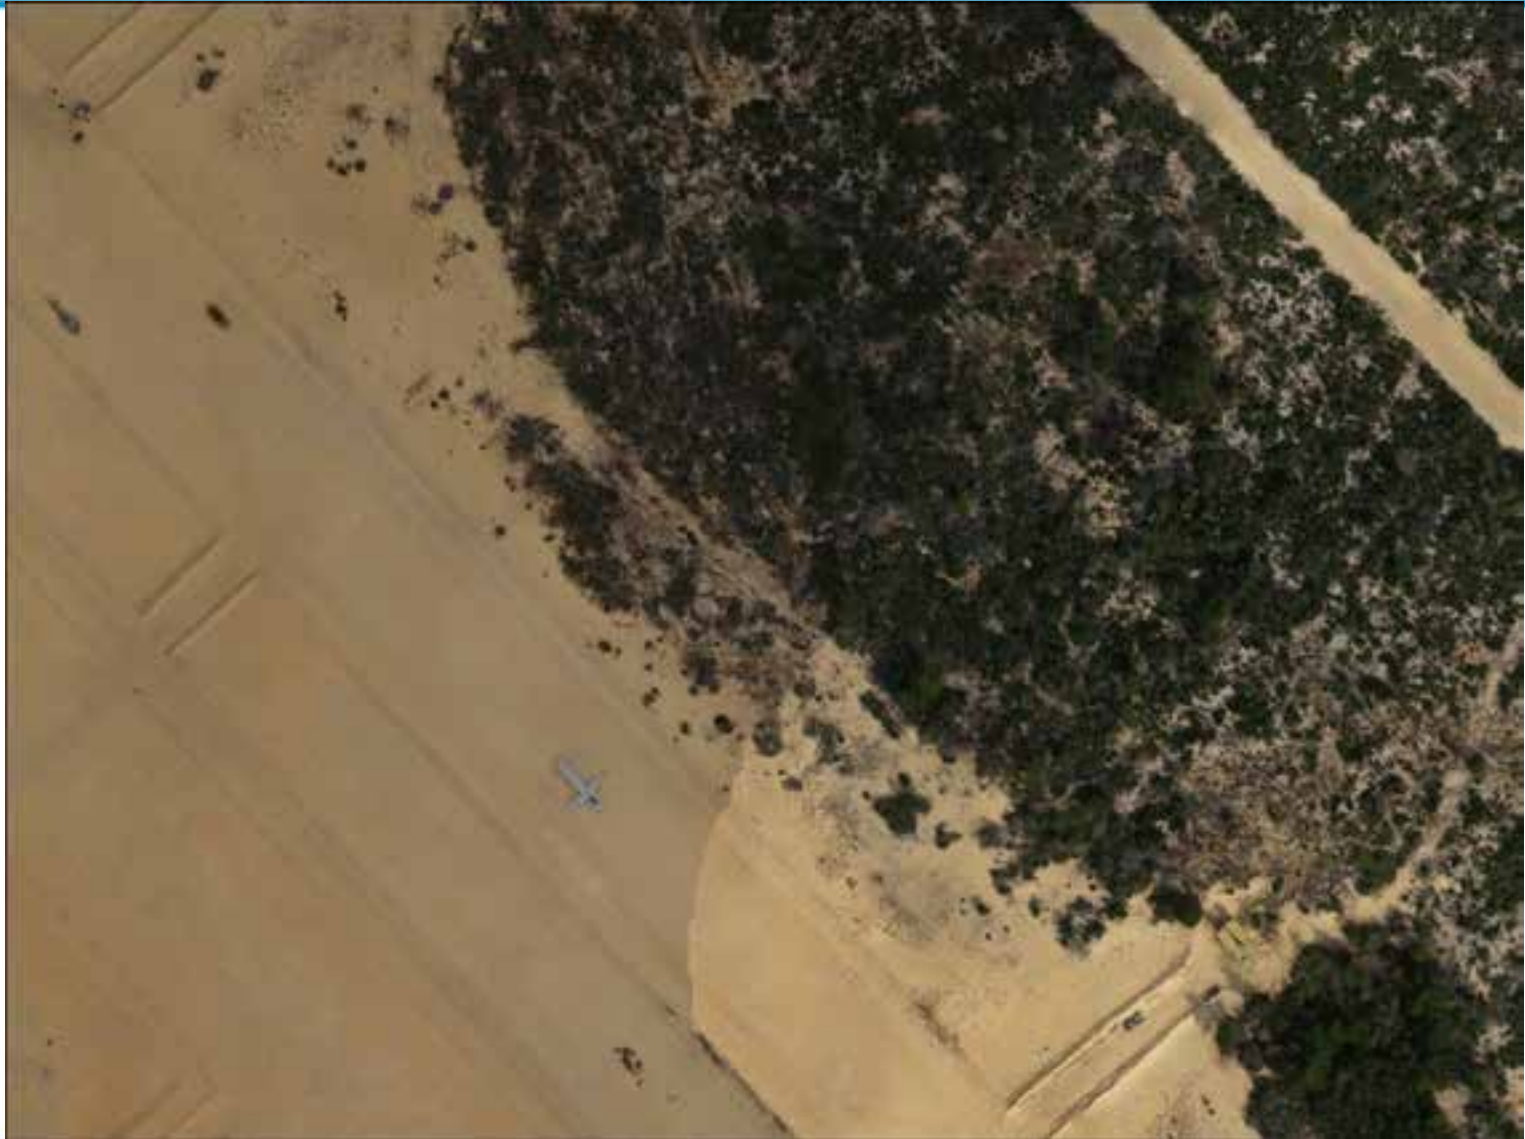
Seam line
