Durango Migrates its Infrastructure GIS to an Asset Management System

Rick Szmajter, GISP

City of Durango Colorado

ESRI International User Conference

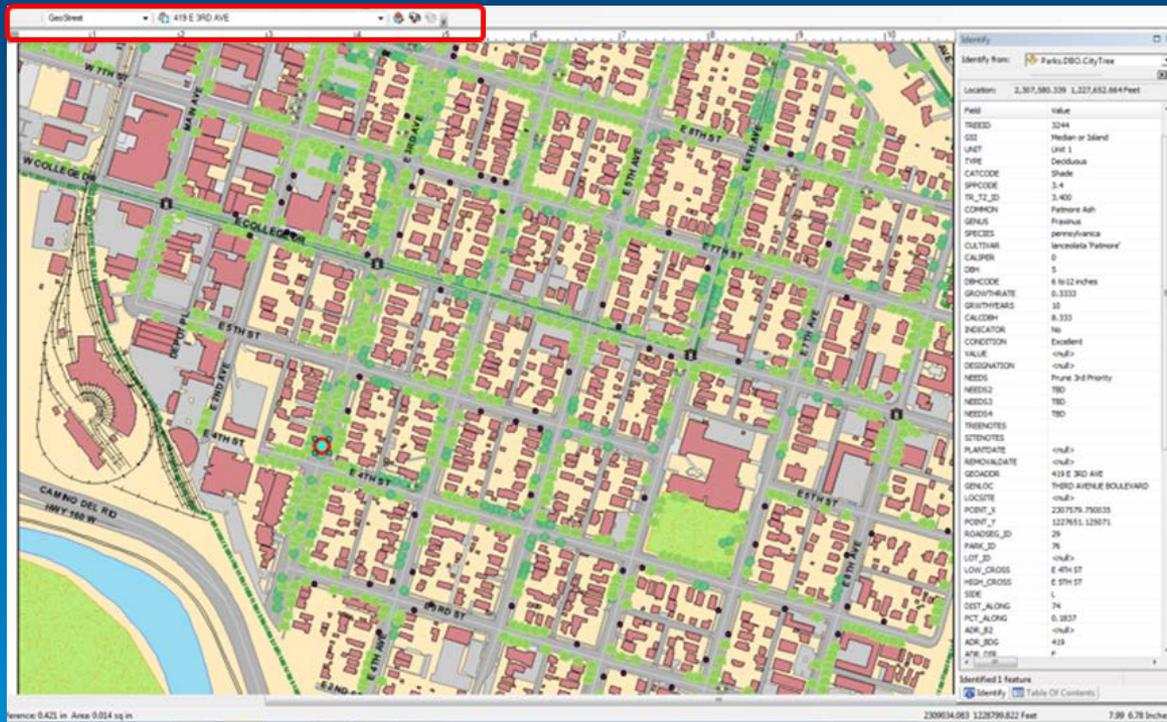
Location attributes of an individual tree

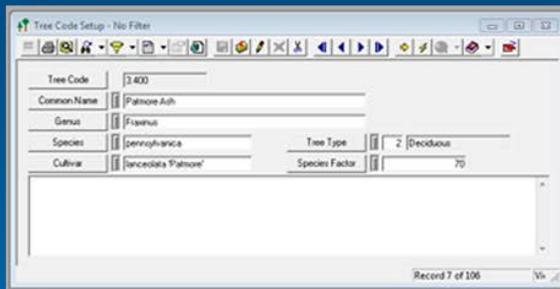
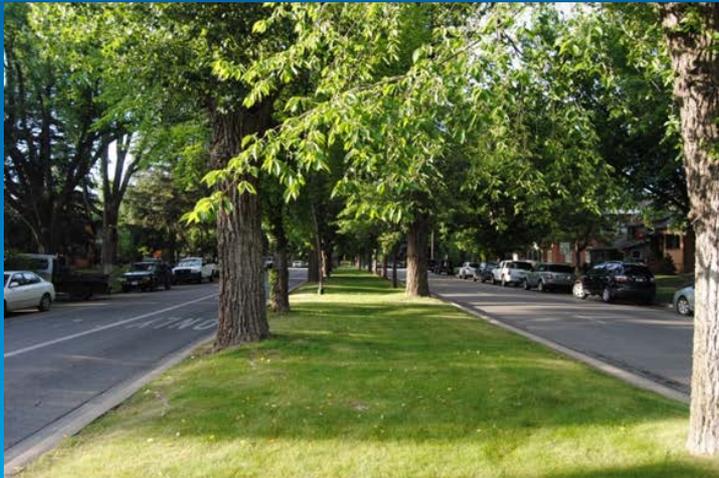
Case Study 2 Durango Tree Species Inventory Library

Tree Code	Common Name	Tree Type Text
18	19.000 Other Species of Honeylocust	Deciduous
19	19.100 Imperial Honeylocust	Deciduous
20	19.200 Shademaster Honeylocust	Deciduous
21	3.500 American Arborvitae	Coniferus
22	20.000 Rocky Mountain Juniper	Coniferus
23	20.100 Colorado Juniper	Coniferus
24	20.200 Wichita Blue Juniper	Coniferus
25	20.300 Utah Juniper	Coniferus
26	21.000 Kentucky Coffee tree	Deciduous
27	21.100 Kentucky Espresso Coffeetree	Deciduous
28	22.000 Other Species of Linden	Deciduous
29	22.100 Legend American Linden	Deciduous
30	22.200 Little Leaf Linden	Deciduous
31	22.300 Greenspire Linden	Deciduous
32	22.400 Sterling Silver Linden	Deciduous
33	23.000 Black Locust	Deciduous
34	23.100 New Mexico Locust	Deciduous
35	24.000 Other Species of Maple	Deciduous
36	24.100 Autumn Blaze Maple	Deciduous
37	24.200 Norway Maple	Deciduous
38	24.300 Rocky Mountain Maple	Deciduous
39	24.400 Anhur Maple	Deciduous
40	24.500 Silver Maple	Deciduous

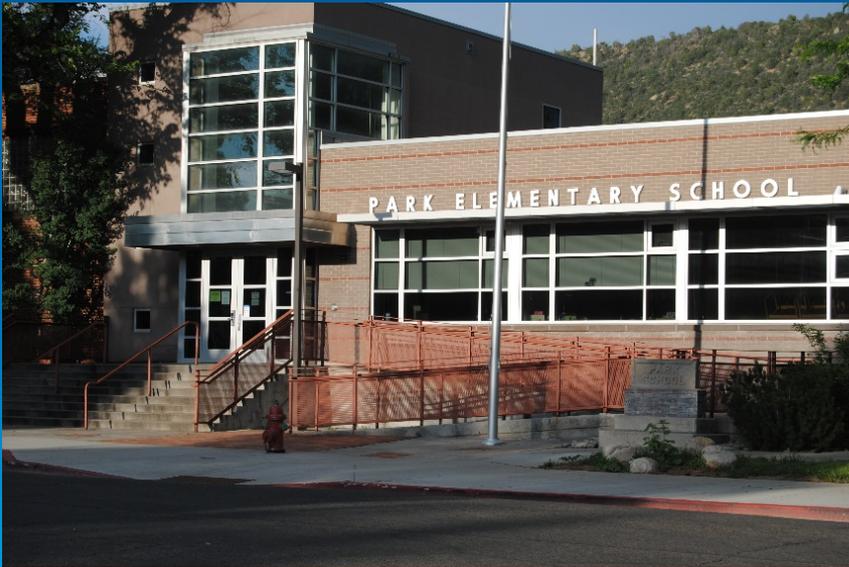
Street Department – Street Segmentation

Reconfigure an existing school zone to initiate better safety measures.

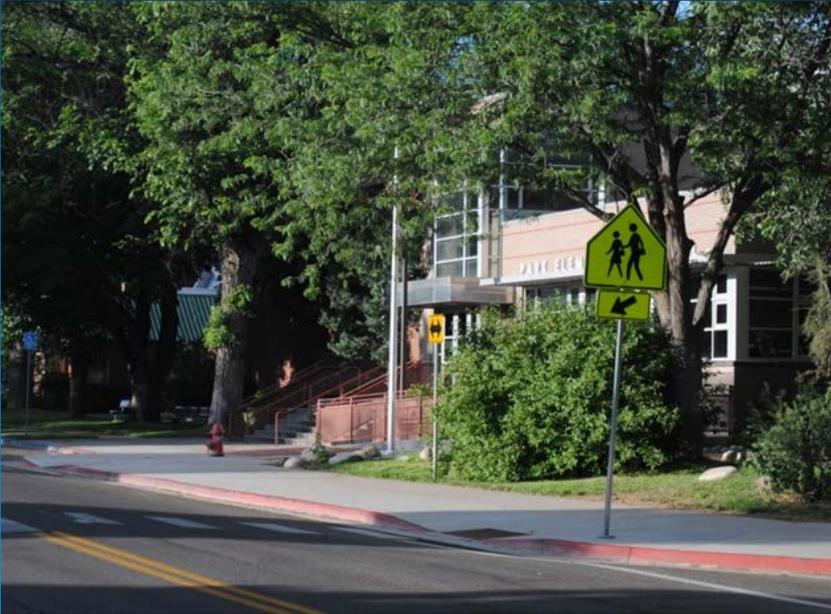
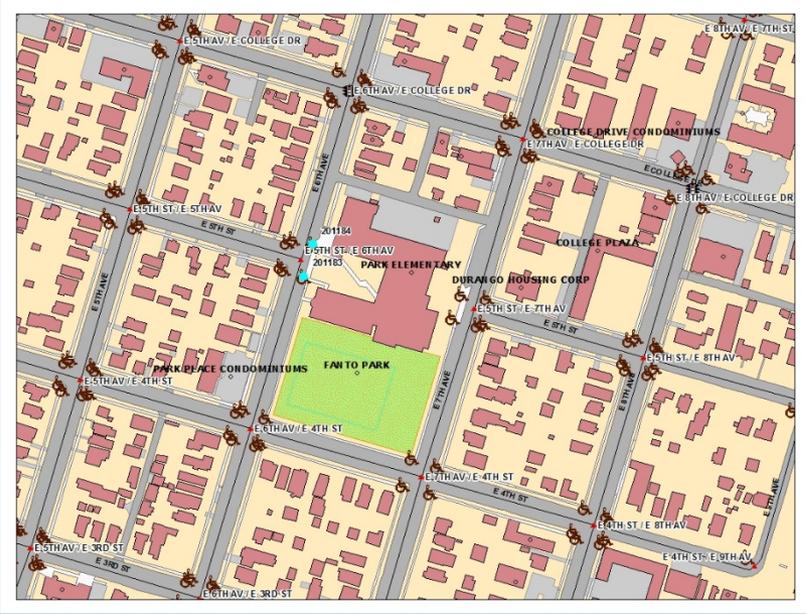
Street Department – ADA Ramps

Spatial relationships exist between ADA ramps and intersections, street segments, sub-segments and super-segments that are proximity-based and often complex in nature. In future phases these relationships will be extended further to include indexed sidewalk and curb features.

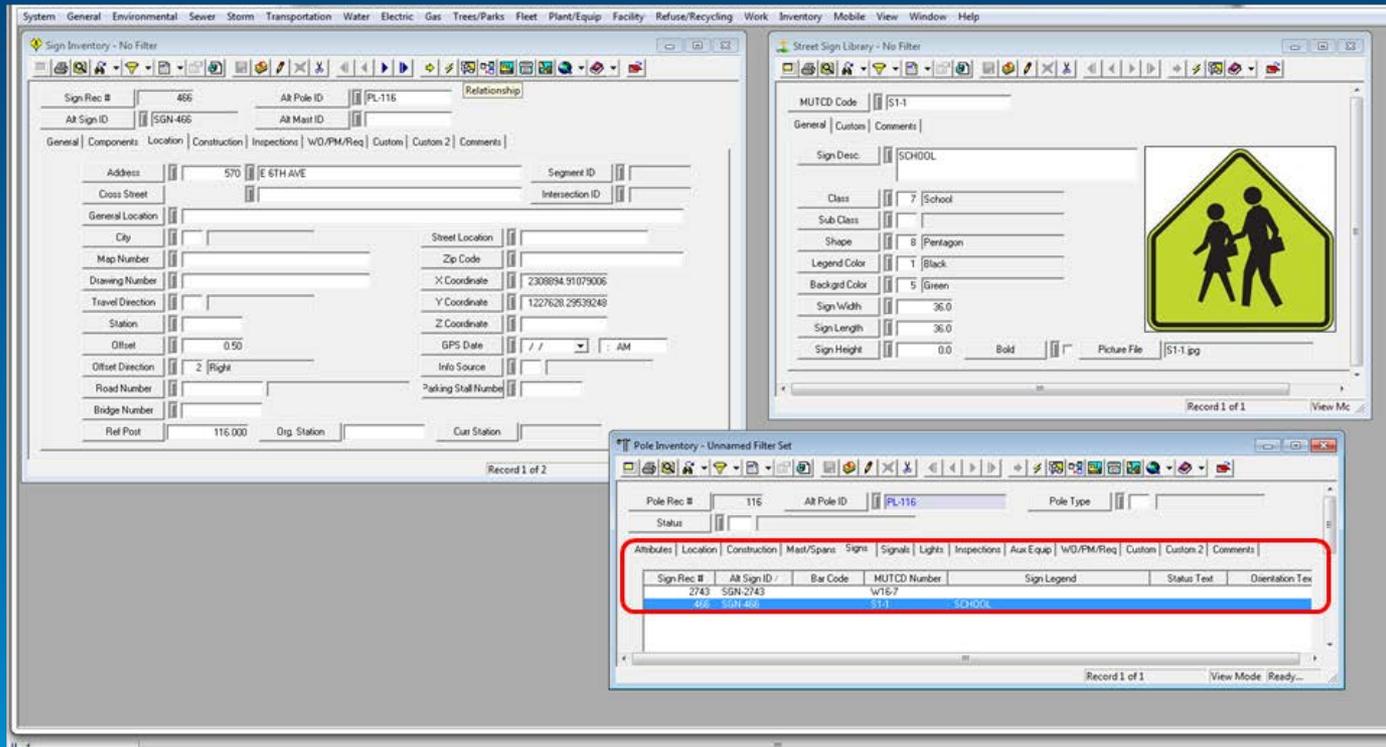
Street Department – Street Signs

Coincident asset relationships (e.g., multiple signs on single signpost) are not easily perceived in GIS but are readily handled by the database.

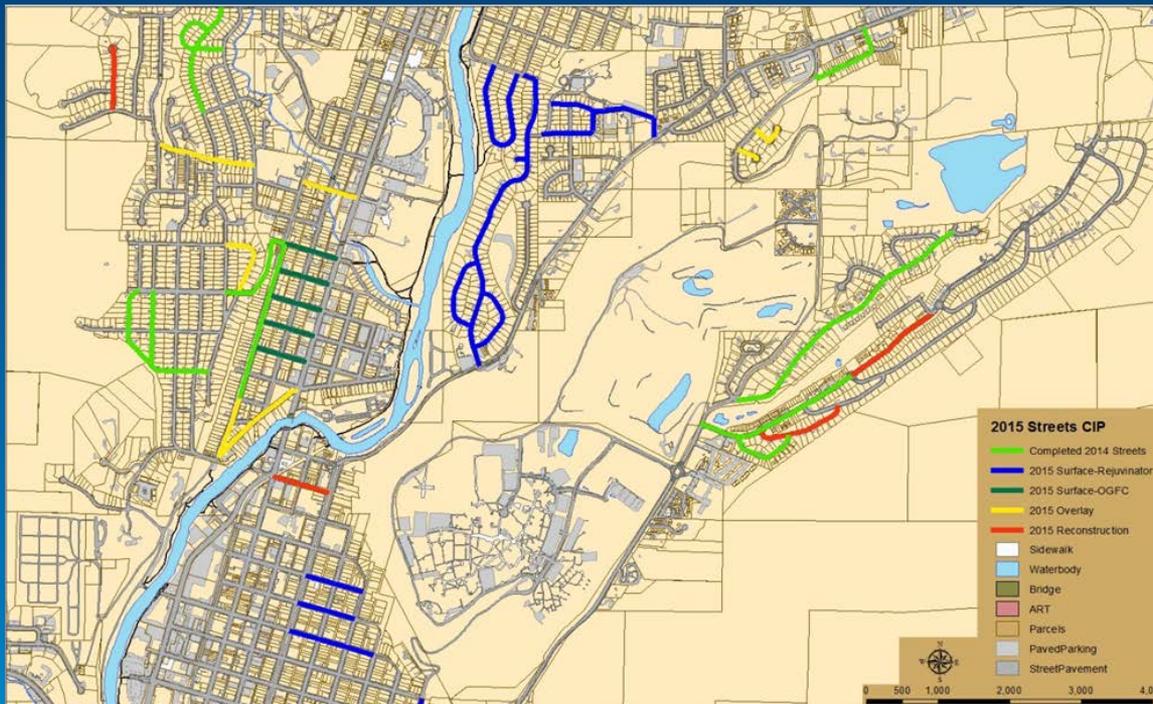
Transportation Inventory– Pavement Analysis

The PCI was used to develop a 2015 CIP and generate revenue into the street department's operational budget.

- **The Pavement Analysis module facilitates storage and application of relevant pavement criteria by street segment and sub-segment for use in planning (city-maintained roads).**
- **Field Inspections allow Durango crews or contracted specialists to gather pavement information on city-maintained streets block-by-block.**
- **Conditional criteria is then used by the street superintendent to selectively evaluate the health of the city road network and to calculate the overall Pavement Condition Index (PCI).**

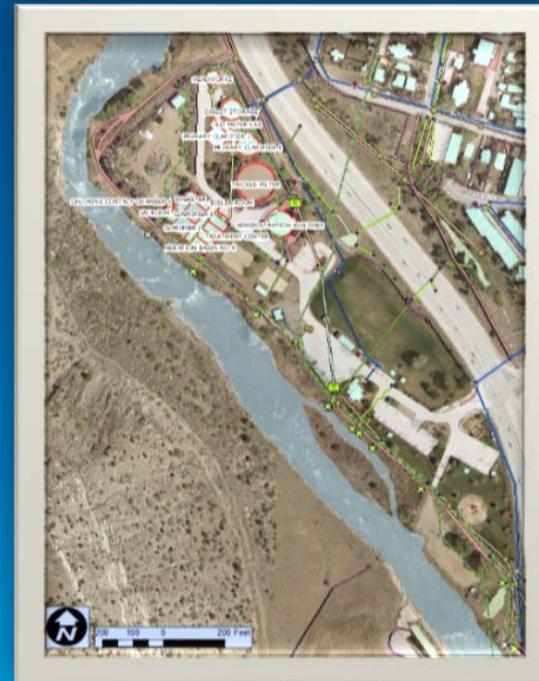
Plant Processes – Equipment Maintenance

The **WTP/WWTP Plant Inventories** define the 2 treatment facilities by sequential process. Each process takes place at a physical location within the plant. Hence assets, parts and equipment are associated to a process stream in GIS (i.e., polygon representation). This housing ensures a more efficient method of data storage and the rapid retrieval of the equipment component inventory, PM/WOs and work histories.
