Monitoring Threats

Are Your Leaks Attached to Your Pipes?

Leak Geocoding and Pipe Association Process

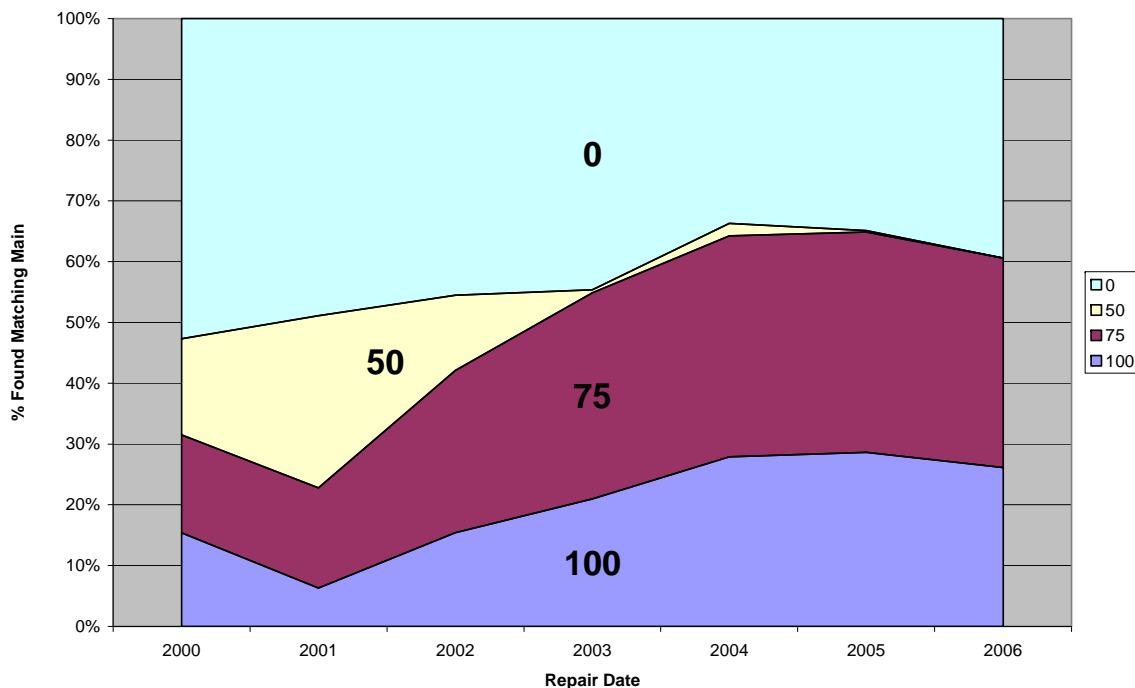
Success Rate by Confidence Threshold

- Leaks from acquired company, single state only
- Attempted to capture at least two 3-year survey cycles
- Improving results for more recent leaks (better data, pipe more likely to still exist in ESRI GIS)
- 17,361 Main Repairs, 11,615 geocoded successfully (67%)
- 9,745 (84%) of those matched to a pipe with confidence > 50%
- Overall success close to 60%
