A Cost Efficient Asset Management Approach Using GIS

Pierce County Public Works – Road Operations - Maintenance Engineering

Pierce County Drainage Assessment Manual

Drainage Collection Procedures and Asset Assessment Manual

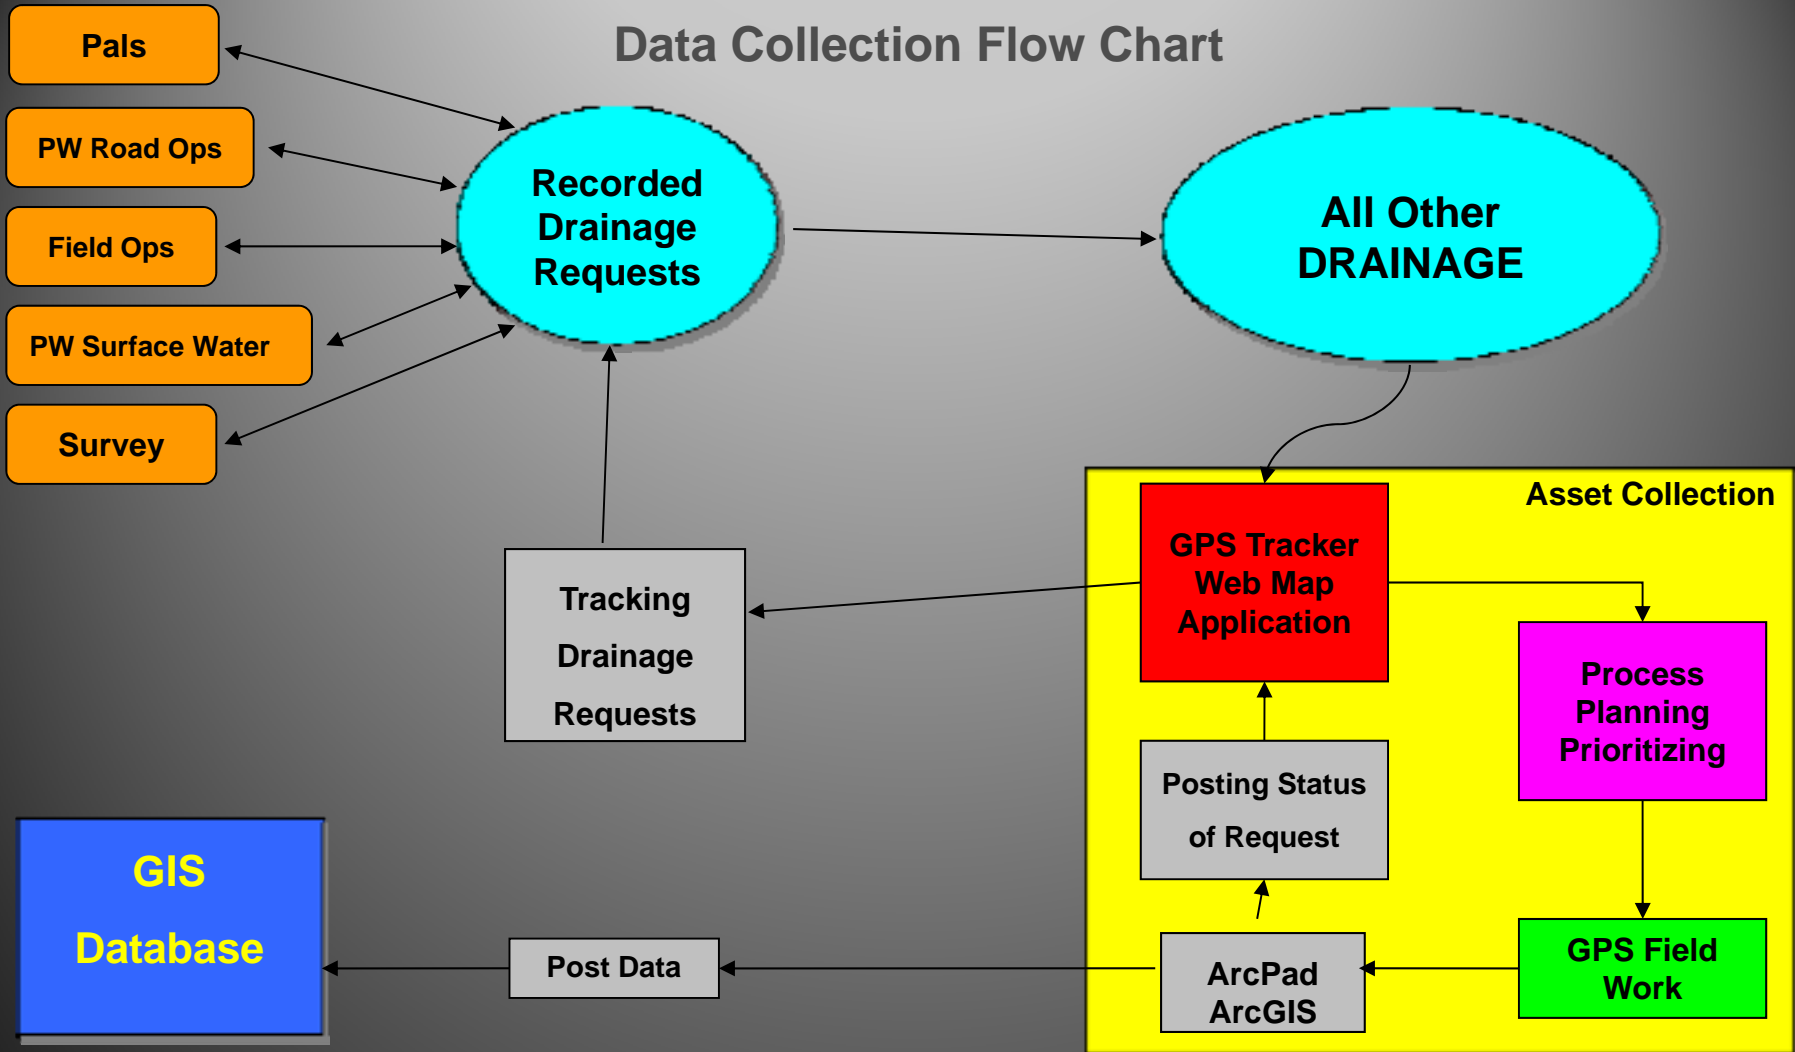
Data Collection Flow Chart

Data Acquisition Methods

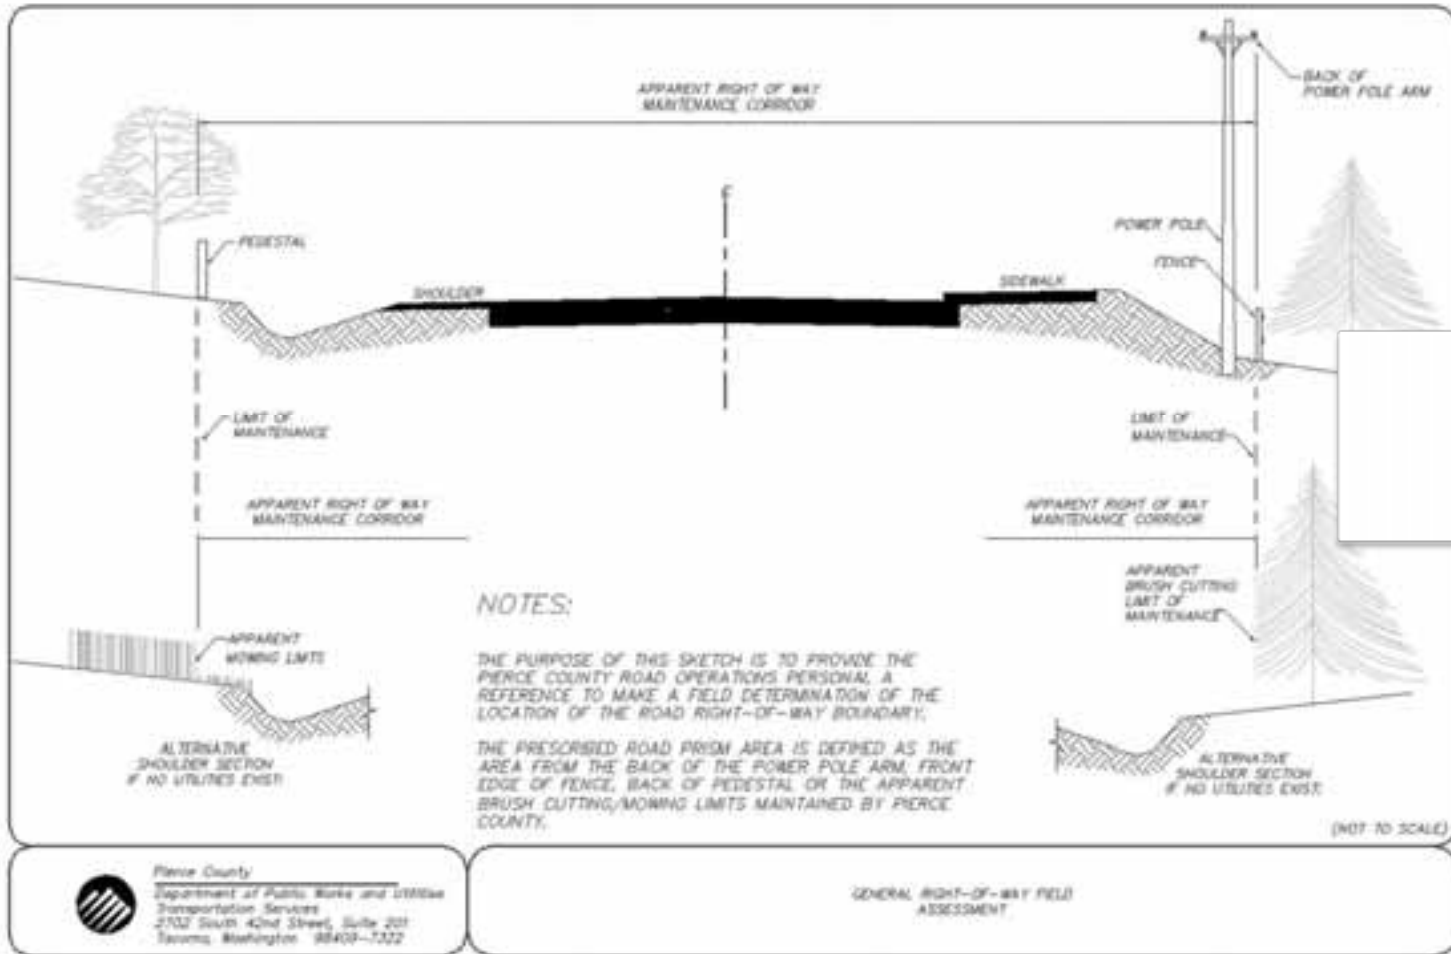
General Guidelines for ROW Limits

**ROW
Limits**

GENERAL RIGHT-OF-WAY FIELD
ASSESSMENT

When cleaning a feature that goes off ROW, clean only to the apparent ROW / maintenance limits.

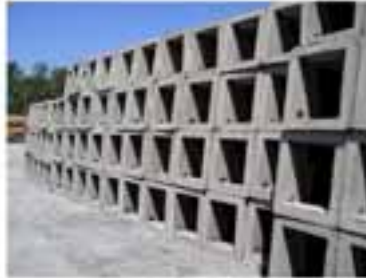
Catch Basin Type 1

<u>No Defect</u>	
MINOR (Do Nothing)	Very minor defects (Minor trash, sediment greater than 1 ft from IE)
MODERATE (Do before next Assessment)	Needs some work within 6 months (Sediment less than 1 ft from IE, crack but no sediment coming in)
SEVERE (Do within 2 months)	Need work now (Cracks allowing soil into structure, water missing structure, sediment in the pipe, major trash)

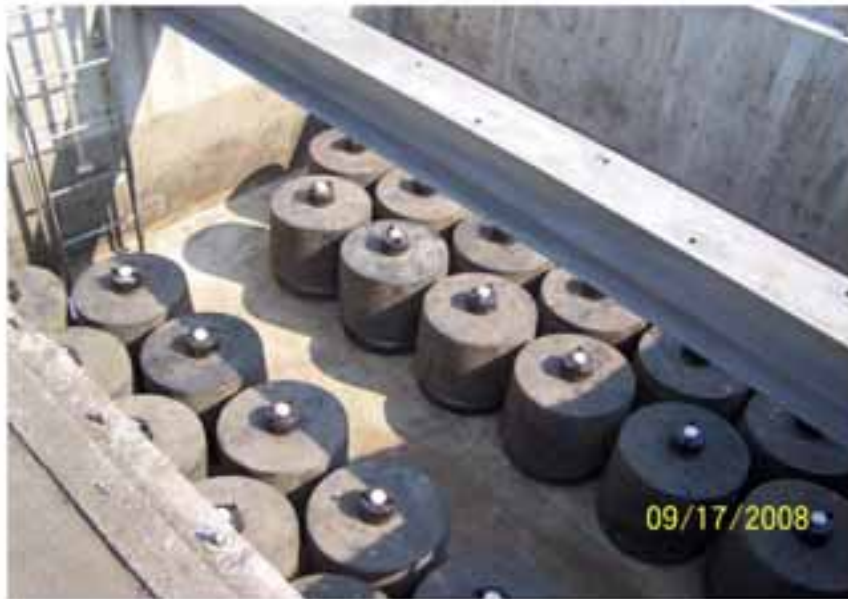
Mechanical Filters

A canister-type filter with zeolite/perlite/granular activated carbon or some other combination of media that are found in vaults, catch basins, or manholes manufactured by a proprietary system. The target pollutants for removal are total suspended solids (TSS), total and soluble phosphorous, total nitrogen, soluble metals, oil & grease and other organics.

(Top of cartridge covered with sediment, scum line above)

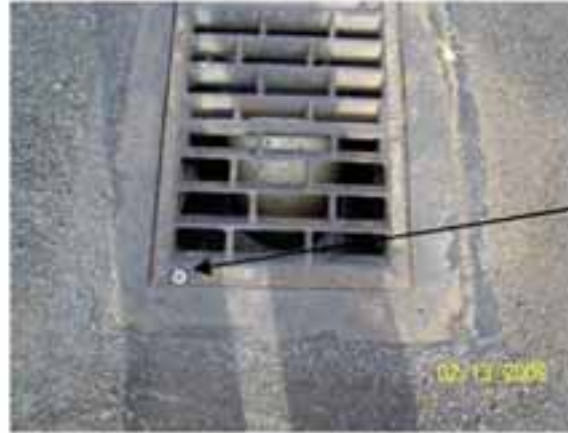
LOCK

Locking Lid:

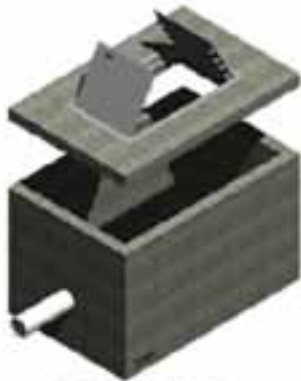
RECTANGLE

Lid Shape:

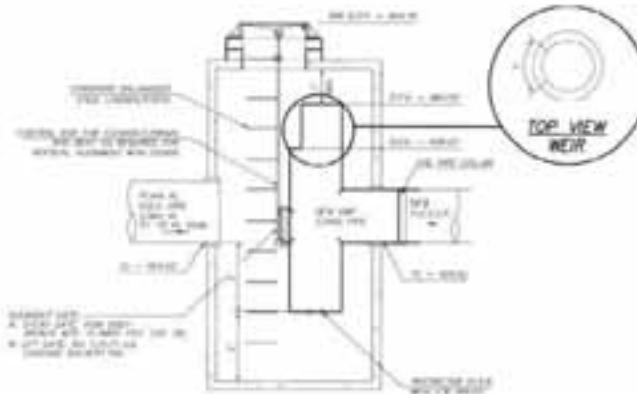
Frap-T

No Defect	
MINOR (Do Nothing)	Very minor defects) (Trace of oil)
MODERATE (Do before next Assessment)	Needs some work within 6 months (Flow restrictor damaged)
SEVERE (Do within 2 months)	Need work now (Flow restrictor not functioning, oil thick at surface)
