ADA SIDEWALK TRANSITION PLAN AND INVENTORY

CITY OF ST. CHARLES, MO

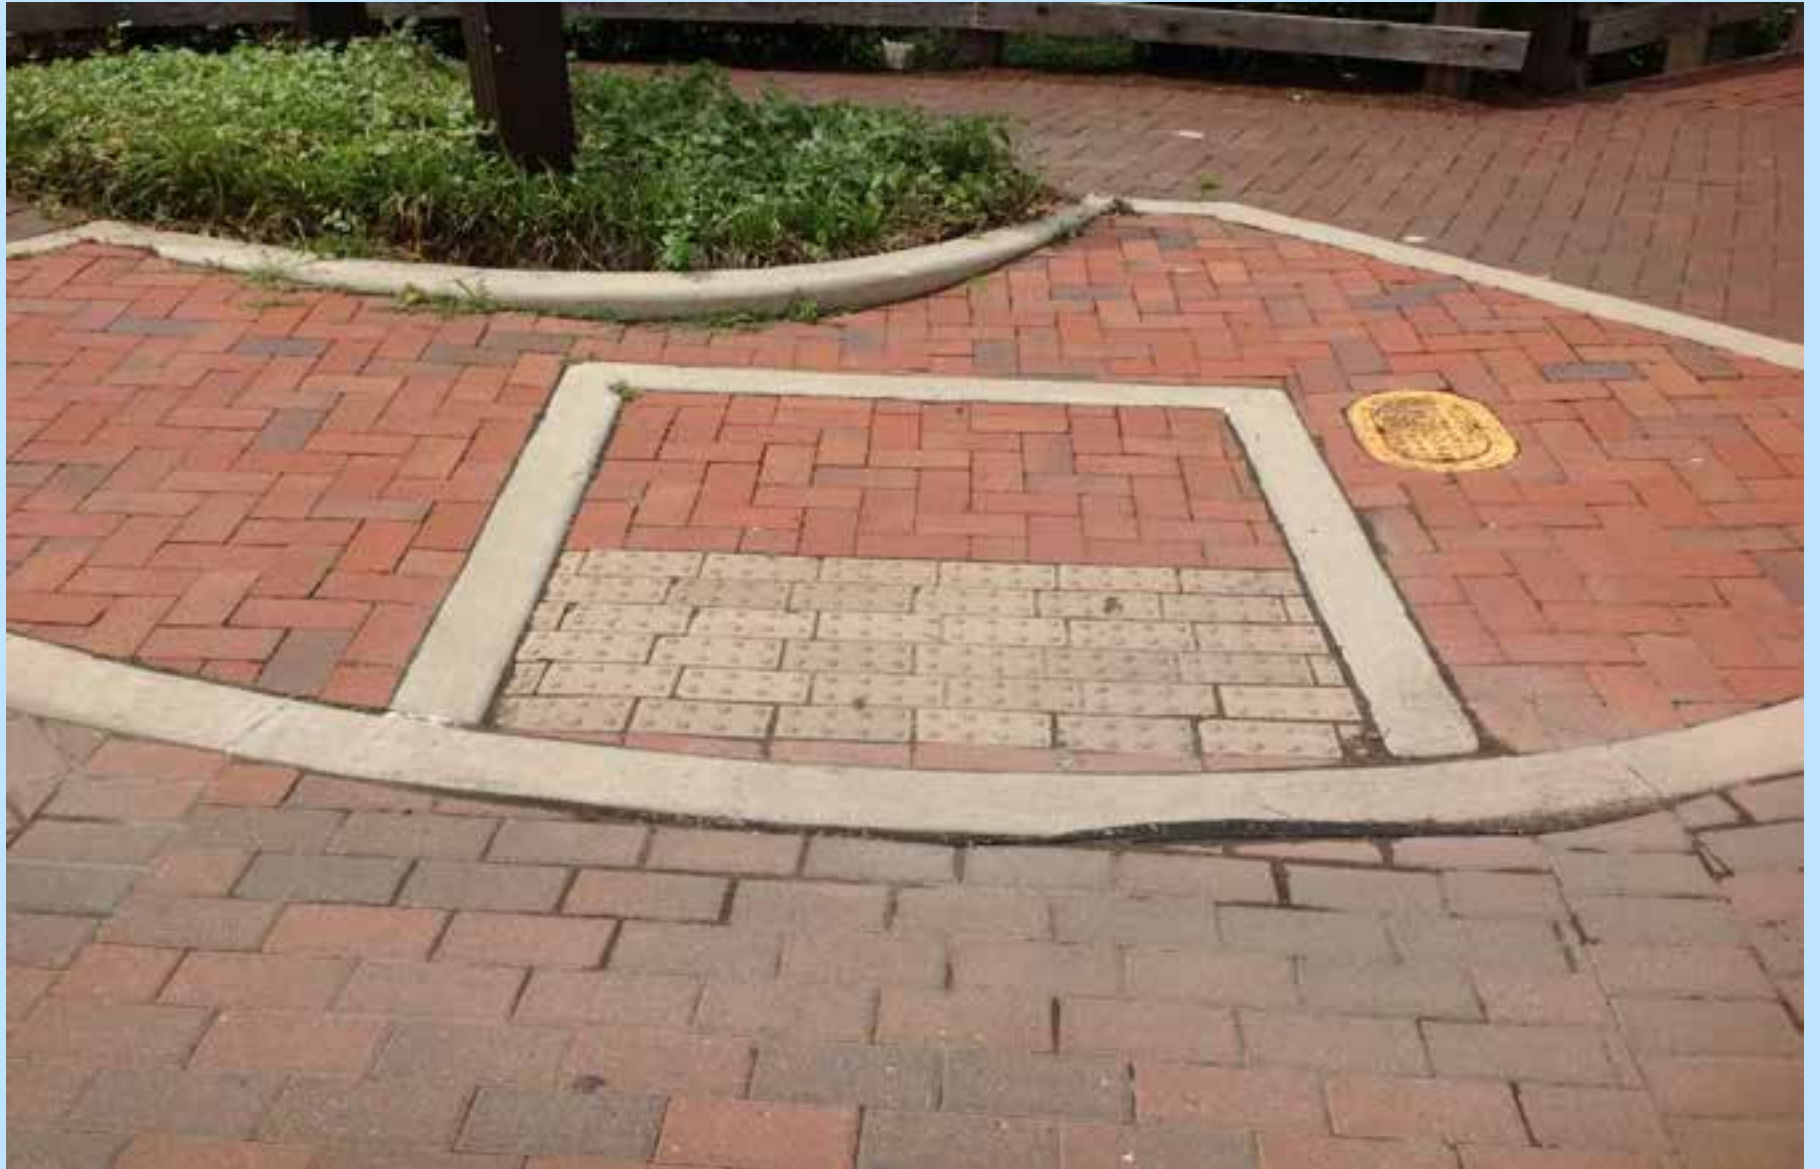
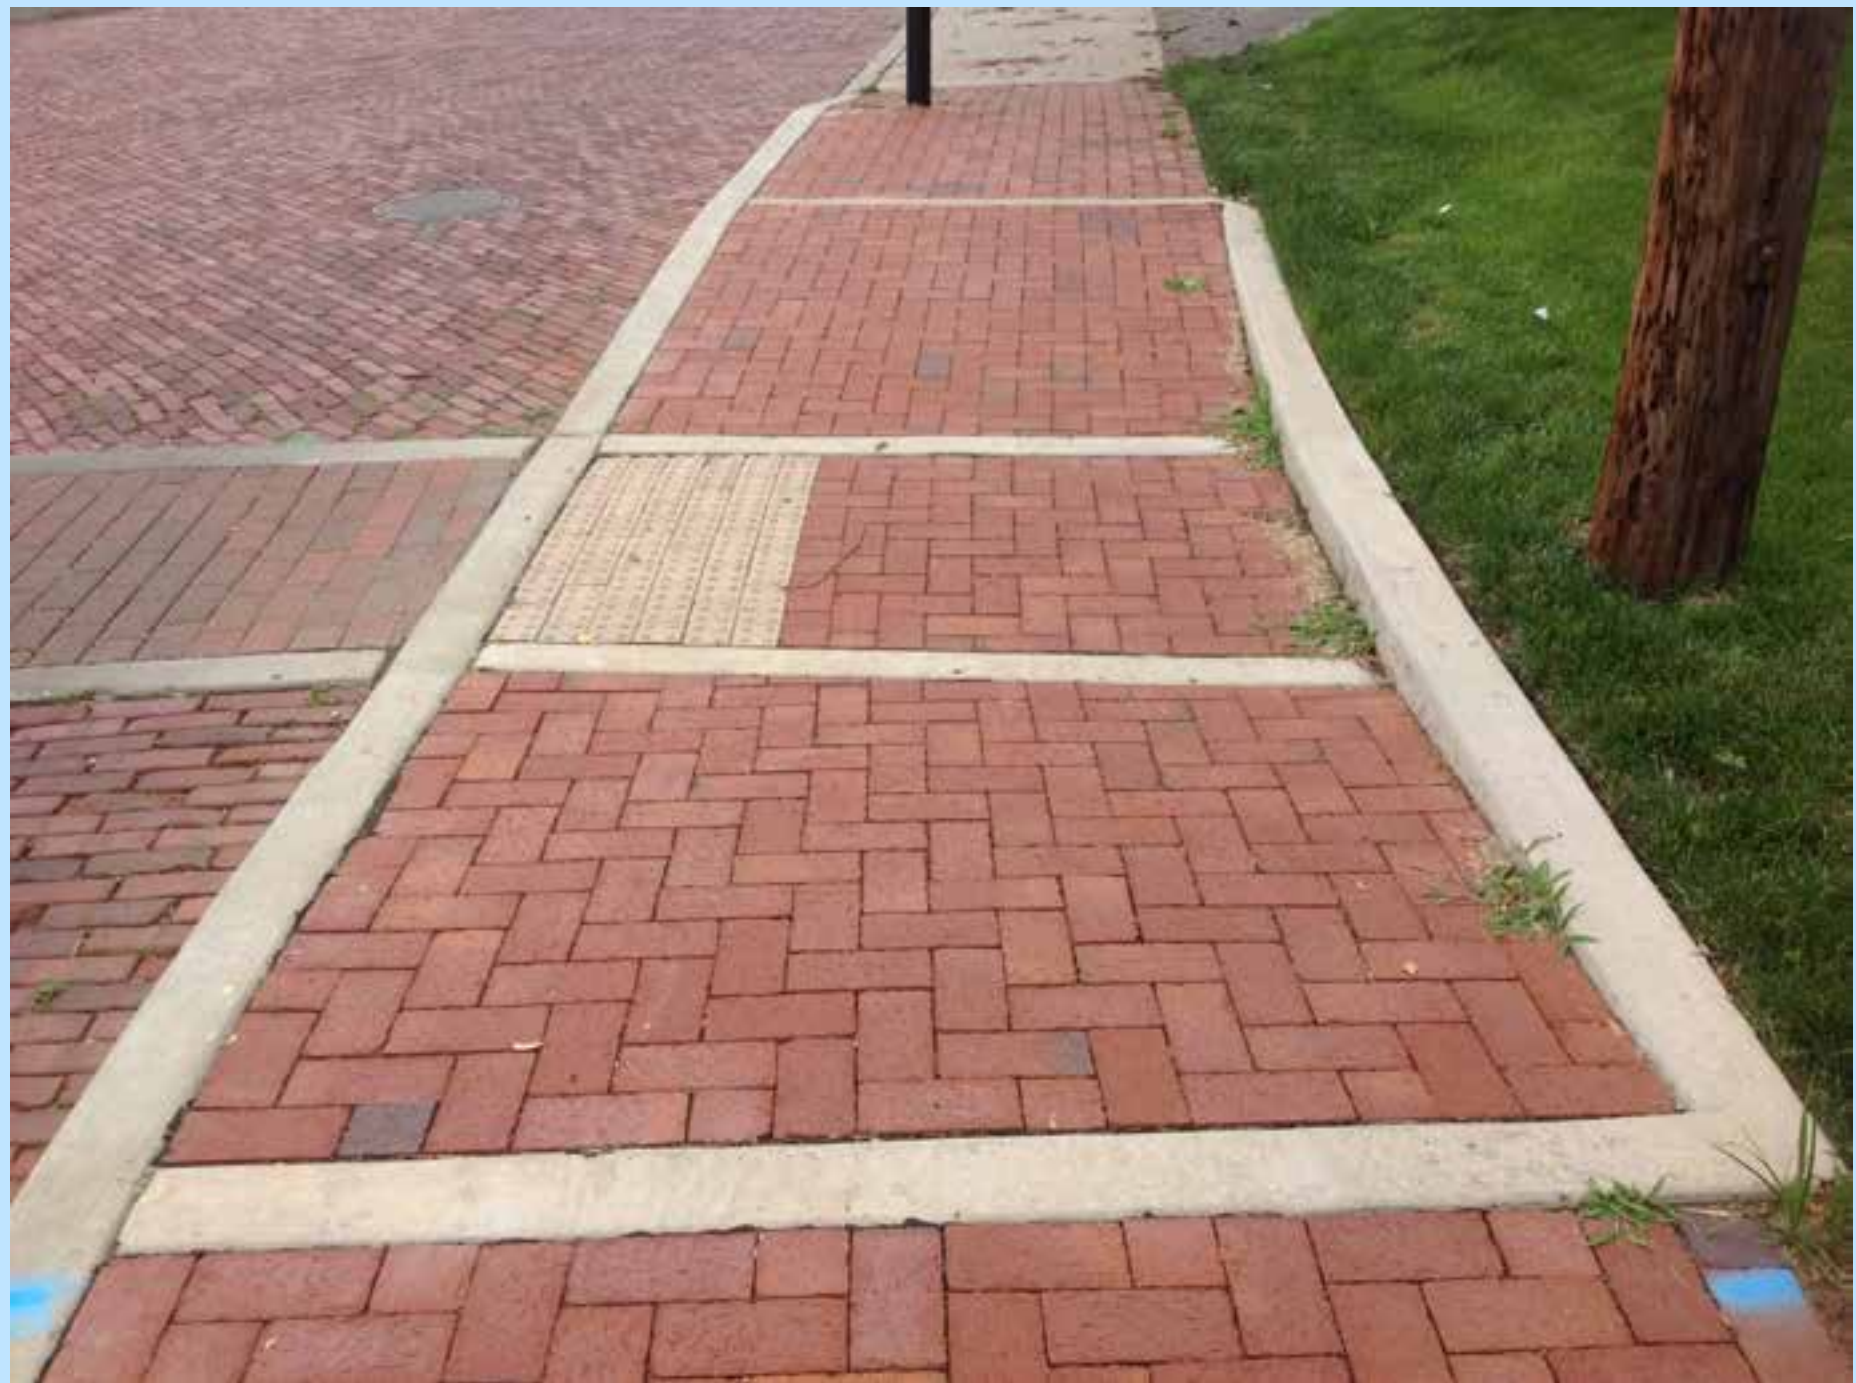
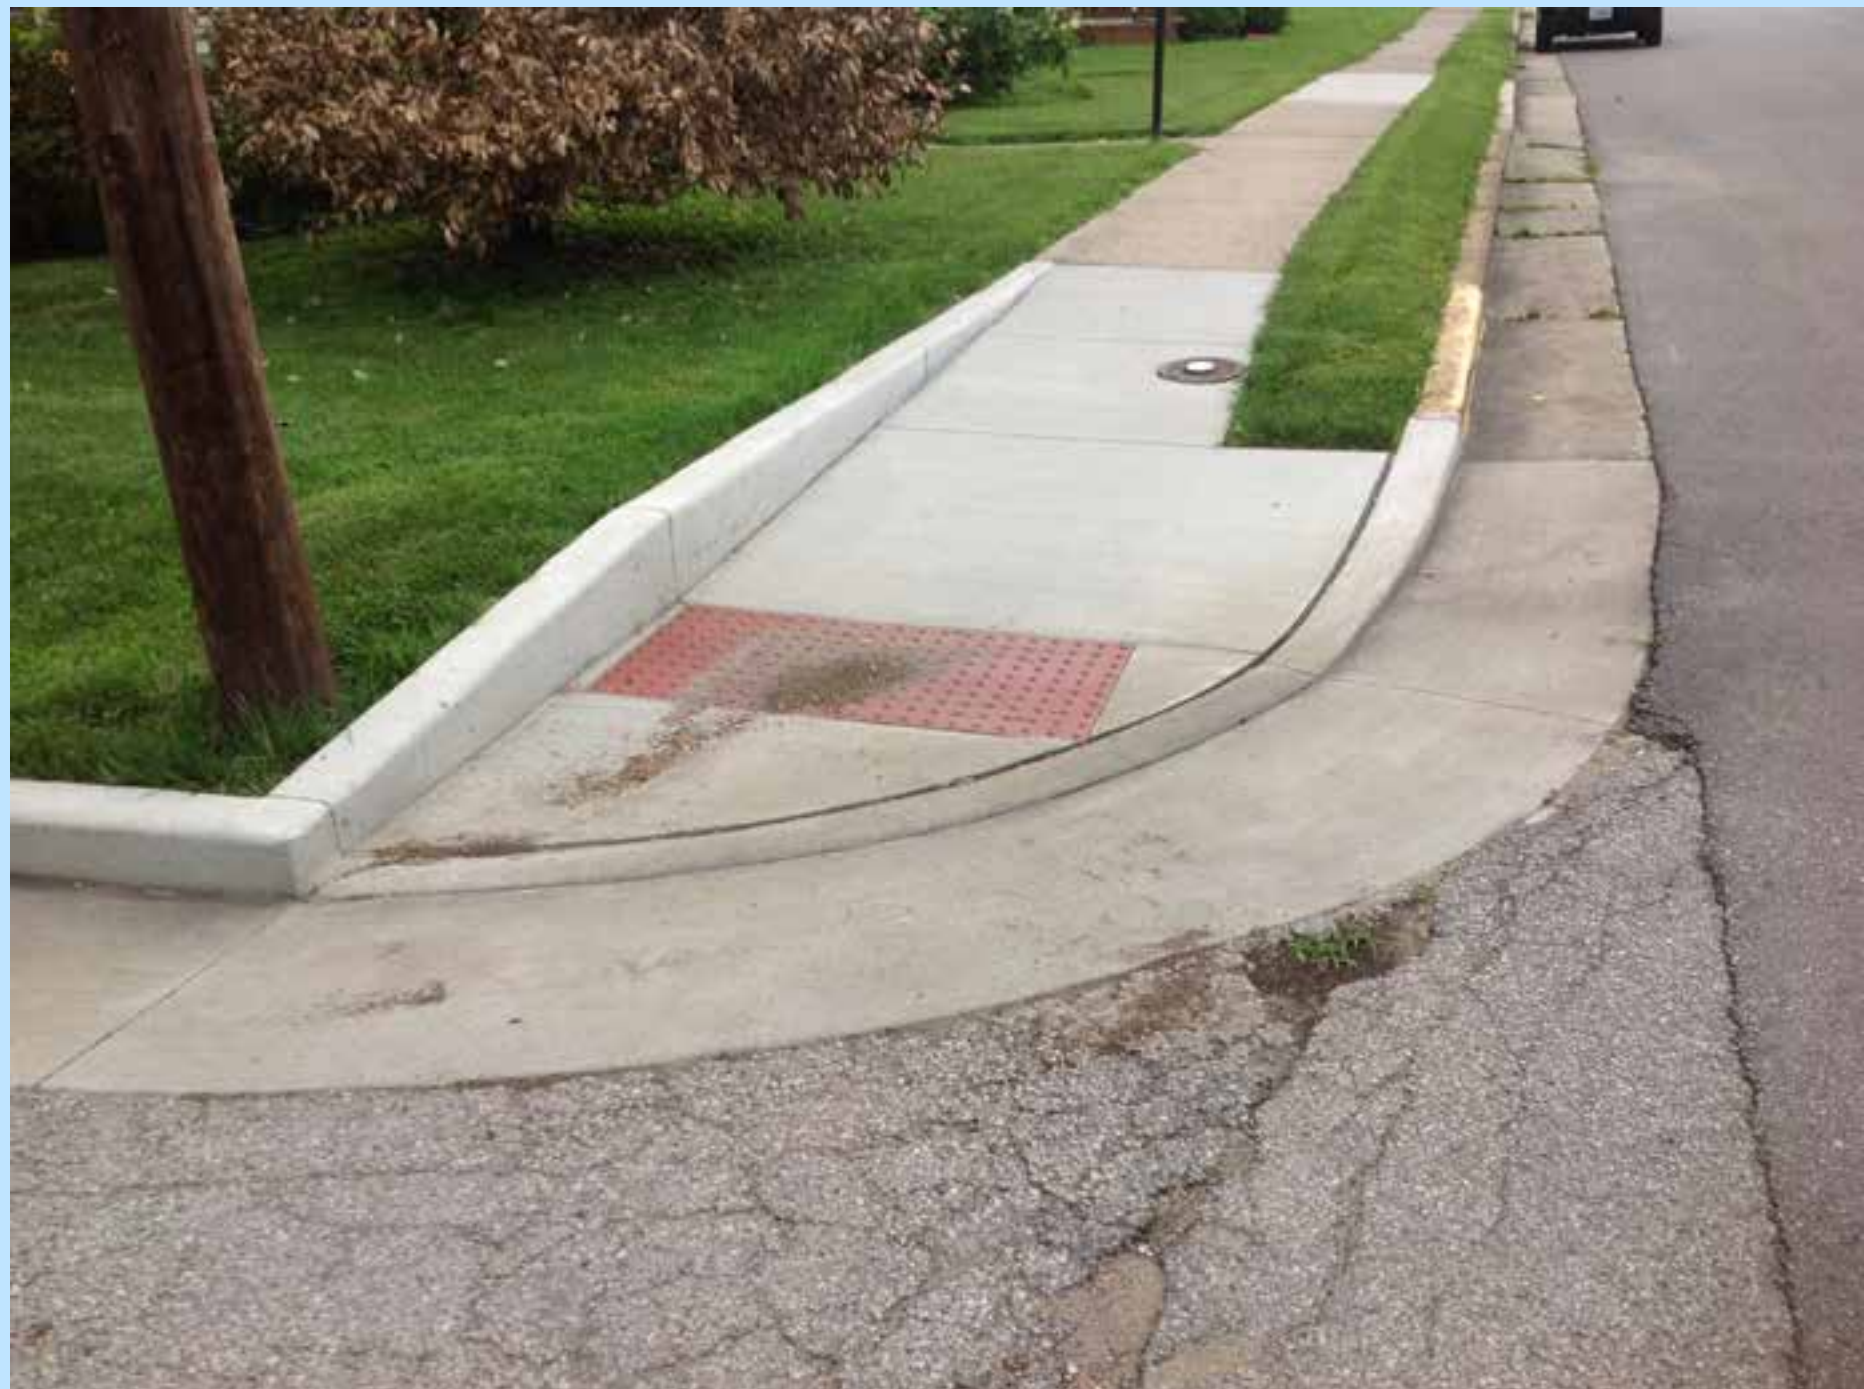
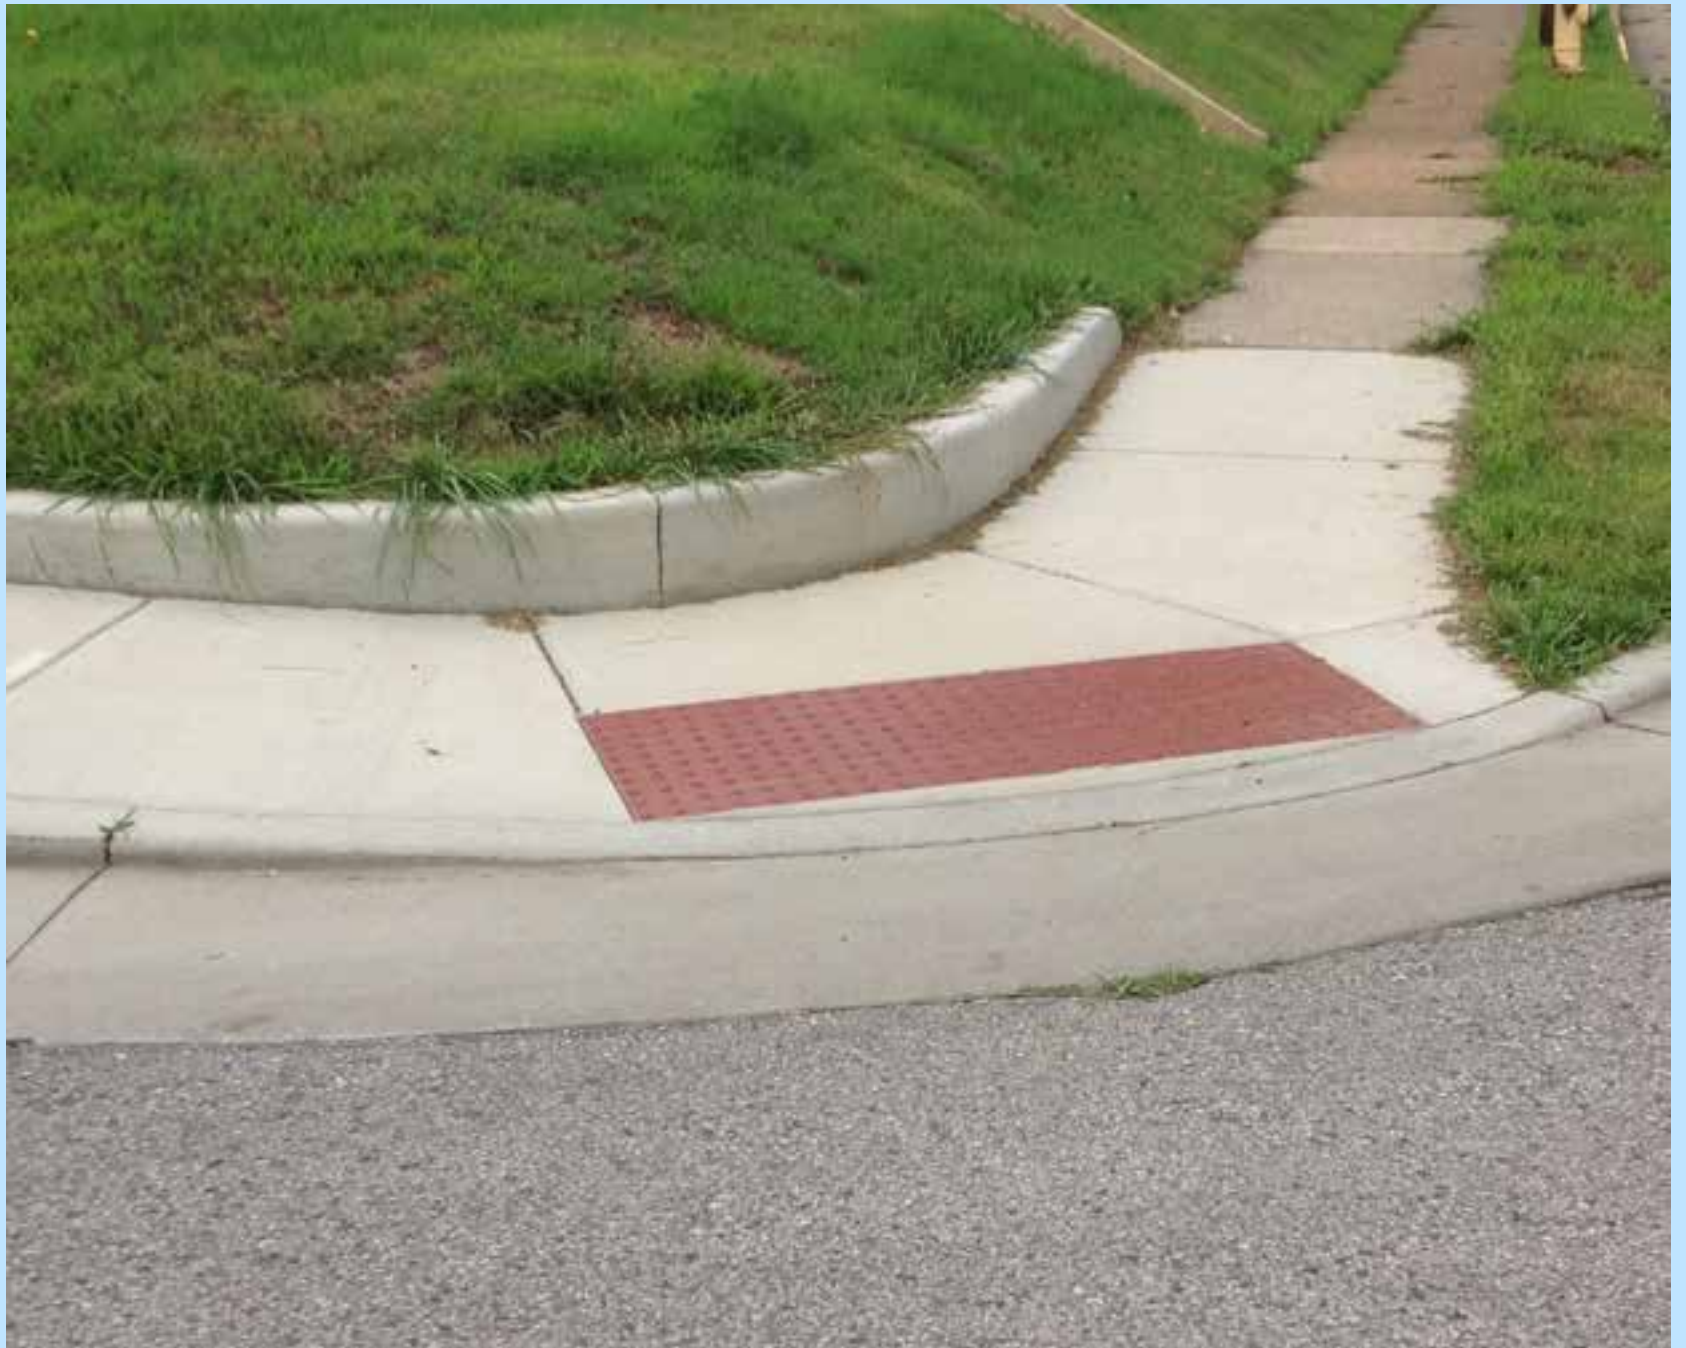
- ∅ By incorporating the field data into GIS allows the City to create color coded maps that highlight the deficiencies within the sidewalk system. These maps have been used in federal grant applications to highlight needs and visually illustrate the existing condition.
